Case Study: Deterioration due to Structural Response

Bridge Introduction

The system is composed of two adjacent bridges, each a four-span, steel, multi-girder bridge with a cast-in-place deck. The bridge serves more than 100,000 vehicles per day and serves as a major link to the George Washington Bridge.

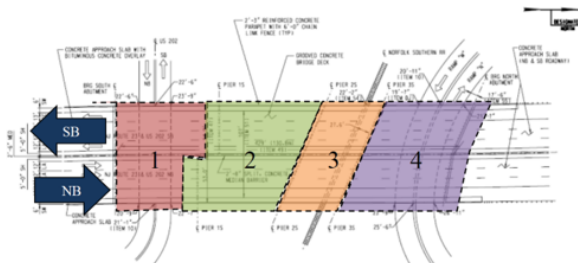
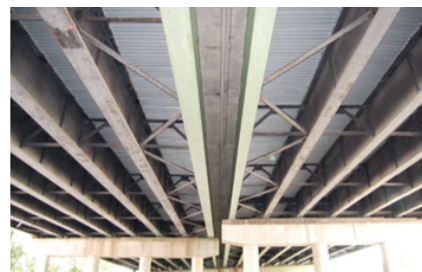
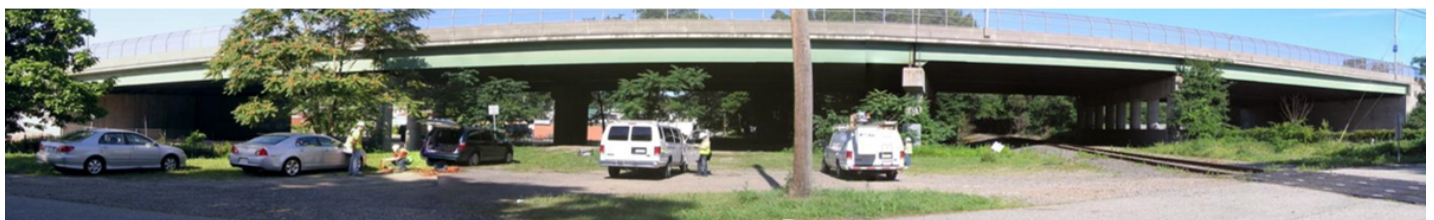
The following performance issues were observed:

- The bridge exhibited fatigue cracks in the girder webs at the wind bracing connections. The exterior bearings were heavily corroded.

- One bearing had a broken pintel allowing it to rotate (about it's vertical axis). Deteriorated joints permitted water to drain on top of the pier caps and bearings.
- The pier cap exhibited a large crack.
- Soil erosion had led to approach settlement, resulting in a bump at the bridge entry. Large traffic induced vibrations were reported.

- Wind bracing did not contribute to structural stiffness or strength capacity. They were, however, the cause of fatigue cracks and should therefore be removed.
- The corroded bearings were not significantly affecting bridge performance, but their ability to maintain bridge stability in the future is uncertain. FE simulations showed that any bearing replacements should be able to accommodate bi-directional movement.
- The large crack in the piercap can be attributed to improper rebar detailing. Dynamic amplification also contributed, and provides explanation for why the crack appeared only on one piercap, when improper rebar detailing could be found on other piercaps.
- The perceived excessive vibrations can be attributed to the bump at the beginning of the bridge caused by approach settlement.

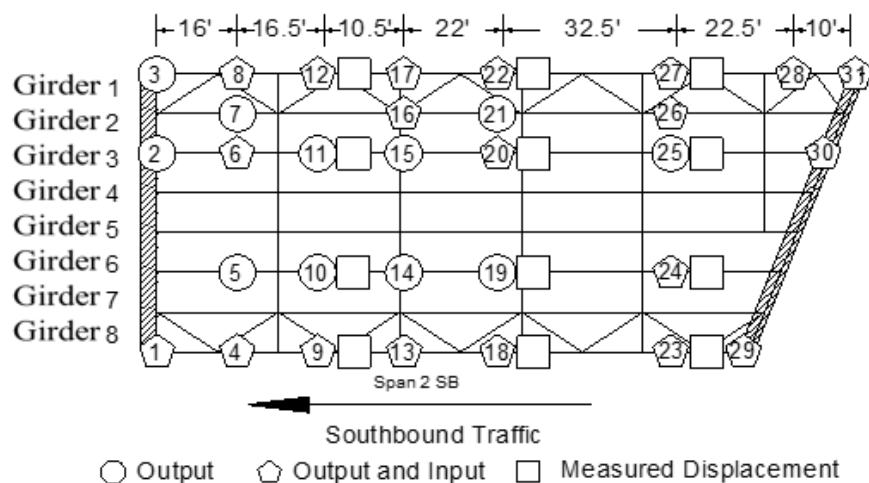
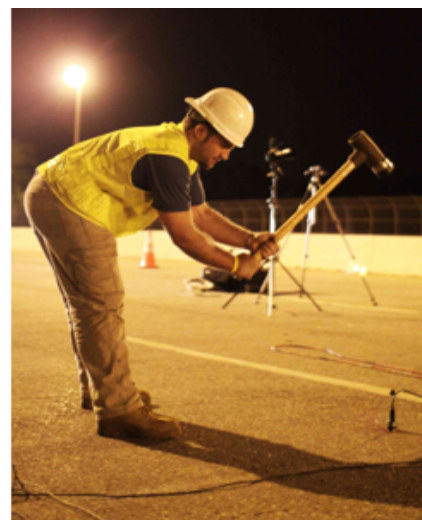
Thirty-one (31) accelerometers were used to capture bridge motion. The accelerometers were installed on the bottom flange of girders six and eight, while the remainder of the sensors were installed on the top of the deck. These accelerometers were used to record the bridge motion under operational conditions as well as due to controlled impacts. The impact test was performed by impacting the deck with a 25 pound instrumented sledge (load cell) at 20 locations. Impacts generally induced forces between 4 and 5 kips with broadband frequency input.

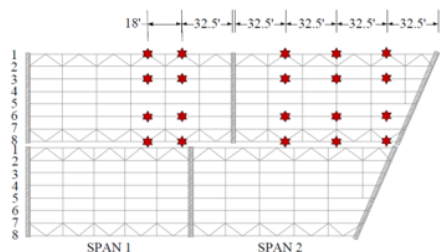
Twenty (20) displacement gauges were installed on the girder bottom flanges. Strain gauges with a gauge length of 1" were welded on the girders, diaphragms and wind bracing. At several locations on the girders multiple strain gauges were placed along the girder elevation in an effort to capture the strain profile along the girder cross-section. A clip gauge was also installed across the crack on the pier cap to measure any widening.

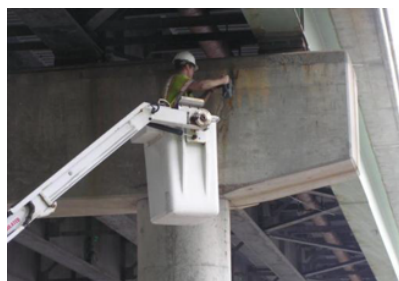
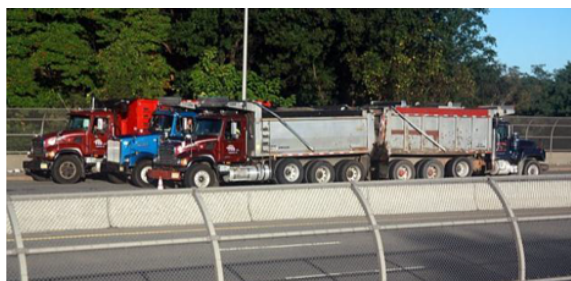
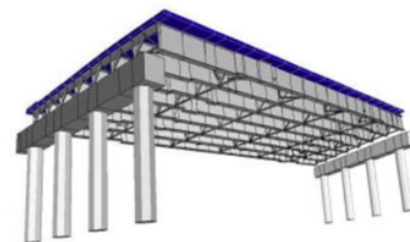
Load was supplied by six tridem dump trucks, both empty and filled. Load levels progressed from 87 kips (3 empty trucks) to 460 kips (6 full trucks).
