## Case Study: Steel Multi-Girder Bridge

### Bridge Introduction

## Case Study: Deterioration due to Structural Response

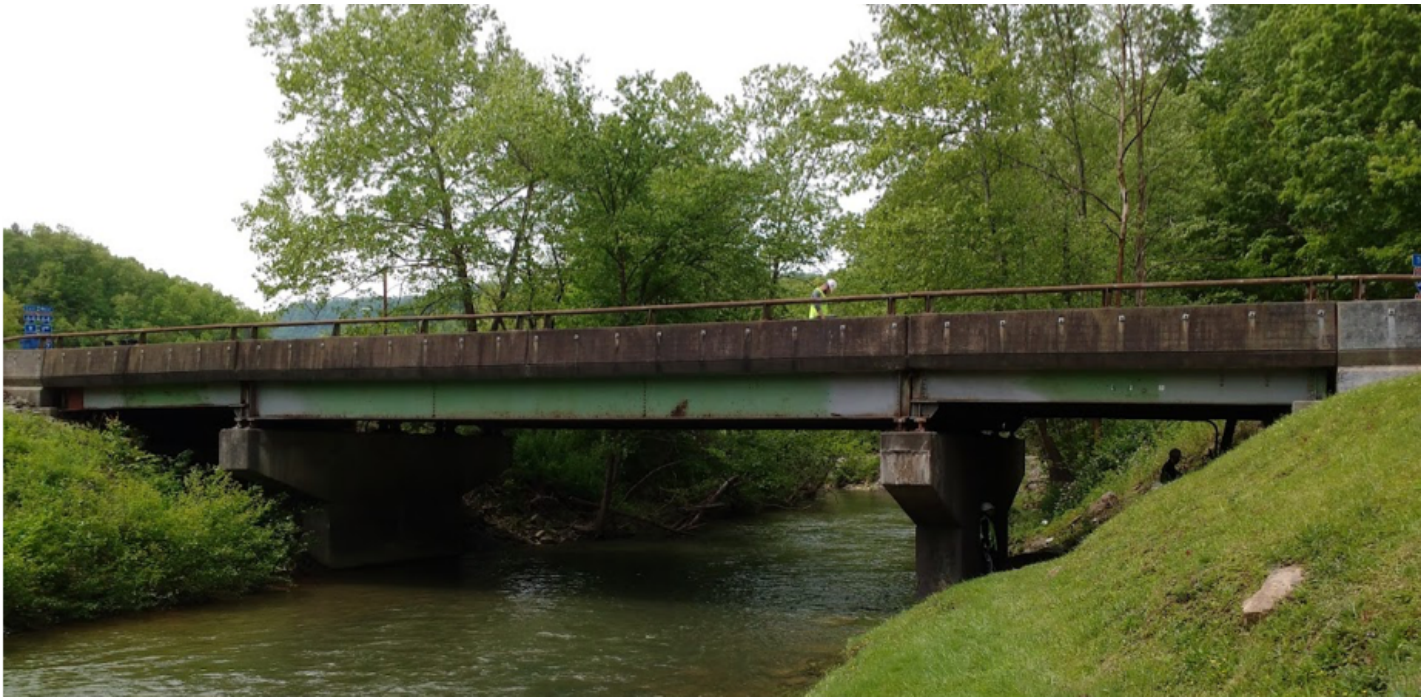
Several bearings were heavily corroded. In these areas, the bottom flanges of the girders also showed considerable corrosion, as already indicated in past inspection reports. This corrosion was likely due to the failure of deck seals in the expansion joints. Furthermore, a bearing on the northern exterior span over the pier was observed to have lost connection to the superstructure. While this “floating” bearing was not a threat to bridge stability, it was indicative of the significant corrosion of the bearing system. The hammerhead piers exhibited signs of efflorescence and some cracking and spalling beneath the bearings. There were also areas on the ends of the hammerhead that have had repairs performed as evidenced by new concrete.

The deck showed signs of shear failure where concrete had broken off as deep as the top layer of reinforcement. Several regions also evidenced deck repairs and patching. It is postulated that the failure of the deck was, in part, due to the braking forces from trucks as they came to a stop at the stop sign at the end of the bridge. It is also possible that the 7” deck as indicated in construction drawings is insufficient to provide durability and adequate reinforcement cover. The underside of the deck had spider web cracking and some efflorescence.

- In spite of the evident deterioration, the structure is capable of carrying legal load levels as evidenced by the successful proof-level load test. The load posting can be removed.
- The conservatism of the structure can be attributed to its ability to effectively distribute load as revealed by the bridge responses during the load test and through the use of refined FE modeling.
- The deterioration of the structure, while not immediately threatening to its capacity, is a concern for the ongoing health of the bridge if allowed to continue. Repair of the deck and deck seals and corroded bearings was therefore recommended.

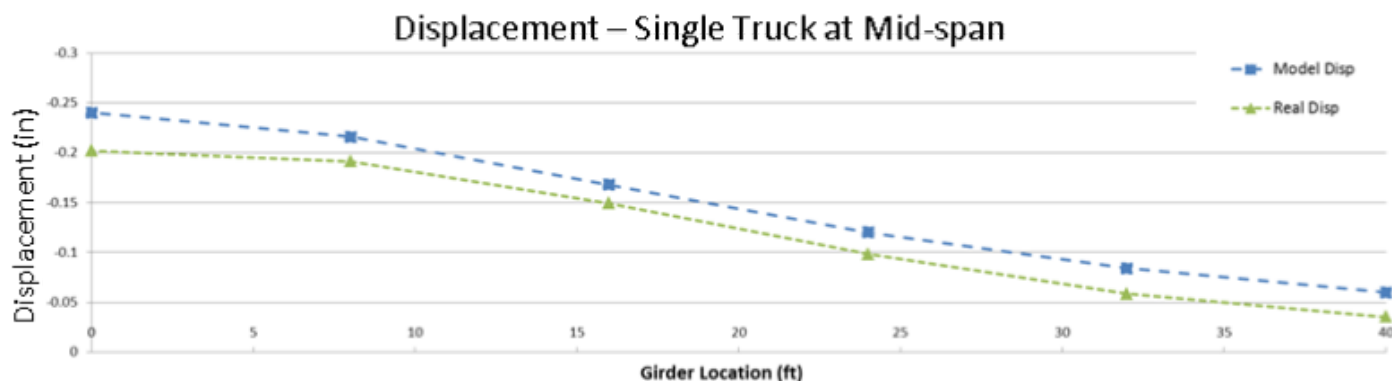
To perform linearity checks, load levels were varied: empty, half-filled, and full. The plot of displacement vs. load shows that the midspan remains predominantly linear through the load levels. A small amount of stiffening can be observed in some girders, which can be attributed to an increase in load transfer through mechanisms that were only engaged under higher level loads as would be expected in a large structure such as this, as the load distributing mechanisms are numerous and varied and may engage to varying levels as the load level is varied.

These results indicate that the proof level was reached without the structure experiencing any distress and therefore has a passing load rating. Furthermore, in spite of the apparent deck deterioration, the structure is still able to effectively distribute loads laterally to adjacent girders, thereby reducing the demand on any single girder. During the load test and for the many truck configurations, no girder ever experienced more than 50% of the imposed load.
