Excessive Vibrations: I-76 Case Study

Example Case Study - I-76 Pencoyd Viaduct

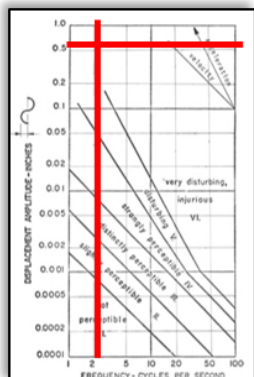
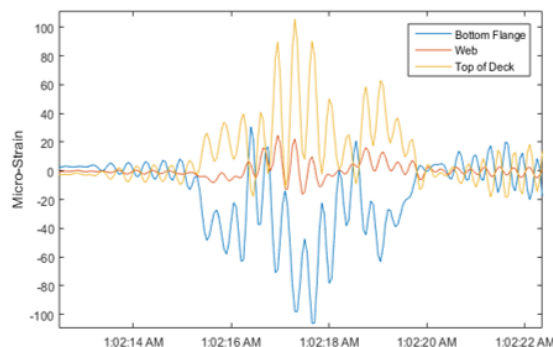
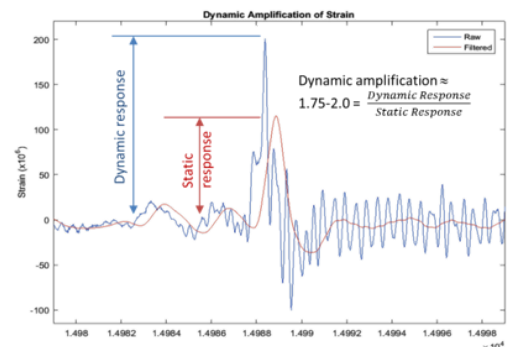
This vibration corresponds to approximately $\frac{1}{2}$ " of displacement which places this bridge in the category of "very disturbing" according to human comfort criteria (Reiher and Meister, 1931). The strain in the deck was extrapolated at midspan and the negative-moment region, revealing events that resulted in strain in excess of 100 microstrain – levels for which long term fatigue cracks begin to form. Dynamic amplification of approximately 75% was estimated by filtering out content greater than 1.5 Hz.
