### **3.2 Selection of the IBS Test Bridge**

### **3.3 Overview of the Structure (Review of Design Drawings)**

### **3.4 Overview of Current Condition (Review of Inspection Reports)**

### **3.6 On-site Observations (Initial Field Visit)**

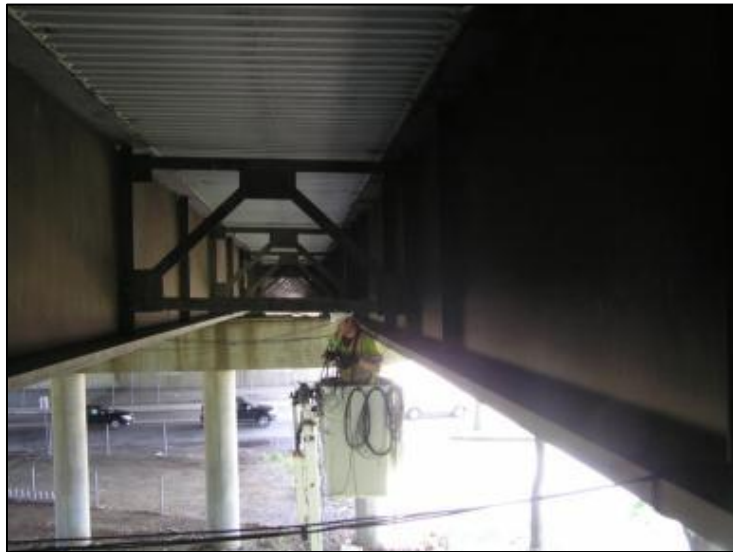
**Figure 3-4 - Typical Diaphragms**

The bridges contain diagonal wind braces (Figure 3-3) between the fascia and first interior girders on every span which are connected via a 'Category E' gusset-to-girder web detail, discussed in Section 3.4. The diaphragms are a standard truss-type composed of four single angles connected to the girders with bolted connections and gusset plates (Figure 3-4).
