Re: Water Drainage
Onto 100 St. Paul Street Condominium
Brookline, Massachusetts

Structural Investigation Report

100 St. Paul Street, Brookline MA, 02446

Prepared by
**SurfZone Engineering
Consultants LLC**
February 10, 2024

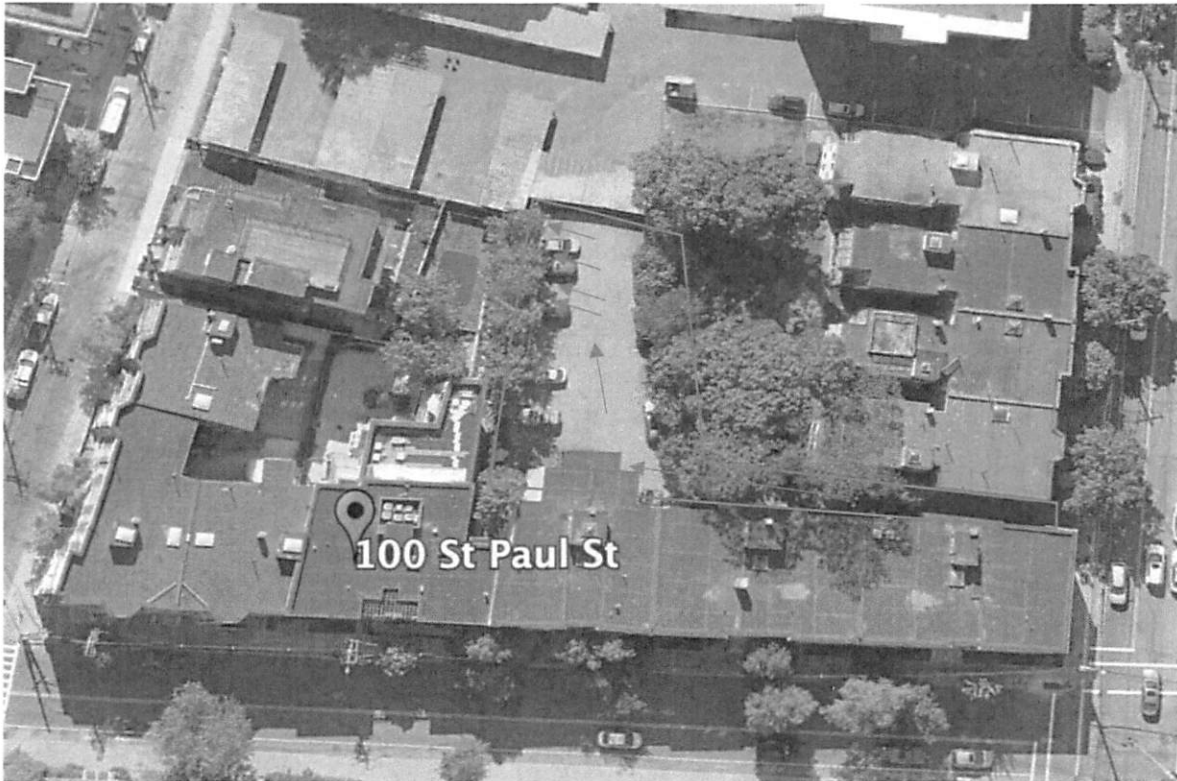
The subject structure was visited on February 1, 2024. The issue is in the backyard of the rowhouse condominium built in 2006.

The right neighbor at 108, 114, and 118 St. Paul St. condominium residential buildings has over 8,500 sqft of paved parking lot without a drainage system. The pavement sloped toward the 100 St. Paul St. backyard. A significant amount of runoff water flowing under the fence at the corner of the property lot has eroded the backyard landscaping and deteriorated the existing 3-foot-tall retaining wall and wooden posts.
