# AURIX™ TC38x errata sheet

**Marking/Step: (E)ES-AE, AE**

10464AERRA

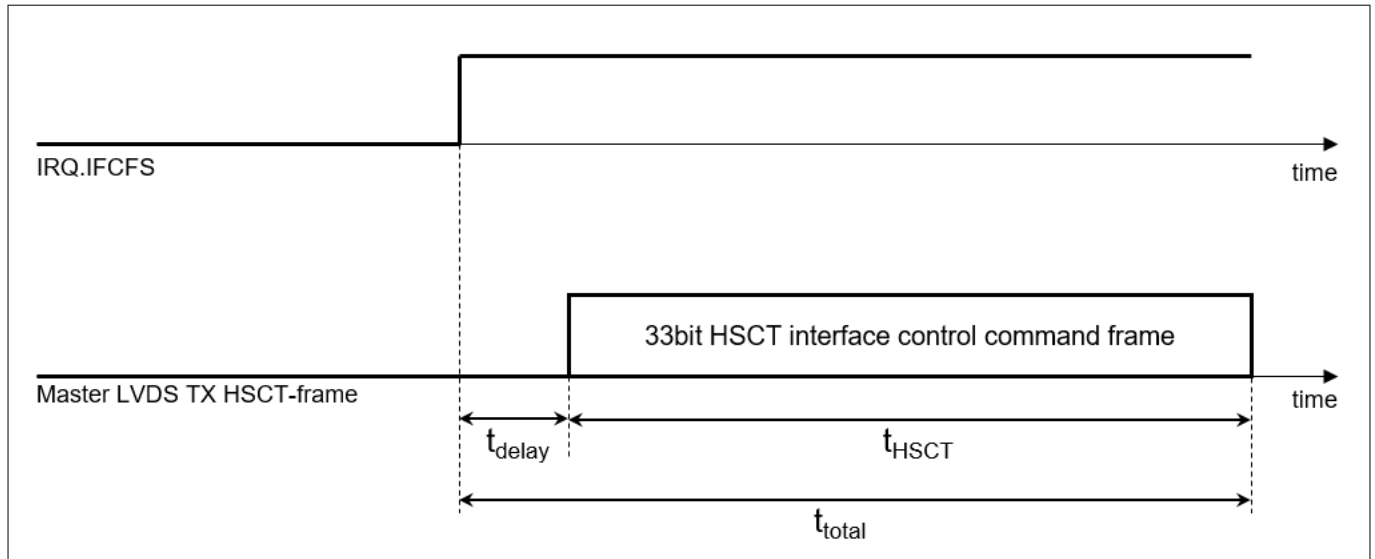
**Figure 14** Timing of LVDS TX interface command sending in relation to IRQ.IFCFS

Instead the timing shown in the following figure applies.
