AURIX™ TC37x errata sheet

Marking/Step: (E)ES-AA, AA

10467AERRA

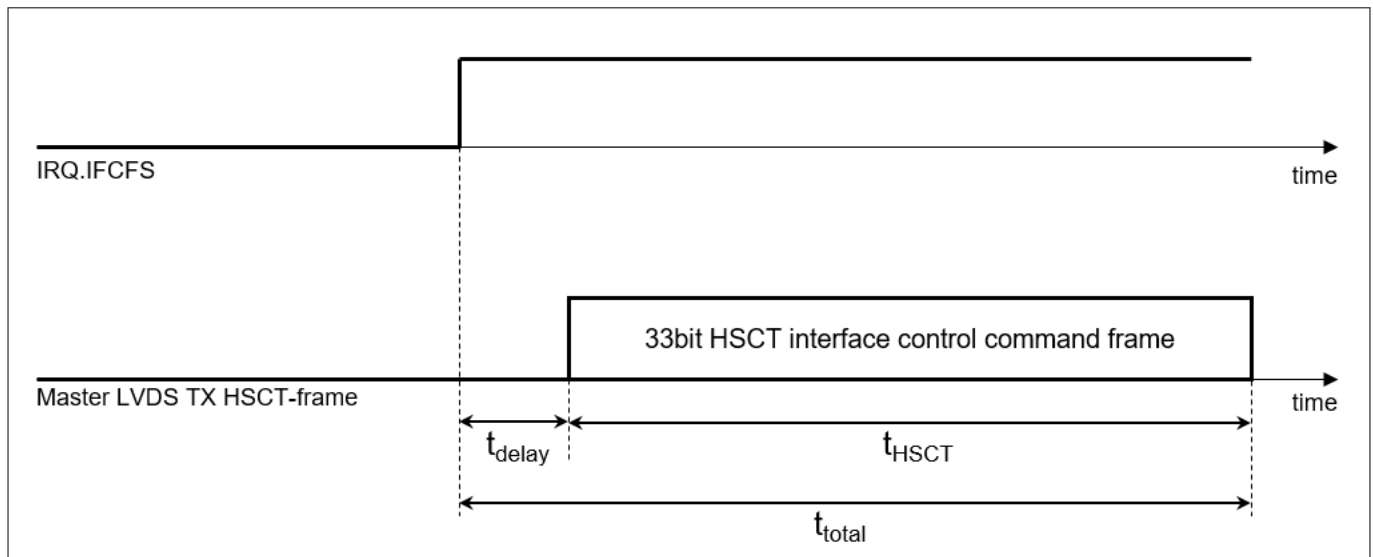
Figure 13 Timing of LVDS TX interface command sending in relation to IRQ.IFCFS

the user might falsely assume that also the actual sending on the LVDS TX port has already occurred once the IRQ.IFCFS flag is set, which is not true.

Instead the timing shown in the following figure applies.
