# AURIX™ TC37xEXT errata sheet

**Marking/Step: (E)ES-AB, AB**

## About this document

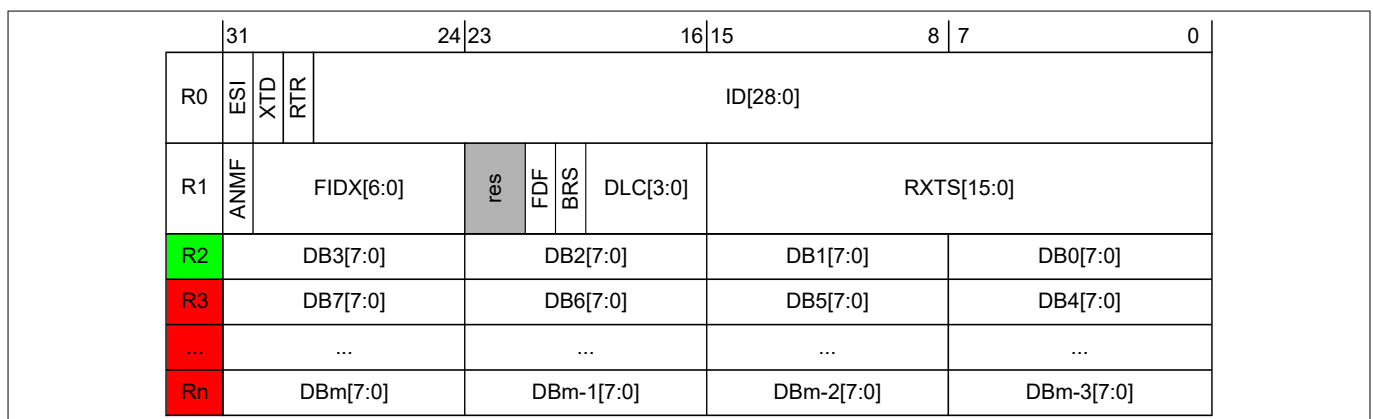
**Figure 9 TC3xx - Rx Buffer and FIFO Element (R<sub>i</sub> holds Data Byte DB(x+3)..DBx (with  $x=4*(i-2)$ ))**

Received data bytes (DB0..DBm) from the CAN Core are buffered in the cache of the Rx Handler before they are written to the Message RAM (in words of 4 byte). Data words inside the Message RAM are numbered from R2 to Rn ( $n \leq 17$ ).

Under the following conditions a received message will have corrupted data while the received message is signaled as valid to the host.

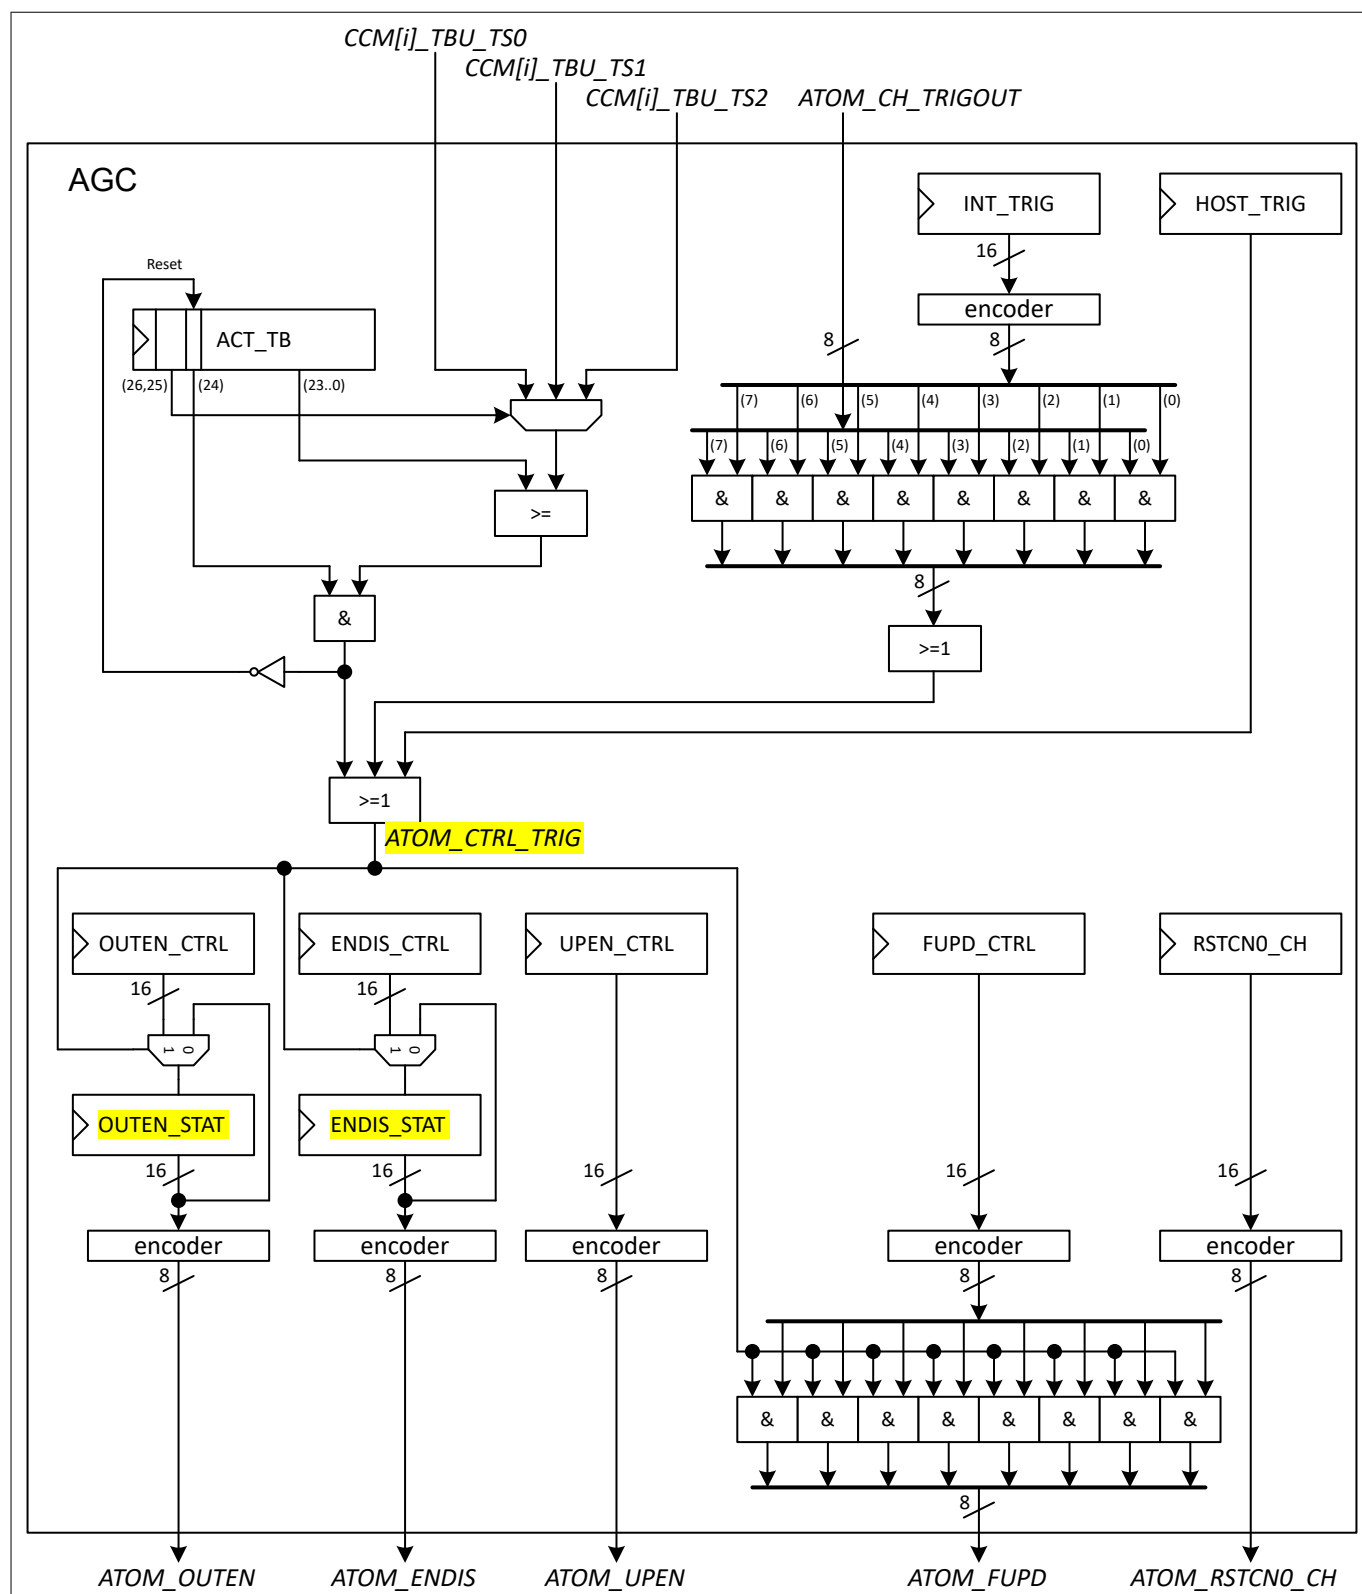
**Figure 11** ATOM Global channel control mechanism

ATOM[i]\_AGC\_ENDIS\_STAT or also ATOM[i]\_AGC\_OUTEN\_STAT is ignored, regardless of the update value from the associated registers ATOM[i]\_AGC\_ENDIS\_CTRL/ATOM[i]\_AGC\_OUTEN\_CTRL.
