AURIX™ TC33x/TC32x errata sheet

Marking/Step: (E)ES-AA, AA

10471AERRA

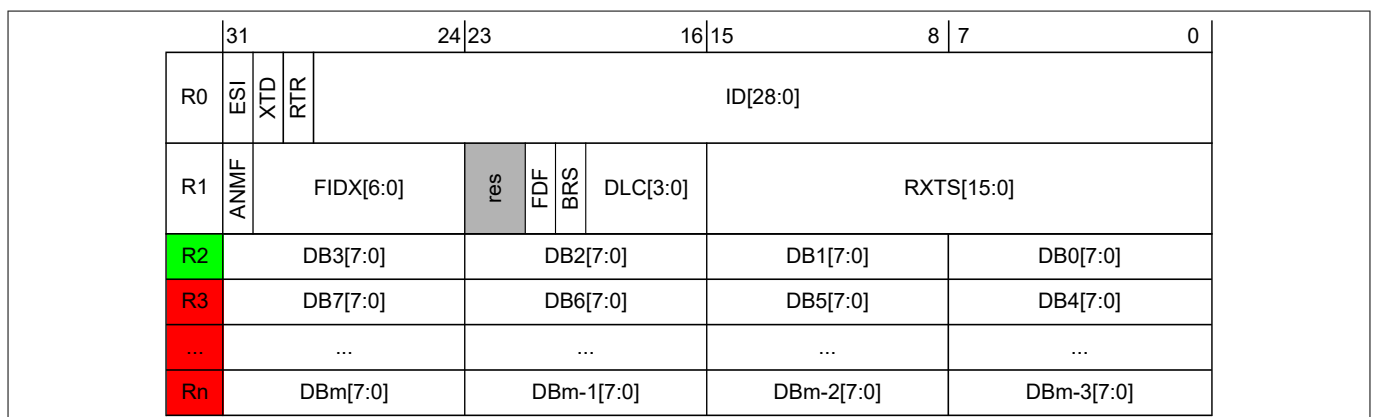
Figure 4 TC3xx - Rx Buffer and FIFO Element (R_i holds Data Byte DB(x+3)..DBx (with x=4*(i-2)))

Received data bytes (DB0..DBm) from the CAN Core are buffered in the cache of the Rx Handler before they are written to the Message RAM (in words of 4 byte). Data words inside the Message RAM are numbered from R2 to Rn ($n \leq 17$).

Under the following conditions a received message will have corrupted data while the received message is signaled as valid to the host.

1. The data length code (DLC) of the received message is greater than 4 ($DLC > 4$)
2. The storage of R_i of a received message into the Message RAM (after acceptance filtering is done) has not completed before R_(i+1) is transferred from the CAN Core into the cache of the Rx Handler (where $2 \leq i \leq 5$)
3. While condition 1) and 2) apply, a concurrent read of data word R_i from the cache and write of data word R_(i+1) into the cache of the Rx handler happens

Due to condition 3) the issue only occurs sporadically. Use an end-to-end (E2E) protection (for example, checksum or CRC covering the data field) and add it to all messages in the CAN system, to detect data corruption in received frames.

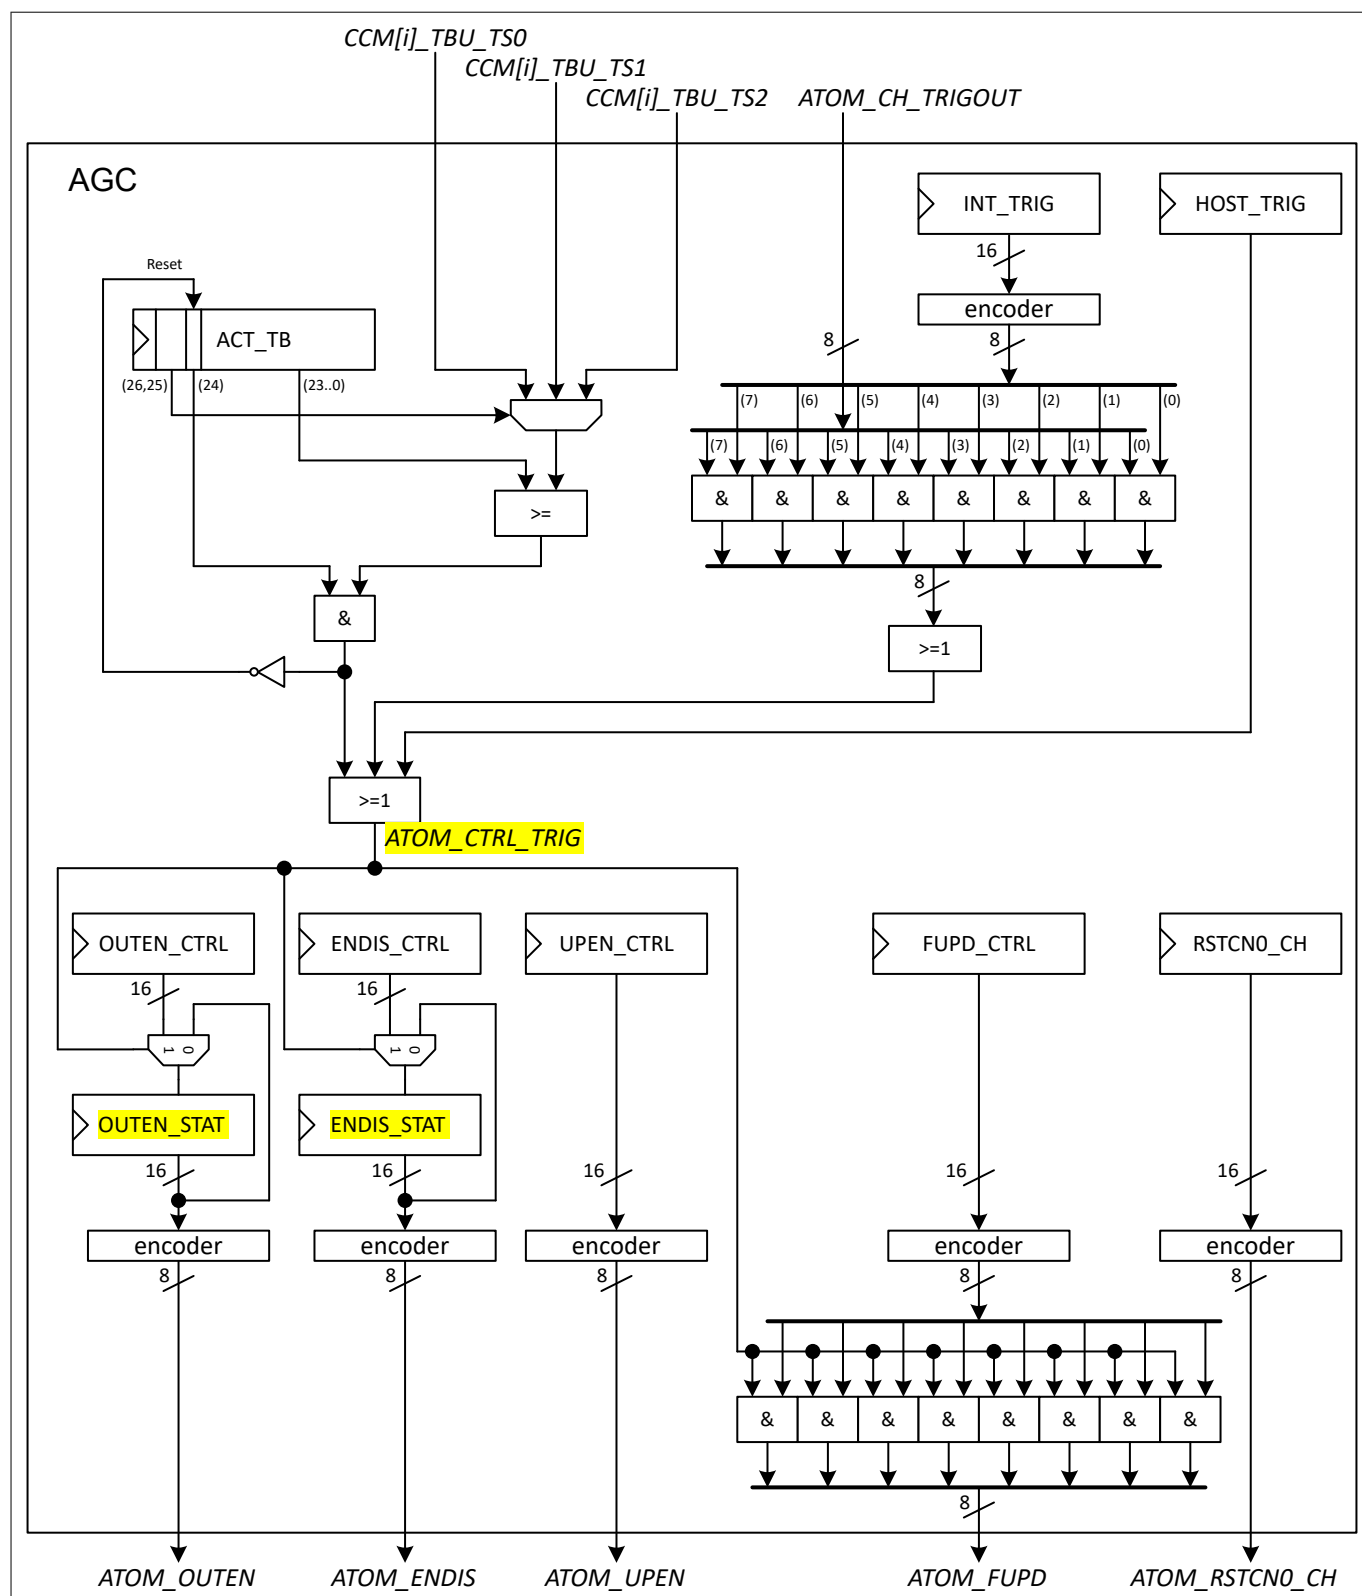
Figure 6 ATOM Global channel control mechanism

The following behavior is part of the ATOM and also TOM. In the clock cycle in which ATOM_CTRL_TRIG (see yellow highlight in the attached figure) is active, a simultaneous bus write access to register ATOM[i]_AGC_ENDIS_STAT or also ATOM[i]_AGC_OUTEN_STAT is ignored, regardless of the update value from the associated registers ATOM[i]_AGC_ENDIS_CTRL/ATOM[i]_AGC_OUTEN_CTRL.

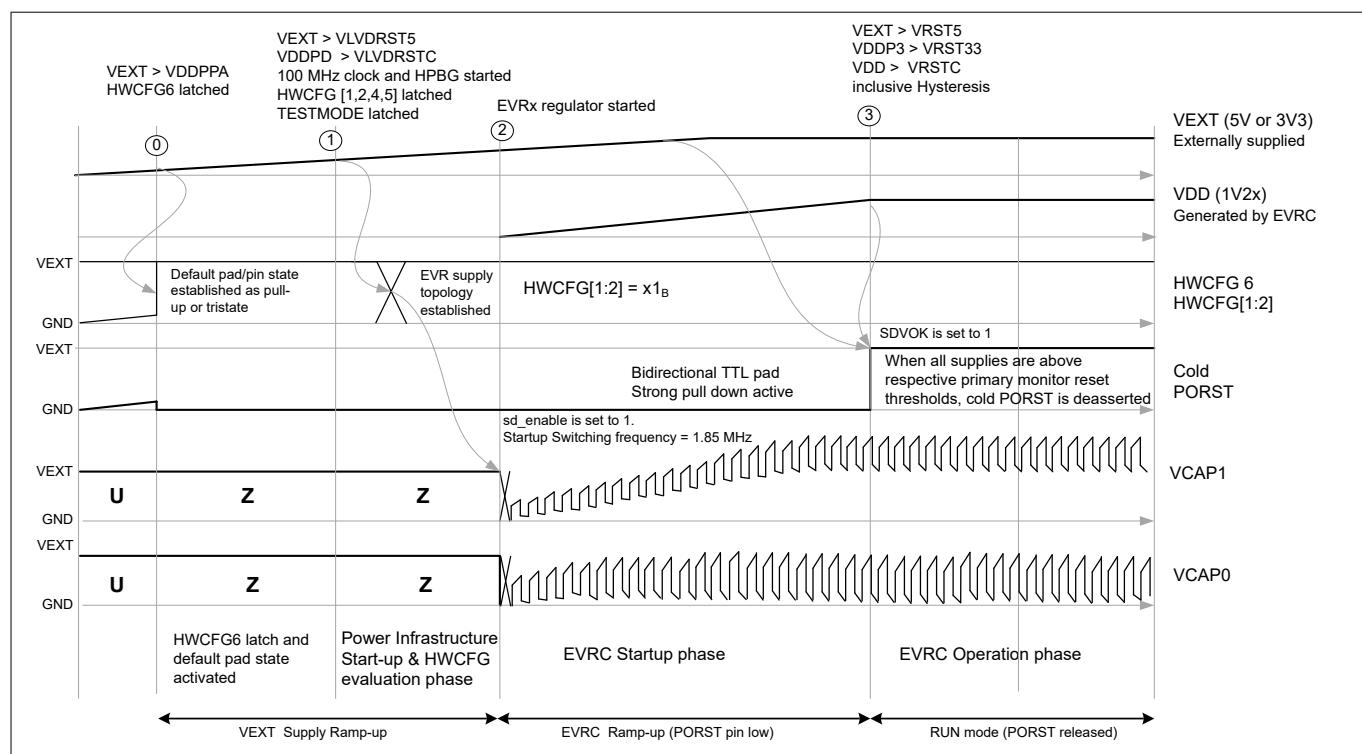
Figure 11 VCAP behavior during start-up when EVRC regulator is used - corrected

See corrected figures included below.
