Some Uncertainties in Embankment Dam Engineering¹

Victor Milligan²

Abstract: In the design and construction of embankment dams, our current capability for precise mathematical analysis and modeling of induced stresses and deformations, or of potential seepage patterns, far exceeds our capability to make judgments of comparable accuracy concerning, for example, the site and geology or how the soil properties may be affected by the weather or by the contractor's methods. In addition, there is often a lack of adequate communication between the design and the supervision of construction. These uncertainties or doubts about the actual performance of the dam when constructed are discussed in the paper and illustrated by case history examples, with particular reference to the uncertain effects of cold weather, to the use of broadly graded soils (tills) as core and to problems in the placement, and segregation of tills and filter materials.

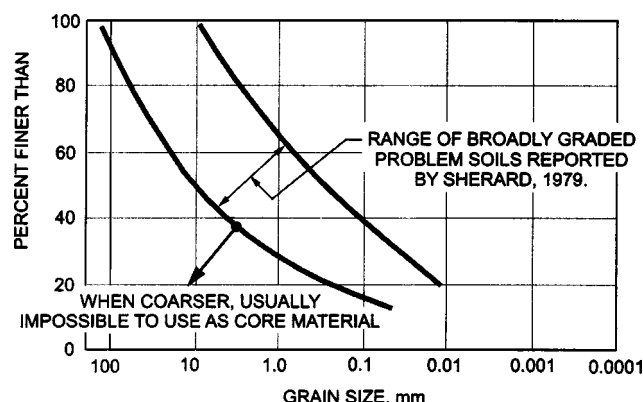
Fig. 3. Broadly graded problem soils [after Sherard (1979)]

The risk of using coarse, broadly graded soils as cores has been examined in a thought-provoking paper by Sherard (1979). He discussed a number of seepage incidents in dams and concluded that soils within the typical gradation illustrated in Fig. 3 are internally unstable, because the fine portion is not compatible with the coarser particles from the standpoint of filter requirements. He considered this instability to be the principal cause of sinkholes that have appeared, sometimes several years after initial impoundment, in the crest of well constructed modern embankment dams where relatively thin, central, nonplastic cores (generally glacial tills) were used. In all the examples cited by Sherard, a single broadly graded downstream filter was provided adjacent to shells of rock fill or gravel; in most of the examples, the foundation bedrock below or against the core was jointed.

character of the fines content depends on the source rock. For example, in Canada the source rocks in much of the western Prairie provinces are sedimentary and the fines can be of high plasticity: in eastern Canada, where the source rocks are igneous or metamorphic, the fines in these tills are either nonplastic (rock flours) or have relatively low plasticity. Most of the incidents, not exclusively, apparently occur in tills of lower plasticity and follow a similar pattern. A leak develops near the base of the core and the finest soil particles are carried away passing through the broadly graded filter into adjacent coarse fill, or into joints in the foundation rock. The remaining "washed" core material is then incapable of preventing progressive erosion of fines over the full height of the core and sinkholes at the crest of the dam then result.

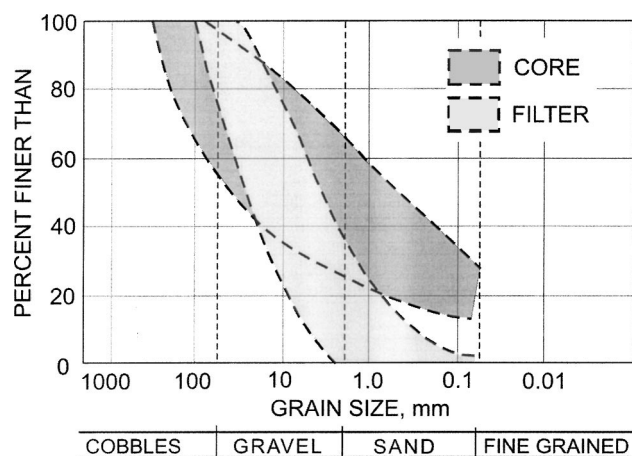
Fig. 7. Incident 1—Core and filter gradations

A longitudinal section of the dam, looking upstream, and a simplified geologic section along the centerline are shown on Fig. 6. Core and filter gradations are given on Fig. 7. Blanket grouting to a depth of more than 6 m was carried out along the complete core/foundation contact area, but not up the abutments.

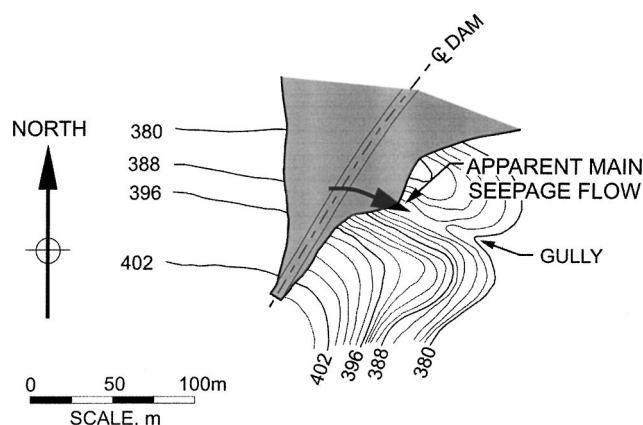
Fig. 9. Incident 1—Plan of south abutment

During initial impounding, when the reservoir level approached within about 4 m of the crest, seepage was observed at the toe of the downstream shell in the lower part of the gully referred to above (Fig. 9). The rate of seepage rose abruptly to about 200 L/s (6 cusecs). The water was relatively clean and contained little sediment. No seepage was evident elsewhere along the toe of the dam and seepage was apparently confined to this local area.

- Horizontal cracking in the core caused by arching of the core fill across the gully;
- Seepage through joints in the foundation rock, possibly opened by blasting for the emergency spillway excavation, and connecting directly to the reservoir at a relatively high elevation; and
- Seepage at the core/foundation contact zone within the gully leading to fines being washed out from the core material, which were not retained by the coarsely graded downstream filter.

Steps were taken immediately to lower the reservoir level; as it lowered, the rate of seepage reduced correspondingly. Investigation of the condition of the core and of the core/foundation contact zone in the gully area was commenced using hollow stem

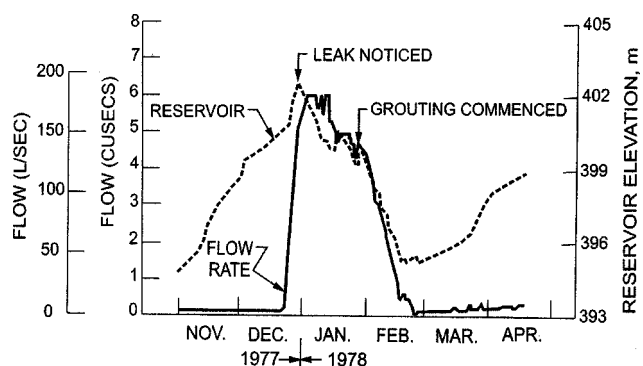
Fig. 11. Incident 1—Observed seepage flow rates

augers to penetrate the core, drilling from crest level. (This method was adopted in order to avoid possible hydraulic fracture, which might be induced by wash boring methods.) The borings indicated the core to be intact throughout its depth except for soft zones close to the contact with the underlying foundation in several borings located on the south side of the gully area. Other borings taken into rock in the same area indicated significant water takes within about 10 m of rock surface. Low-pressure cement grouting was then carried out in rock over about a 100 m length, extending from the gully to the south abutment; holes within the dam fill were backfilled with sand/cement/bentonite grout under gravity head. The effectiveness of the grouting is demonstrated in Fig. 11; the reservoir level was then raised to full height with no further incidents of seepage.

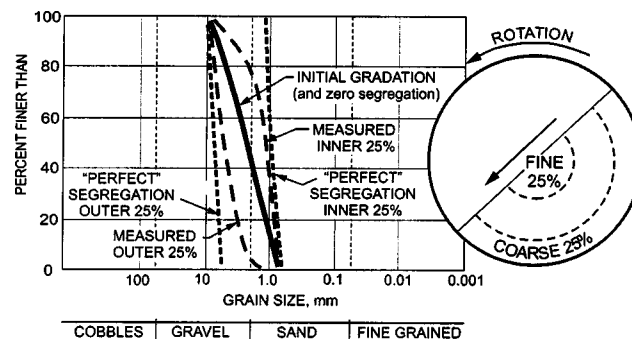
Fig. 16. Relative segregation index

Uncertainty always exists in ensuring that filters and transition materials are placed satisfactorily without leaving segregated zones of sufficient coarseness, which would permit loss of fines from the core. It has been pointed out by Milligan (1986) in discussion to the paper by Kenney and Lau (1985), which examines the internal stability of granular filters that the gradations of the "unstable" materials tested tend to be typical of materials which segregate readily. In relation to this problem, the later work on the segregation of cohesionless soils carried out by Kenney and Westland (1993) is extremely relevant and provides an approximate method of quantifying their potential for segregation. Tests were carried out in the laboratory using a large rotating drum to induce segregation of a variety of relatively coarse granular materials. By sampling the inner and outer zones of the material after testing (each zone representing 25% of the total volume), they assessed the degree of segregation by defining a Relative Segregation Index (RSI), as illustrated in Fig. 16. If the outer zone corresponded in gradation to the coarsest portion of the initial sample and the inner zone to the finest portion, then this would represent perfect, or complete, segregation with a corresponding RSI of 1.0. If the initial gradation remained unchanged

in both zones, which would be the case if there were no segregation, then RSI would be zero. For results between these two extremes, the RSI can be expressed in relative proportion to the bounded areas illustrated on the grain size curve.

It was found that all the cohesionless soils tested, over a wide range of gradation, tended to segregate about the same amount *relative to their original gradation* with a corresponding RSI value of about 0.7. This result is particularly significant in relation to the placement of filter materials. Even for the uniform sand and gravel shown in Fig. 16, the D_{15} size of the material, when segregated, could possibly range from about 0.9 to 3 mm. While we must recognize that the rotating drum test produces an extreme degree of segregation, which probably exceeds that which usually occurs in engineering practice, this range is excessive if a maximum D_{15} value of 1.0 mm has been assumed for design. In itself, this is a strong argument against the use of broadly graded filters. However, if the filter has a gradation corresponding to that of a concrete sand, a potential RSI of 0.7 gives a possible range of D_{15} size from about 0.2 to 0.7 mm, which is acceptable for the protection of almost all soils.

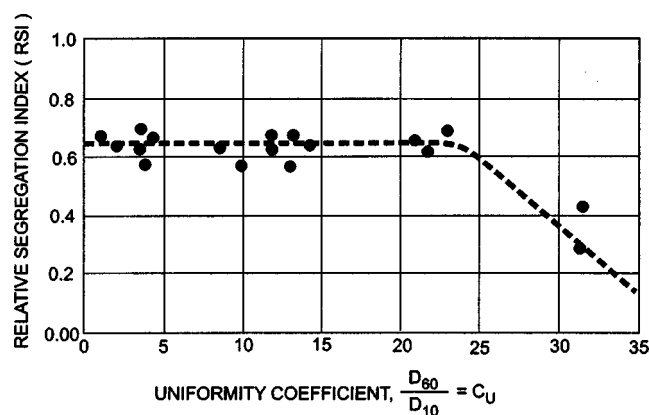
Fig. 17. Influence of the degree of uniformity on segregation

While some degree of segregation of *dry* cohesionless coarse materials can thus be assumed to be almost unavoidable, an increased content of sand sizes markedly inhibits segregation *provided that* the material is wetted prior to placement. The apparent reduction of RSI when the uniformity coefficient ($C_u = D_{60}/D_{10}$) exceeds about 25, as noted in Fig. 17, is the result of increasing fines (<0.06 mm sizes) in the *dry* material tested. If the more sandy materials are *wetted*, segregation is almost completely inhibited; in contrast, water has little influence on the segregation behavior of gravels. A very approximate gradation limit to the effect of wetting in preventing segregation is indicated in Fig. 18 (Milligan 1999). It is of some interest to note that this limit corresponds approximately with the coarsest filter gradation proposed by Sherard in 1985 as a means of inhibiting segregation.

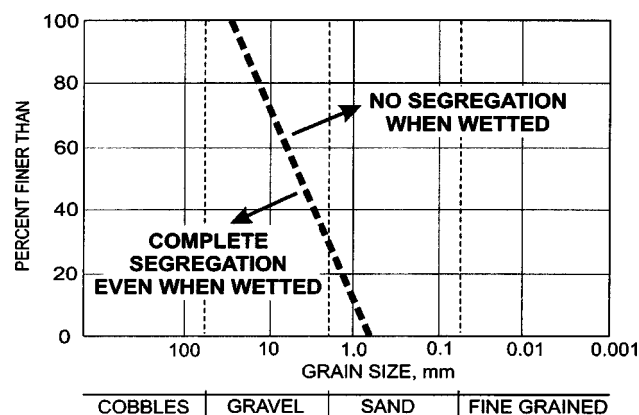
Fig. 18. Approximate gradations limit to the effect of wetting in preventing segregation

It is widely accepted that, in addition to controlling the filter D_{15} size, a low value of C_u is highly desirable. However, as pointed out by Kenney and Westland (1993), the coefficient of uniformity is only of limited usefulness and should only be used with caution as it does not account for particle sizes larger than D_{60} . These sizes are those most likely to separate out and thus lead to problems. It is essential therefore that the maximum particle size be restricted. Ripley (1986) recommends that the maximum filter size be restricted to 18 mm, that at least 60% of the particles be finer than 5 mm, but no more than about 2% be finer than 0.08 mm. This gradation also falls within the limit proposed in Fig. 18.

It can thus be concluded that much of the uncertainty related to appropriate filter design and placement may be largely resolved by specifying the use of wide, narrowly graded, sand-rich filters, of a gradation finer than the limit suggested in Fig. 18, and placed wet in thin lifts. Then the specification clause that "segregation will not be permitted" is a practical reality.

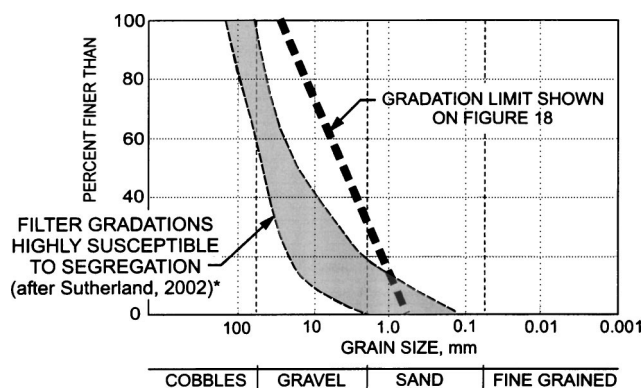
Fig. 19. Filter gradations highly susceptible to segregation

The work on segregation by Kenney and Westland (1993) has now been extended by Sutherland (2002) through a detailed examination of the various mechanisms of segregation, conducting laboratory tests that would better model the process of field placement of granular materials and reassessing the potential for coarse zones to be created by segregation, particularly in filter materials. Sutherland's work has demonstrated that most, if not all, of the problem filter gradations reported in the literature are materials that can be classified by his proposed method as highly susceptible to segregation. Typical results are illustrated in Fig. 19 and complement the suggested coarse limit shown in Fig. 18.
