Experience of Ammonia Converter with Catalyst Leakage and Repairs

Muhammad Aleem Khan

Fauji Fertilizer Co., Ltd., Goth Machhi, Pakistan

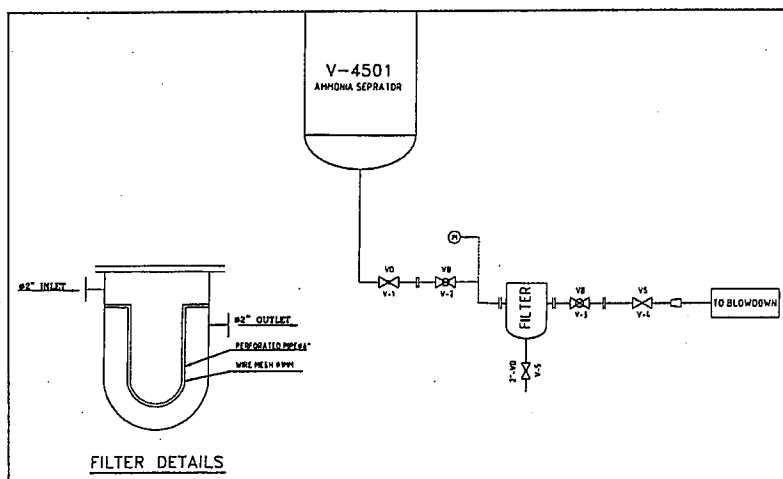
Figure 3. Provision of filter on V-4501 drain.

In order to answer most of the questions listed above, a high-pressure catalyst separator (filter) was installed on the drain line of the ammonia separator V-4501 with an arrangement to remove the catalyst during normal plant operation (see Figure 3). After installation of the filter, the catalyst leakage rate from the converter is generally found to be 4–5 Kg/day.
