A Case Study of Feedwater Heater Life Management

This paper describes the methodology of life management and its application to a feedwater heater at KCPL. A life management case study is presented which focuses on KCPL's LaCygne power plant, Unit No. 2, first-point extraction, high-

pressure feedwater heater no. 21. LaCygne Unit No. 2 is a 630-MW generating unit which was upgraded to 710 MW in 1991. Feedwater heater no. 21 is a three-zone horizontal hemi-head heater containing 1568 U-tubes constructed of SA-556 C2 carbon steel.

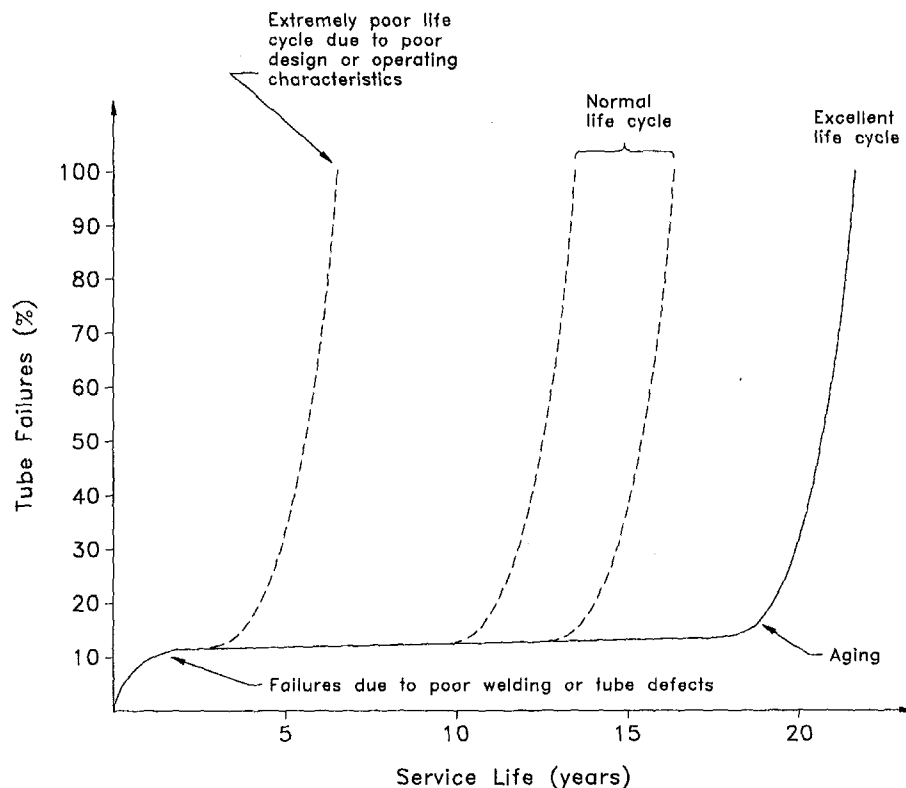
Projected Life. As illustrated in Fig. 1, the tube failure rate in a feedwater heater increases exponentially with age. Therefore, to reduce the potential for costly maintenance, it is imperative to predict when the tube failure rate will enter the steep portion of the curve. This prediction will provide lead time to plan for the replacement or refurbishment of the feedwater heater. Prediction is accomplished by fitting an exponential growth function to the feedwater heater's historical tube failure data.

Performance degradation of a feedwater heater is usually related to tube failures. Bell et al. (1991) report that the tube failure rate in a feedwater heater increases exponentially with age. When the tube failure rate is allowed to reach the steep portion of the exponential curve, tube failure events become more frequent.

Fig. 1 Life cycle of a high-pressure, carbon steel tubed feedwater heater (Bell et al., 1991)
