PROBLEM STATEMENT

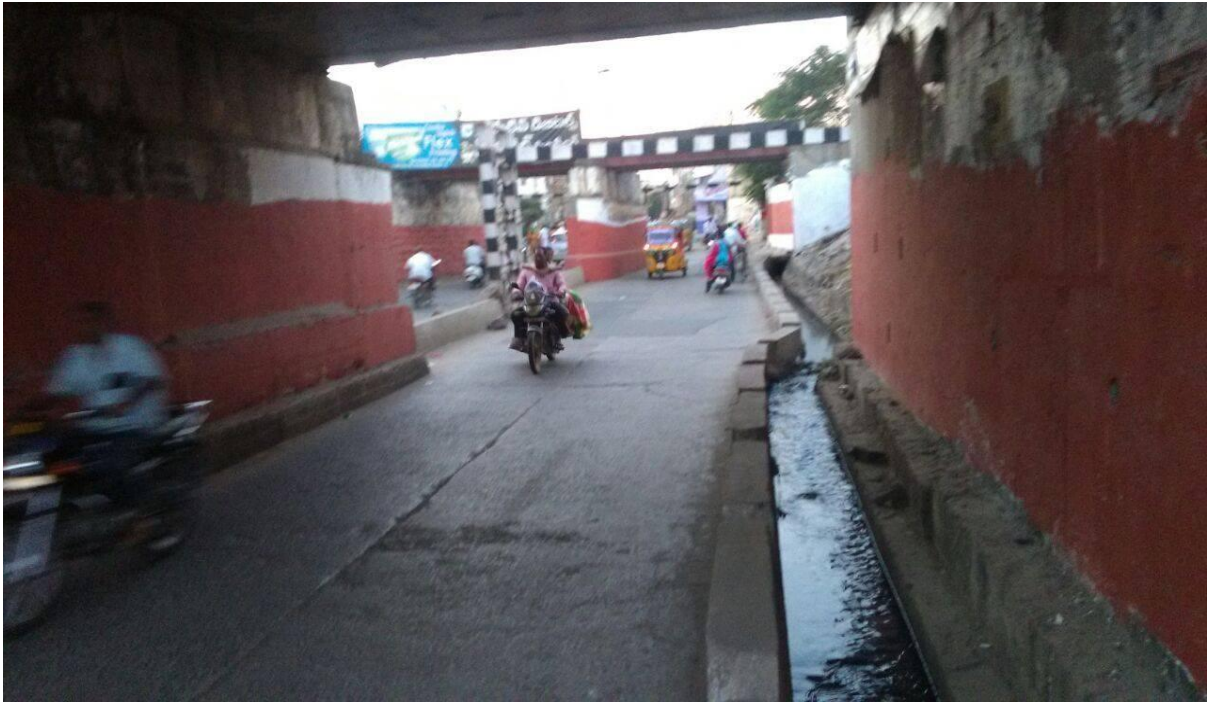
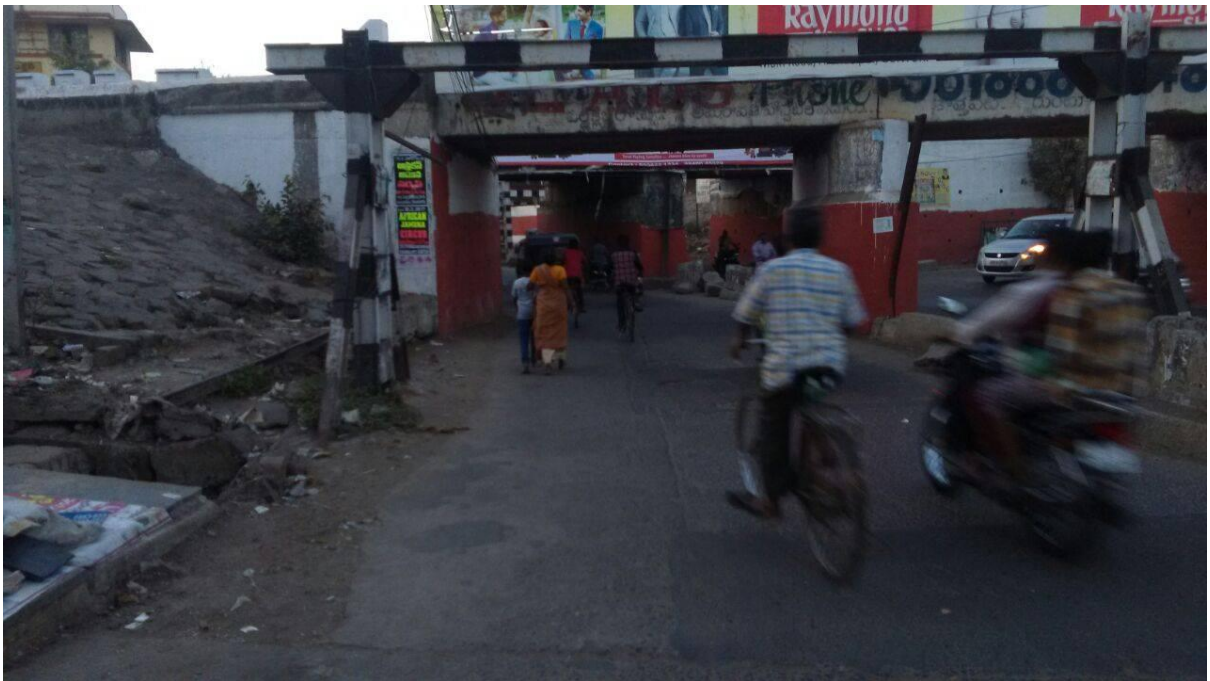
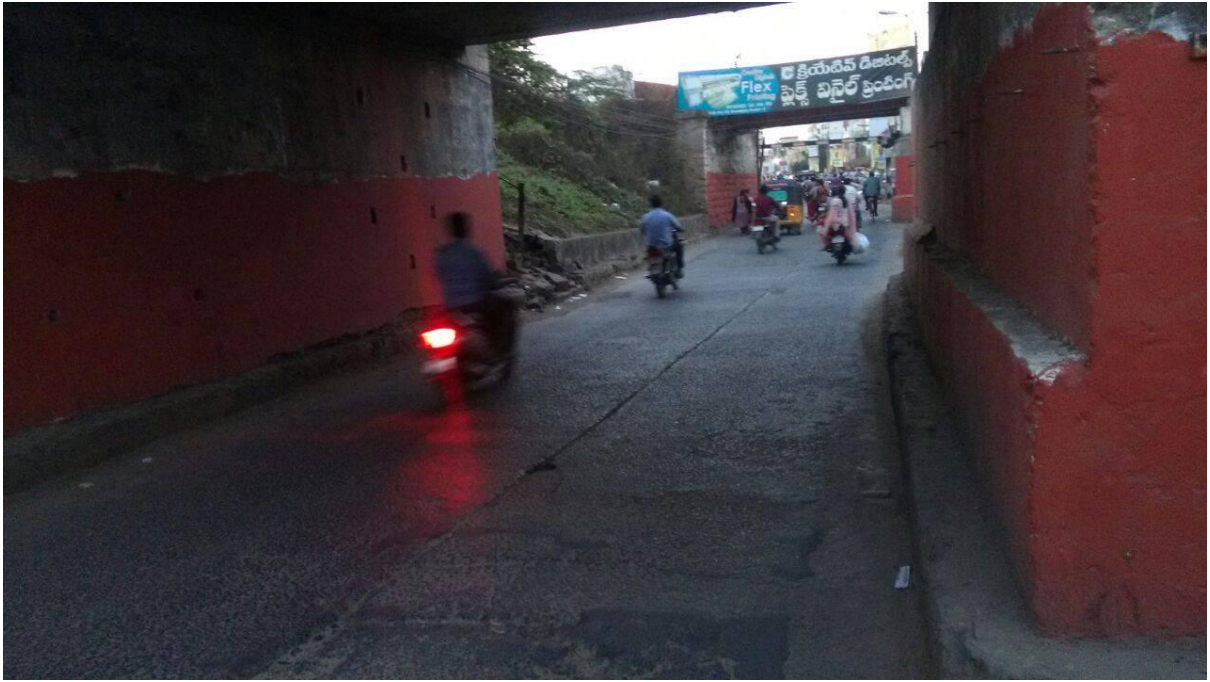
The road shown in the below picture is from “Mudu Vanthenalu” area of Guntur city. Since 2002 the pavement has been replaced many times which got damaged every rainy season. The road has got a drainage system beside it. Every rainy season rain water gets stagnated, gets mixed with drainage water and surface course gets damaged. In addition to this, due to the presence of drainage system the subgrade portion of road is getting disturbed. The waste from Nehru nagar and nearby areas is being dumped here. There is no chance of increasing the road thickness as there is a railway bridge over the road. So, we require a solution which is economic, innovative, without disturbing the other parameters or structures around road.
