# ILOC Faulty Trip Supervision Relay

HOL011 ILOC DEF/OOC during Feeder OCEF Injection

Dated 14/07/2023

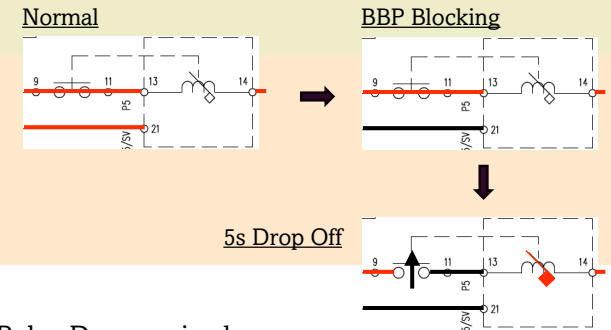
# ILOC with Feeder OCEF Injection

After **OC3 START** operated, no contact will be reconnected for BBP Blocking Relay.  
 → Breaking of P91 – P97 path

Before BBP Blocking Relay De-energized -

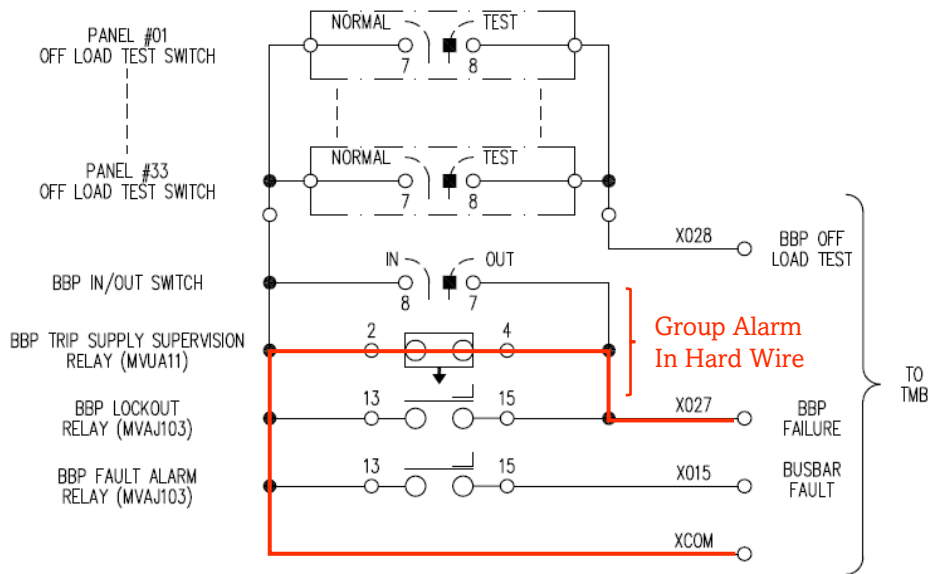
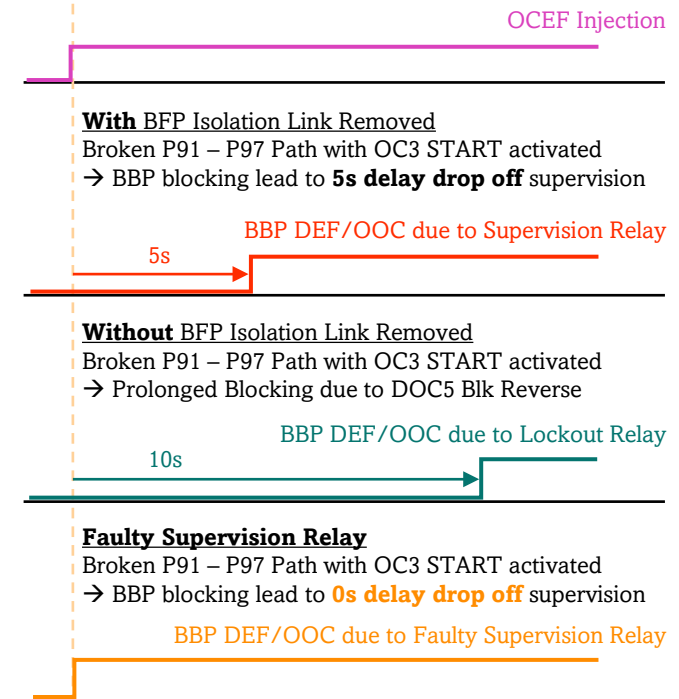
# ILOC with Feeder OCEF Injection

\* 01, 69534    011 BB \_BBP  
 Composite ID: HOL.019.BB.\_BBP  
 Area : Dist+Tuen Mun    Default : PD  
 RTU 260    DI POINT 197    comments :  
 1. PROTN SUPPLY FAIL  
 2. LOCKOUT  
 3. OOC

1. BBP Blocking Relay (Broken P91 – P97)
2. WD due to faulty OCEF relay
3. VTS / DOC5 BLK REV TRIP

- **BBP DEF/OOC due to supply supervision** (only alarming purpose) does NOT affect the actual function of ILOC.
- It does NOT lead to lockout (from 5s to 10s).
- It just blinds the actual lockout alarm if any.
