CIM3410

Check 24V DC Power supply plug
The problem is relating to the X4 plug connection where the 24VDC is supplied to the HUB Controller.

445 - Hub computer com fault - V82

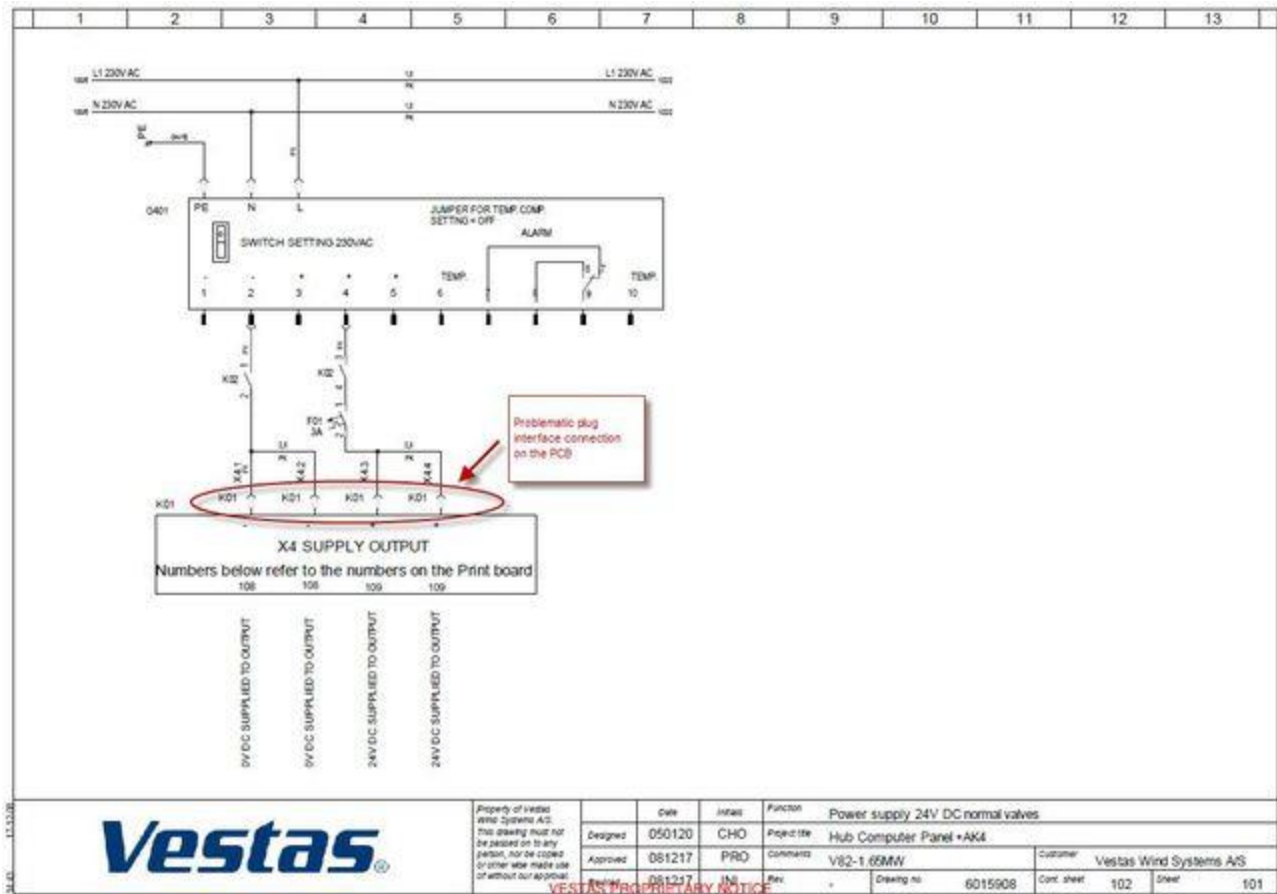
It has in many cases been seen that the plug connection have been overheated and burned as indicated on the below pictures.

The Minor Component Repair Team, has been requested to implement an improved interface on the PCB, so that the overheated connections could avoided.

Case creator have proposes a simple fix to mitigate the problem. Namelyto install a screw terminal versus the existing pin plug connector.

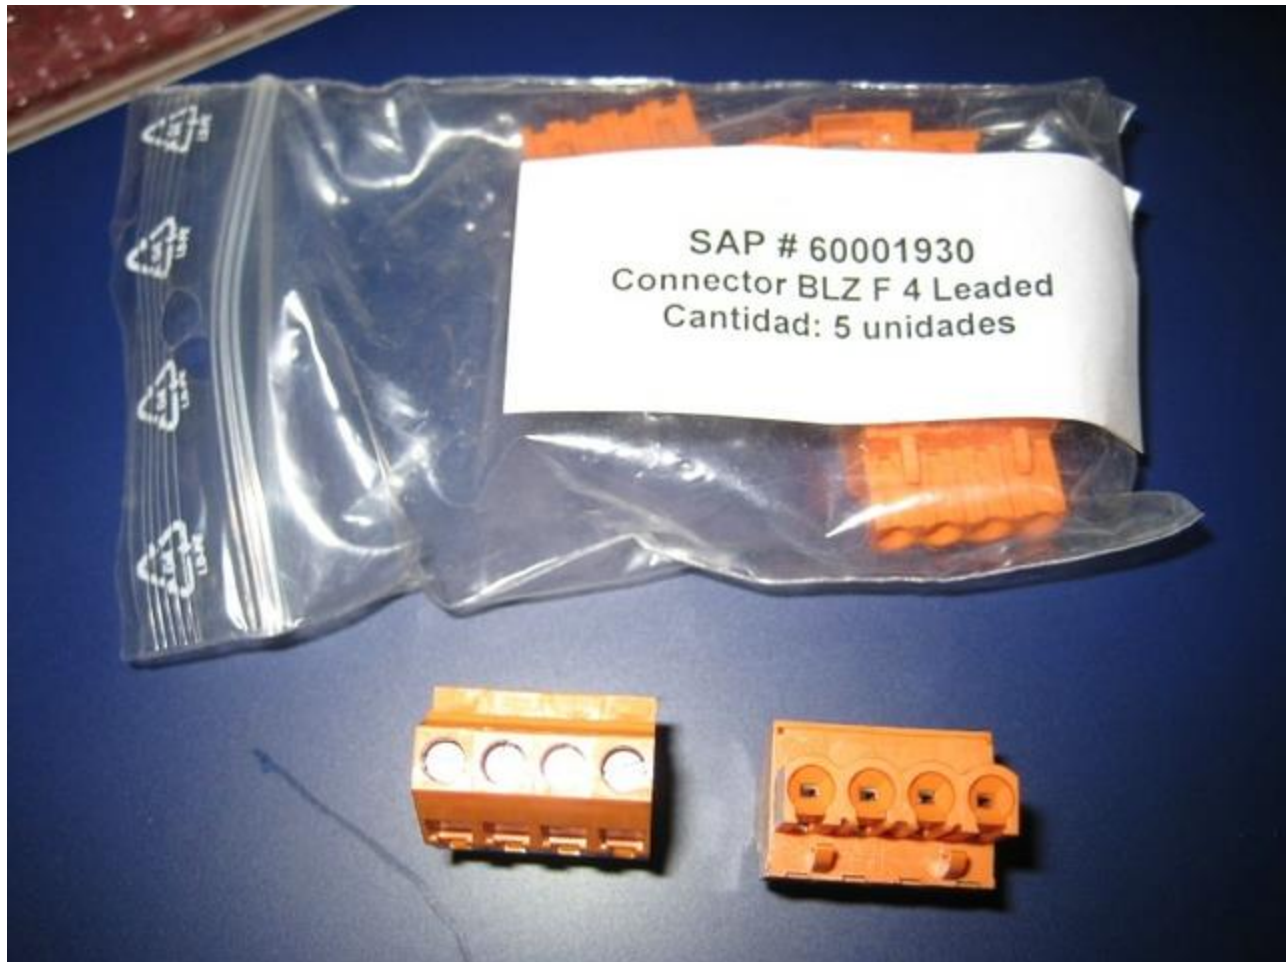
picture of a new 4 pin connector (X4:108-109)

The proposed solution by case creator have been forwarded to the Minor Component repair Program, awaiting approval from technology responsible.

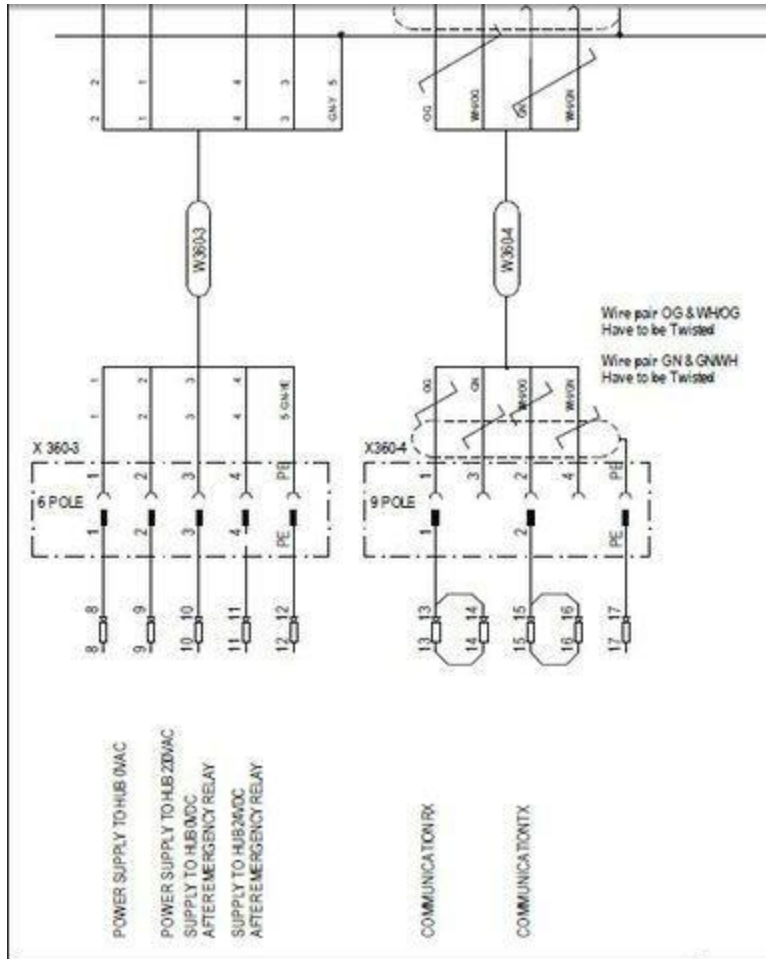
In most instances, a bad connection at the slip ring causes this alarm. Investigate the slip ring for damage, dust or oil contamination. Use document "0001-4933 - Cleaning Procedure for Slipring Unit" as a guideline.

Pay particularly close attention to brushes on rings for 230VAC supply to hub and hub communications:

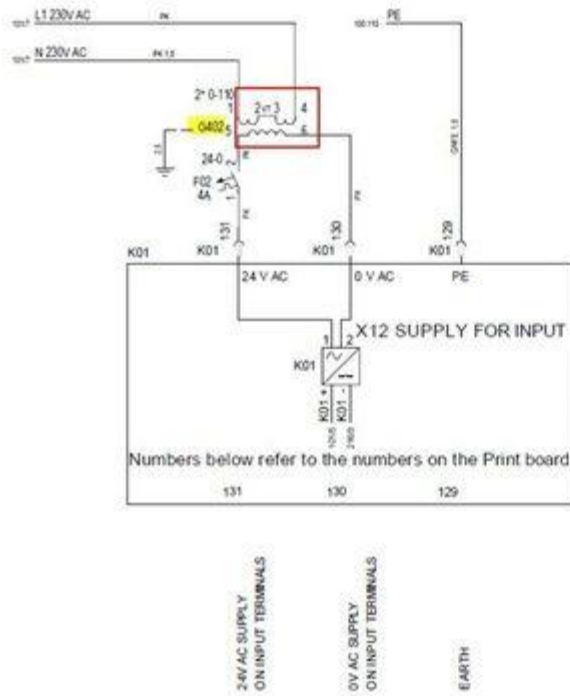
Measure the input and output voltage of Power Supply Transformer (G402) and replace the Transformer, if output voltage of 24V AC is 0V.

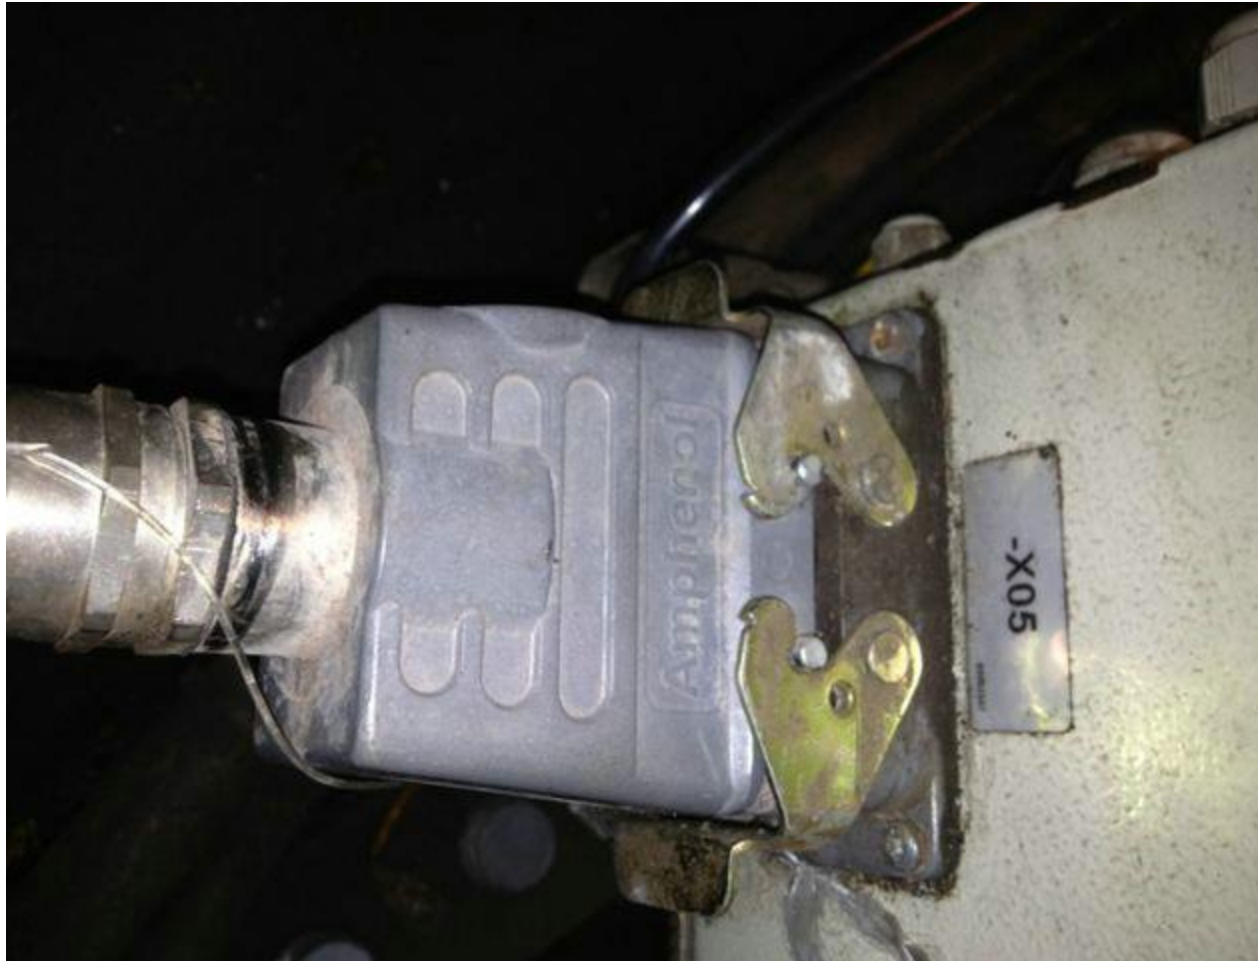
-X05 Amphenol plug (230VAC supply to the hub):

Check the condition of Plugs x05 (supply) and X03 (communication) on the AK4 panel in the hub.

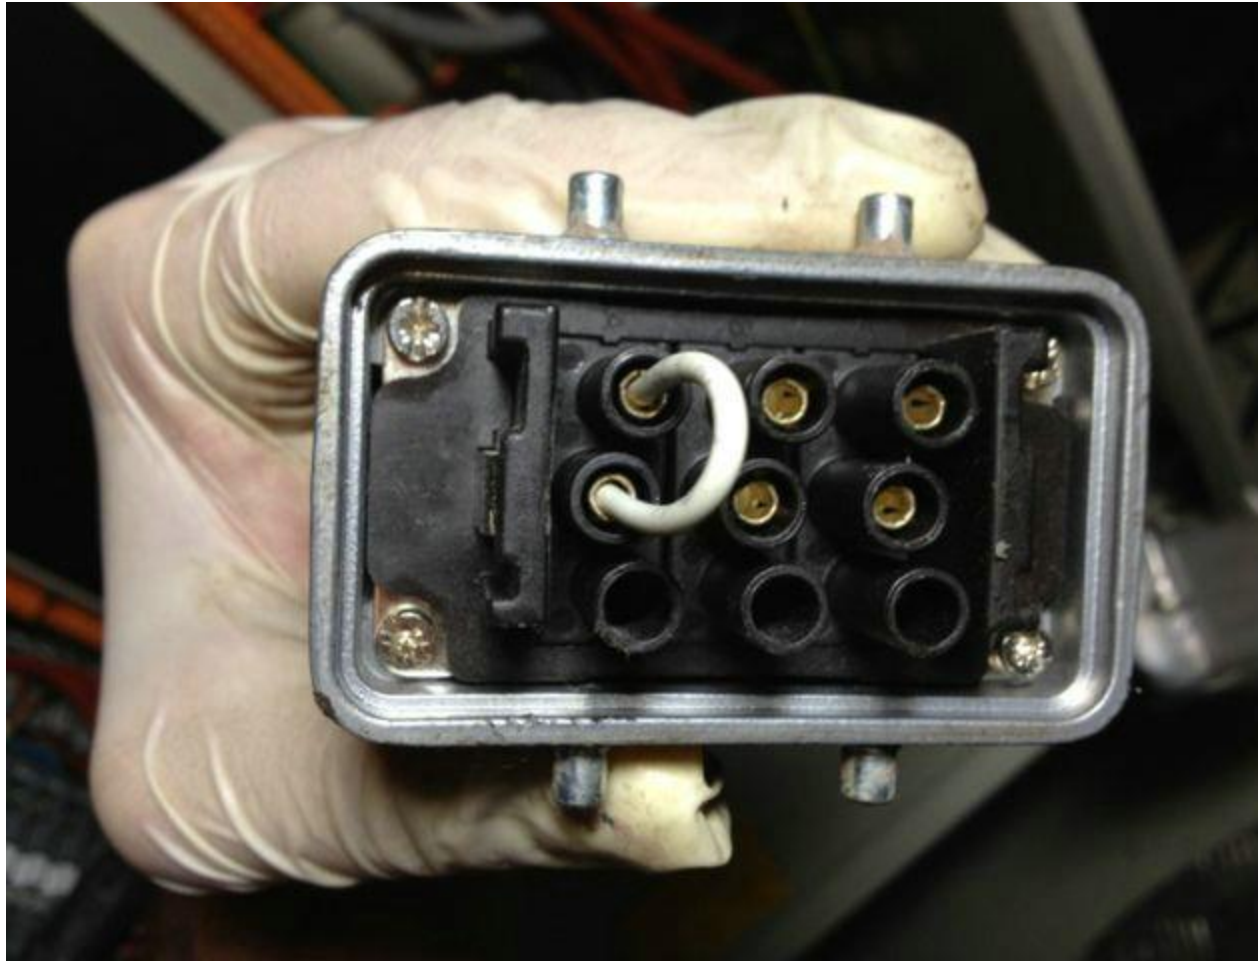
Place a jumper between Pins 1 & 2 in module A of the Amphenol plug on the –W980 cable.

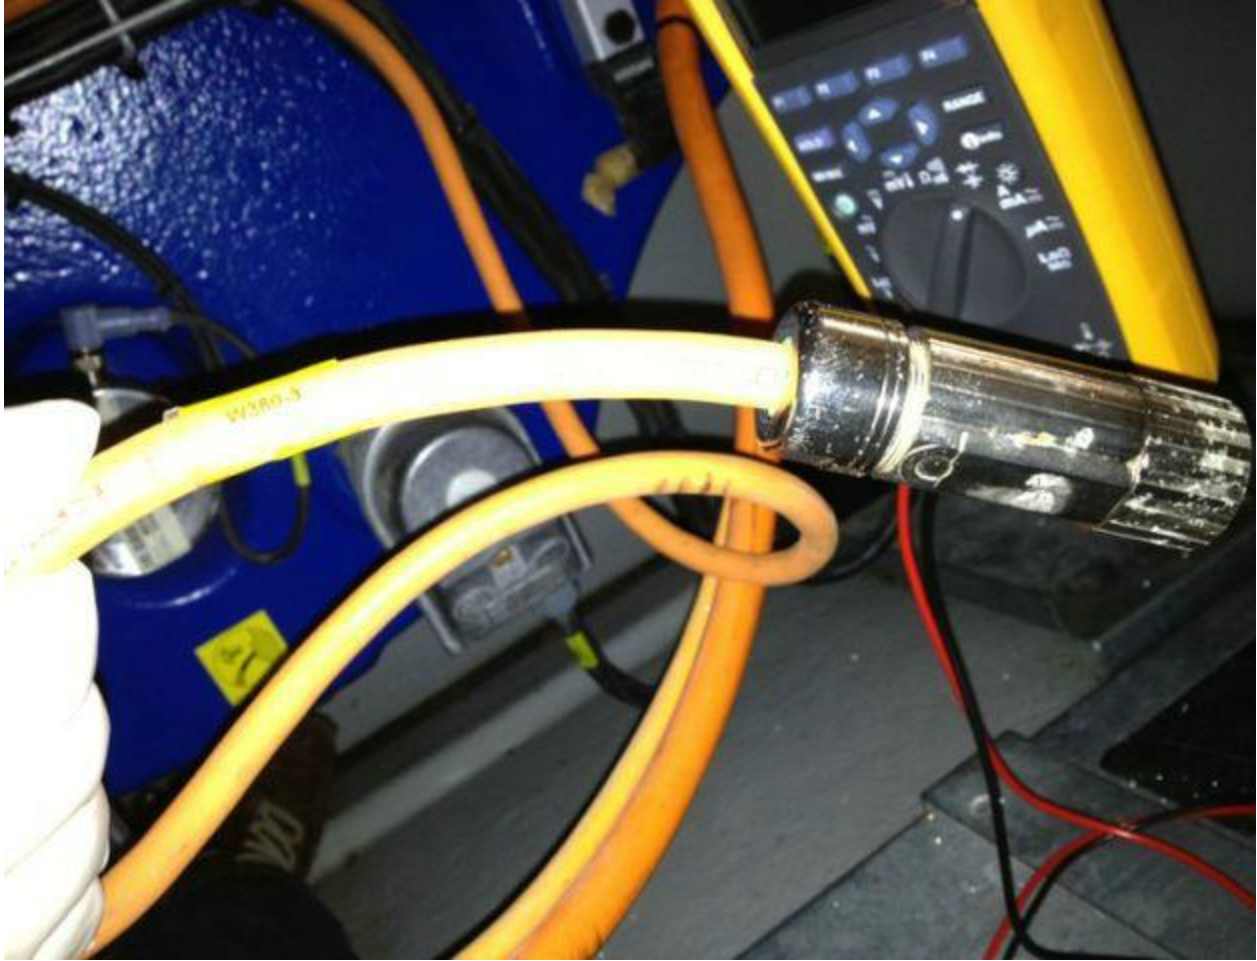
In the Nacelle, remove the –X360-3 plug from the slip ring.

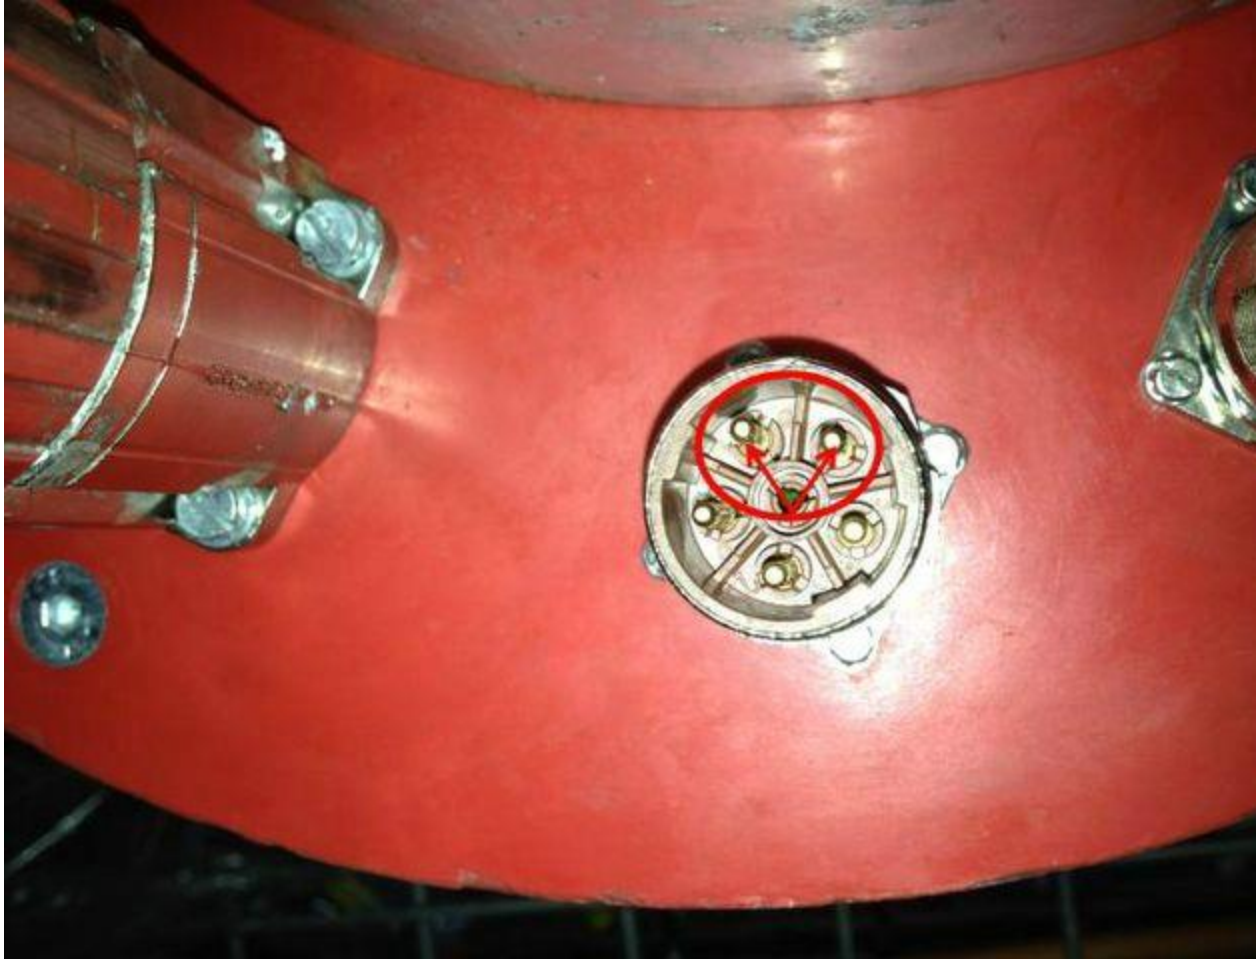
With a multimeter set to read Ω , measure between pins 1 & 2.

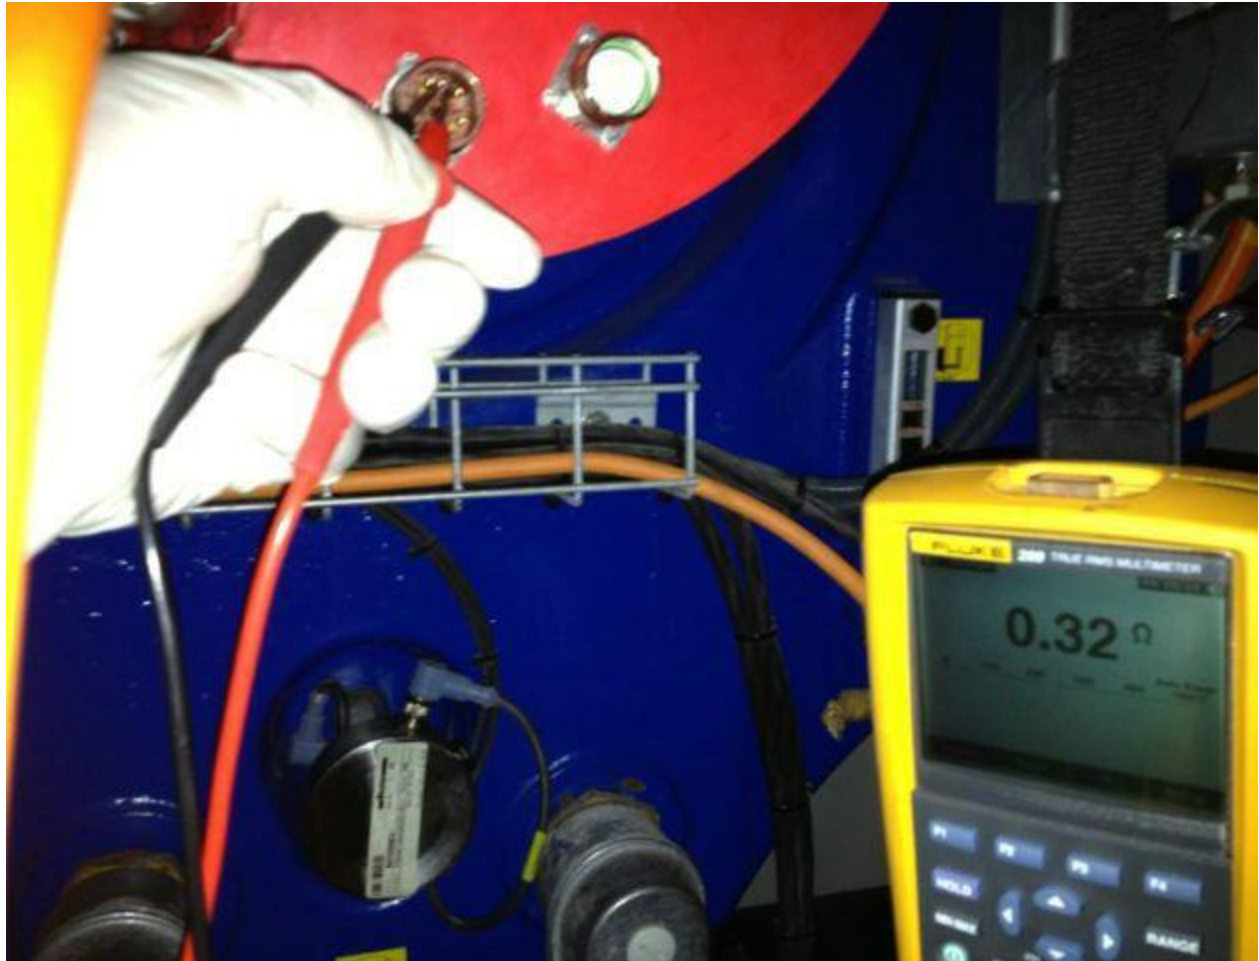
With the jumper in the hub, there should be a very low resistance value read by the meter.

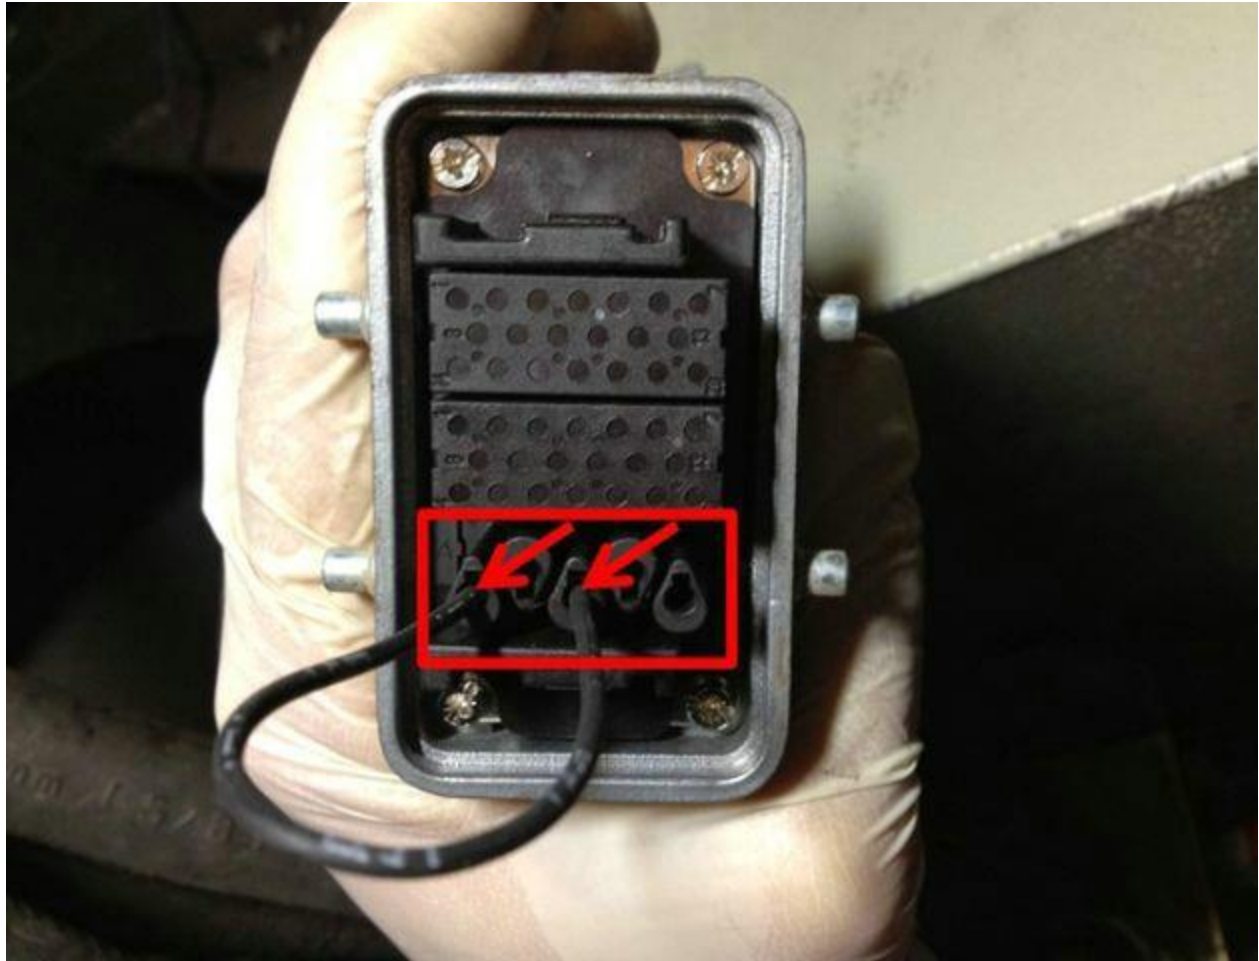
Perform a continuity check on the –W990 cable:
Place a jumper between Pins 1 & 3 in module A of the Amphenol plug on the –W990 cable.

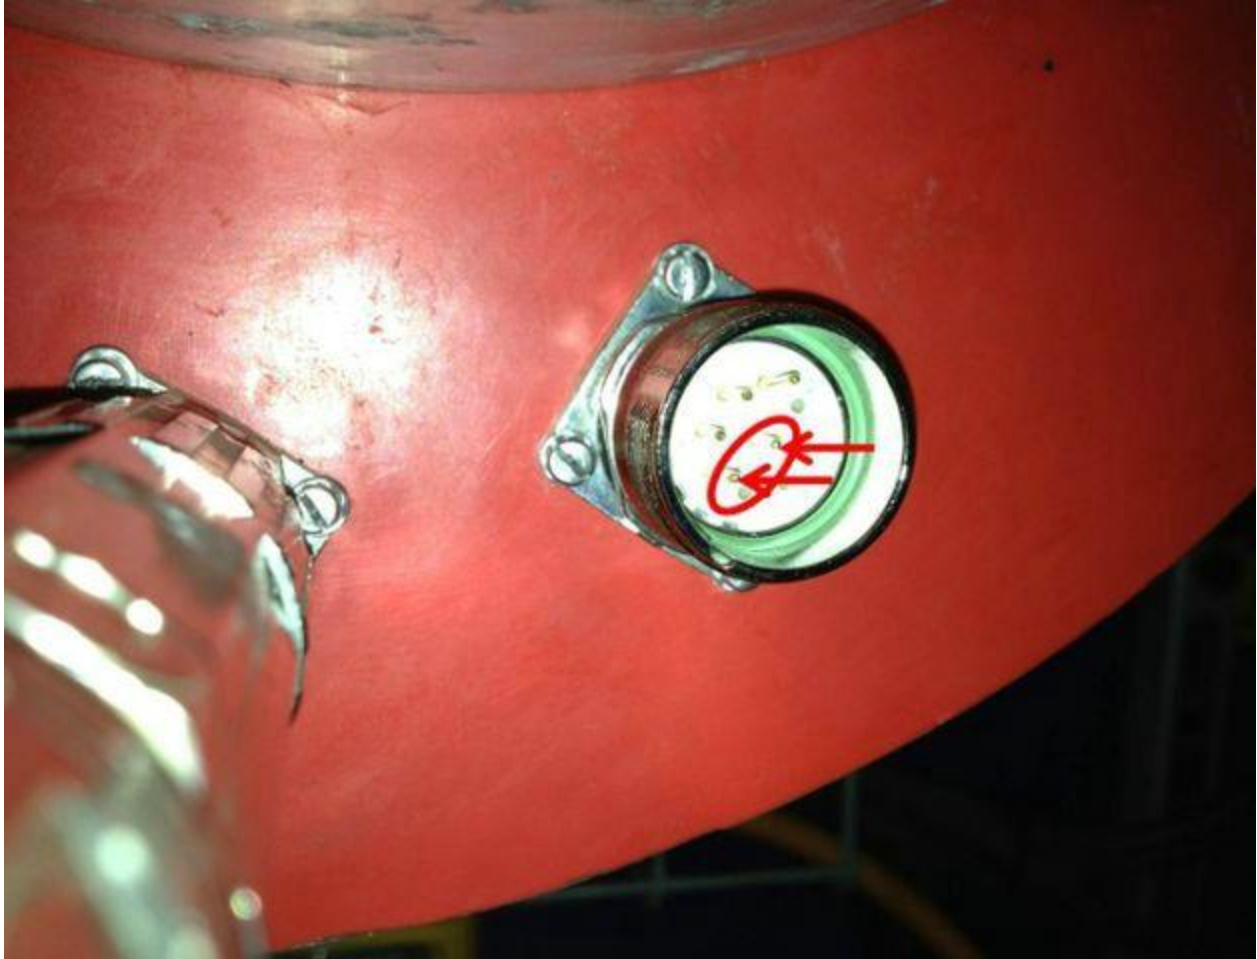
In the Nacelle, remove the -X360-4 plug from the slip ring.
With a multimeter set to read Ω , measure between pins 1 & 2.
With the jumper in the hub, there should be a very low resistance value read by the meter.

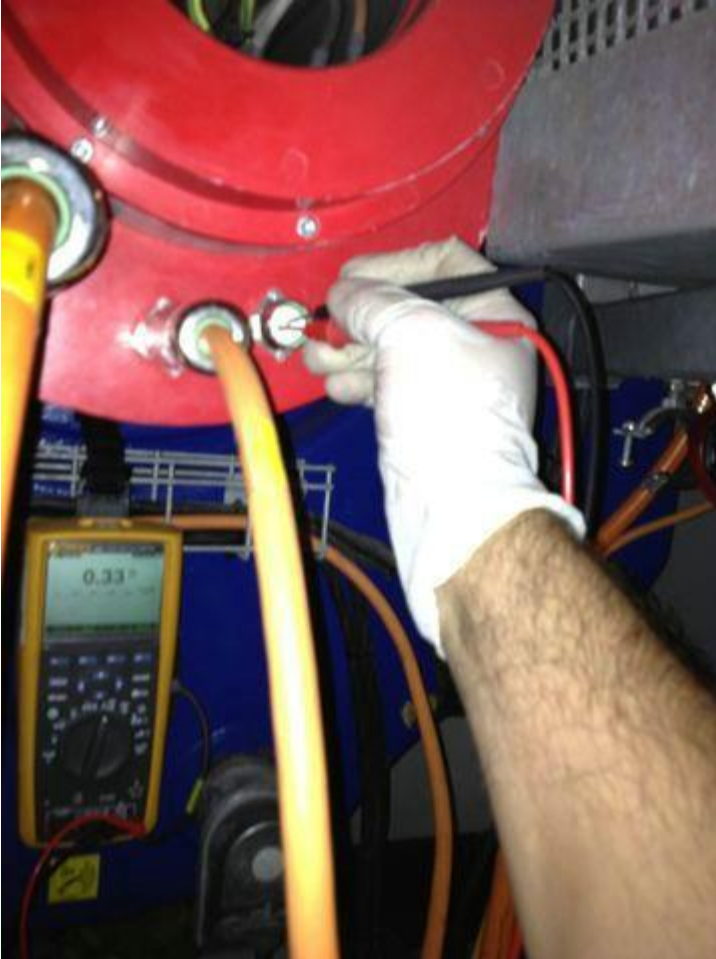
Perform continuity checks on the -W360-3 & -W360-4 cables between the slip ring and AN1 cabinet. Replace faulty cables if found.

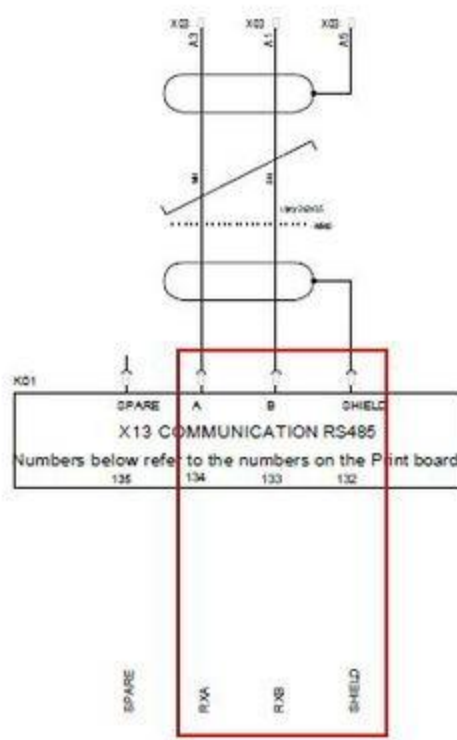
Check the cable connection in X13 connector at Hub Computer end and re-terminate, if found loose/cut.

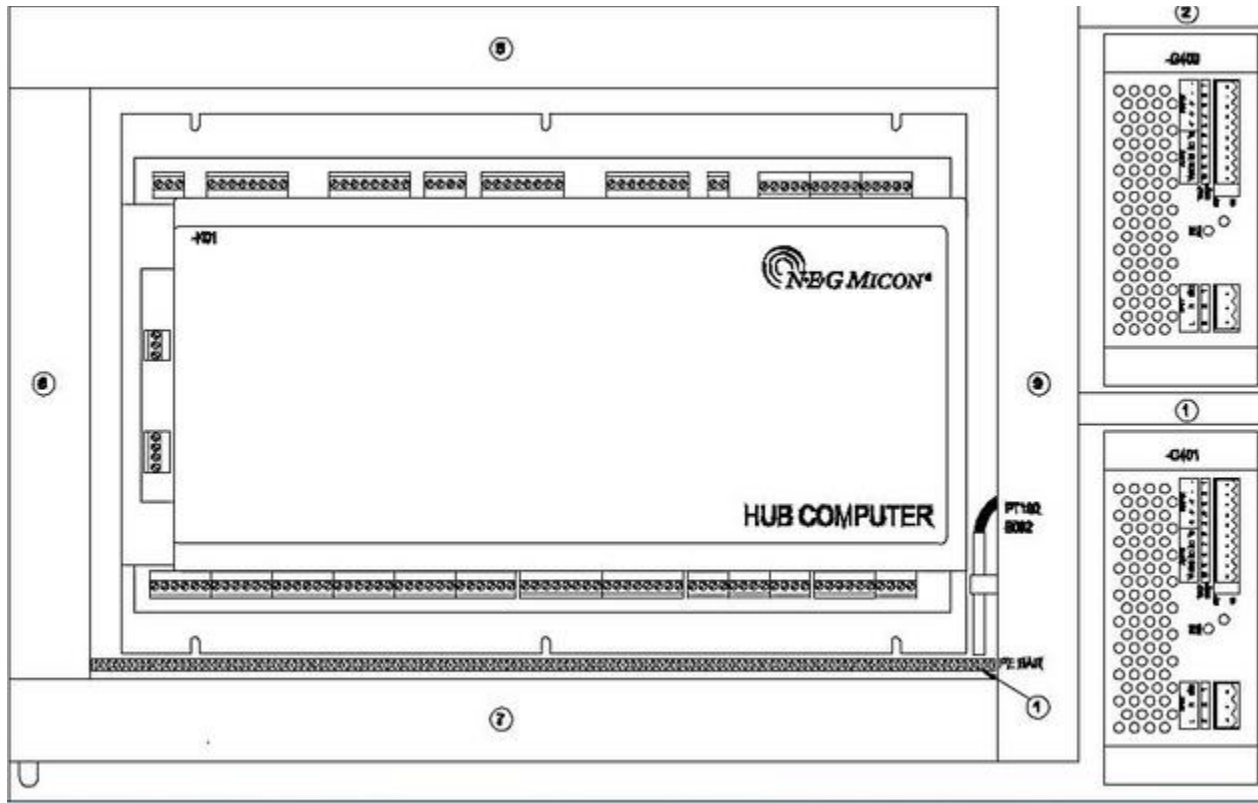
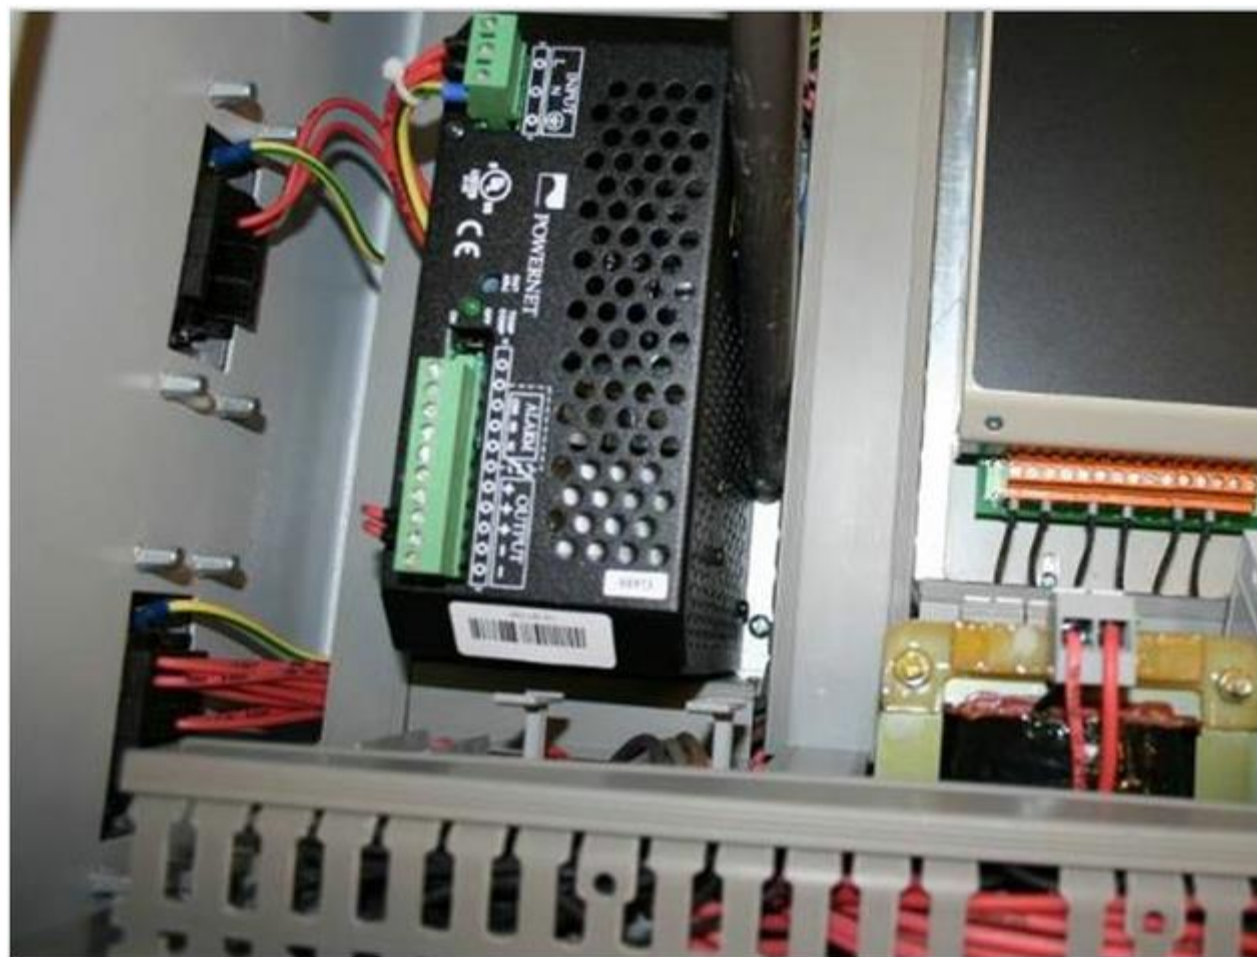
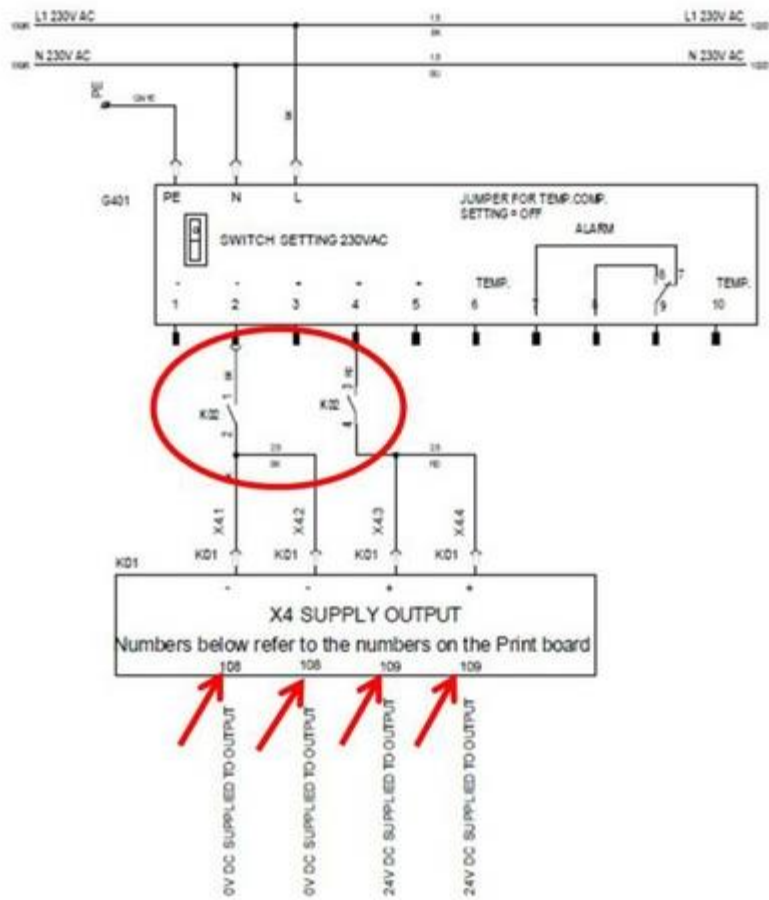
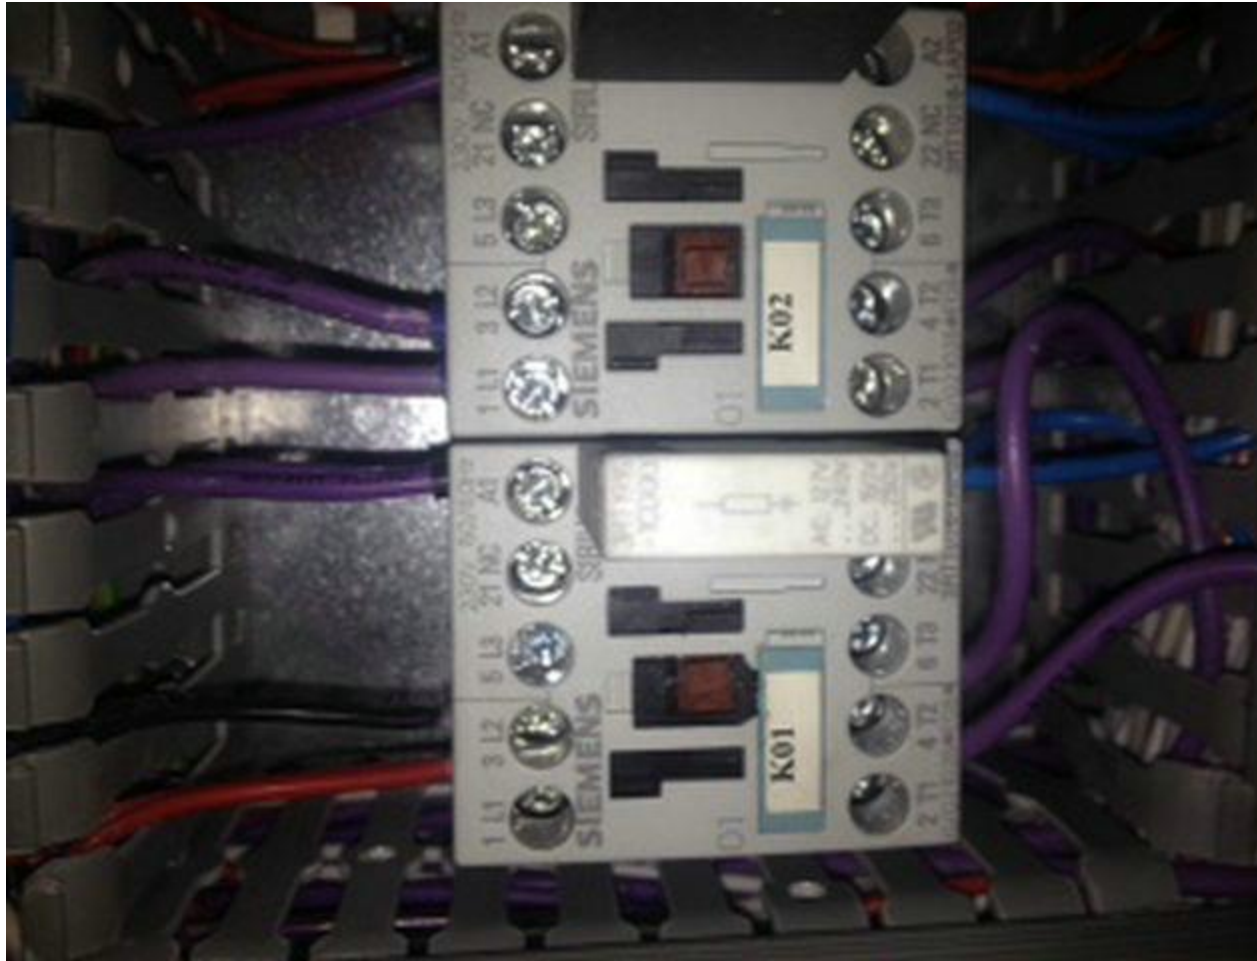
Check for any loose connections at the power net (Pos: G401)
 Check the input and output voltage 230/115VAC => 24VDC
 Replace the power net if it is defective.

Power supply G401 supplies the shutdown and parking valves (215 & 210) for each of the three blades and is the most common cause for this fault.

Test the output voltage to the valves at the power supply for 24VDC. If the voltage is good, test down the circuit until reaching the valves (failing valve solenoids or shorts in the circuit/plug/cables can drag down the voltage and cause this alarm).
