Replace the defect PT100 Sensor

882 - Pt100 fault gear oil exchanger NM72 NM82 V82 Mk1-5\_

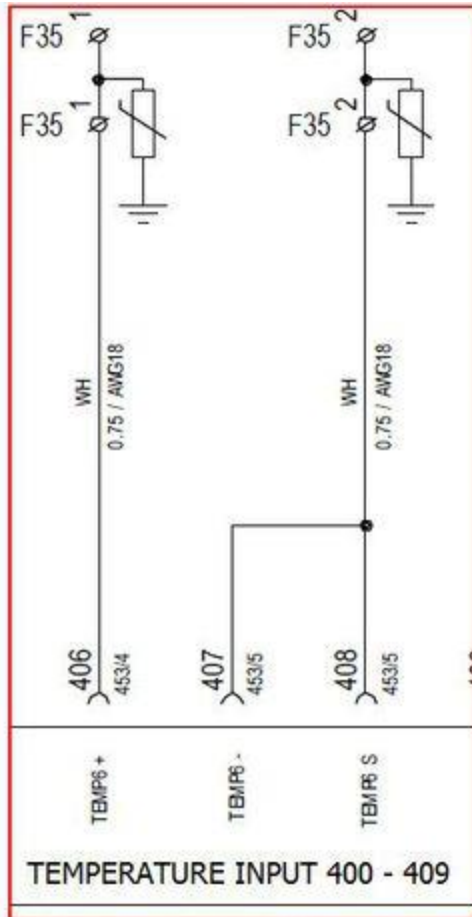
GEAR OIL TEMPERATURE AFTER EXCHANGER

Varistors (F35-Mk3 and above. F11 for Mk2 and below turbines) can be tested individually by placing a multimeter (set to measure  $\Omega$ ) lead on the common (earth) side of the varistors and the other on the individual varistor terminals. The resistance value over the varistor should be  $\infty$  or in the high M $\Omega$  range. If the resistance is lower, the varistor has been damaged by an over voltage in the circuit and must be replaced
