## Replace the breather

**Replace the defective level switch**

**Check the electrical connection**

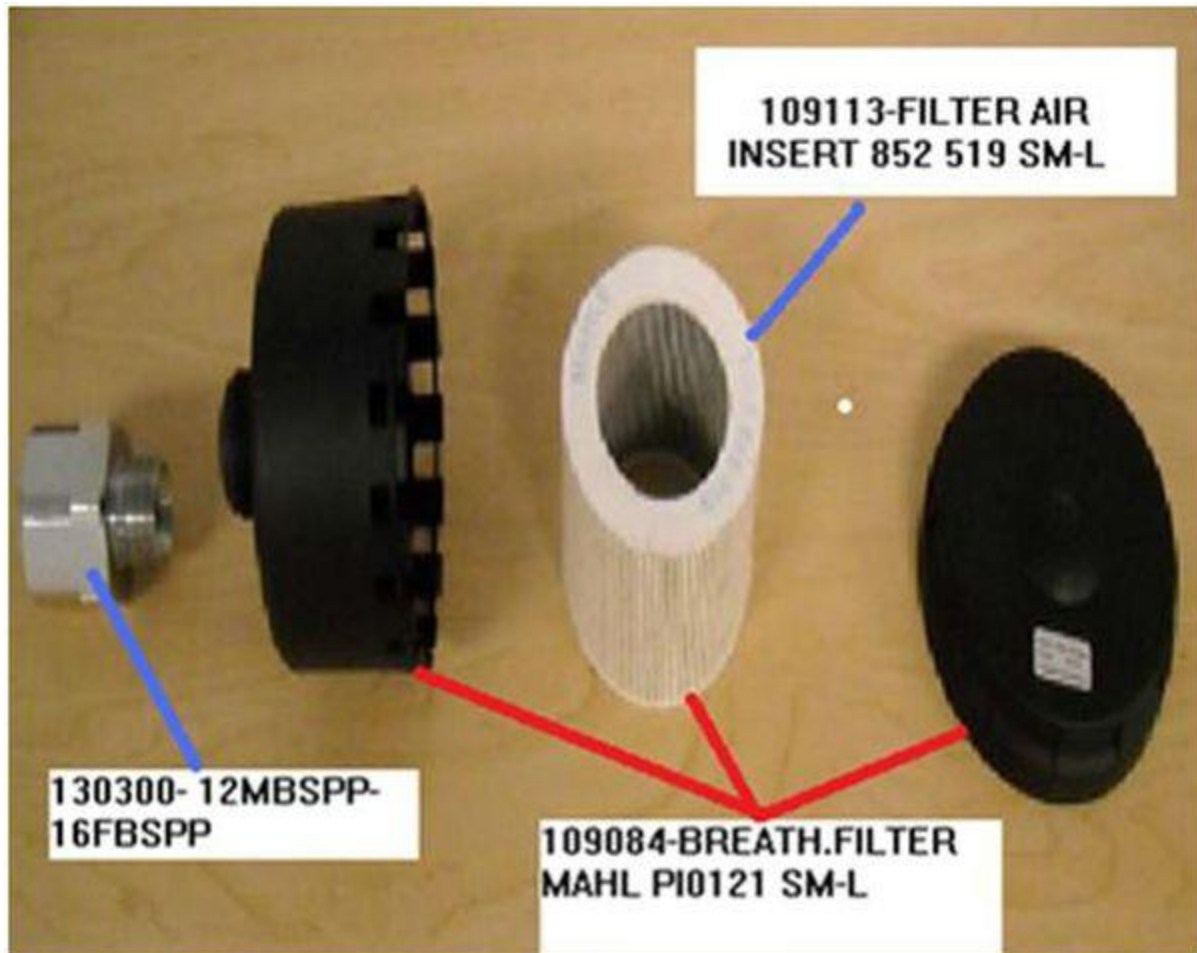
**Part number details for whole breather unit:**

Ensure that the breather for the gearbox is not saturated with oil. A clogged gear breather will cause the pressure inside the gearbox to deviate from atmospheric; when this happens the sight glass sensor is affected as well as the seals.

A new type breather is available that is much less susceptible to oil saturation and clogging.

Replace the breather if necessary.

**Part number for air filter unit:**

109113-FILTER AIR INSERT 852 519 SM-L
