## Locate and repair leak

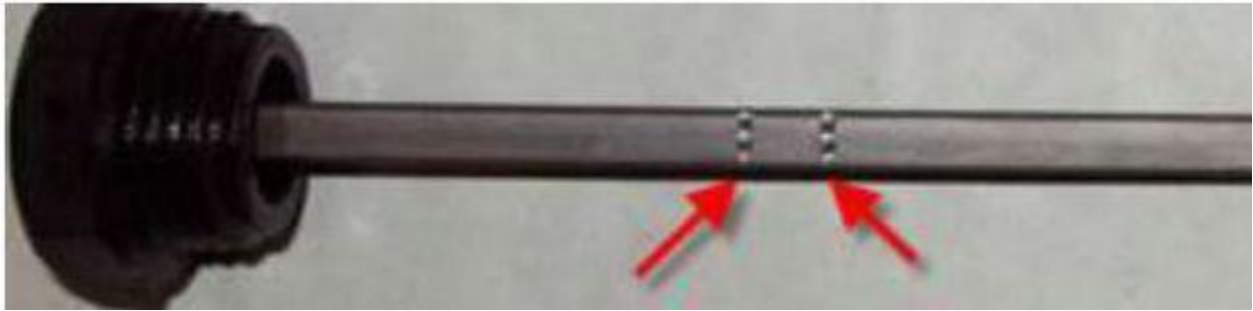
Mk3-5 turbines: Ensure the oil level is between the marks on the dip stick:

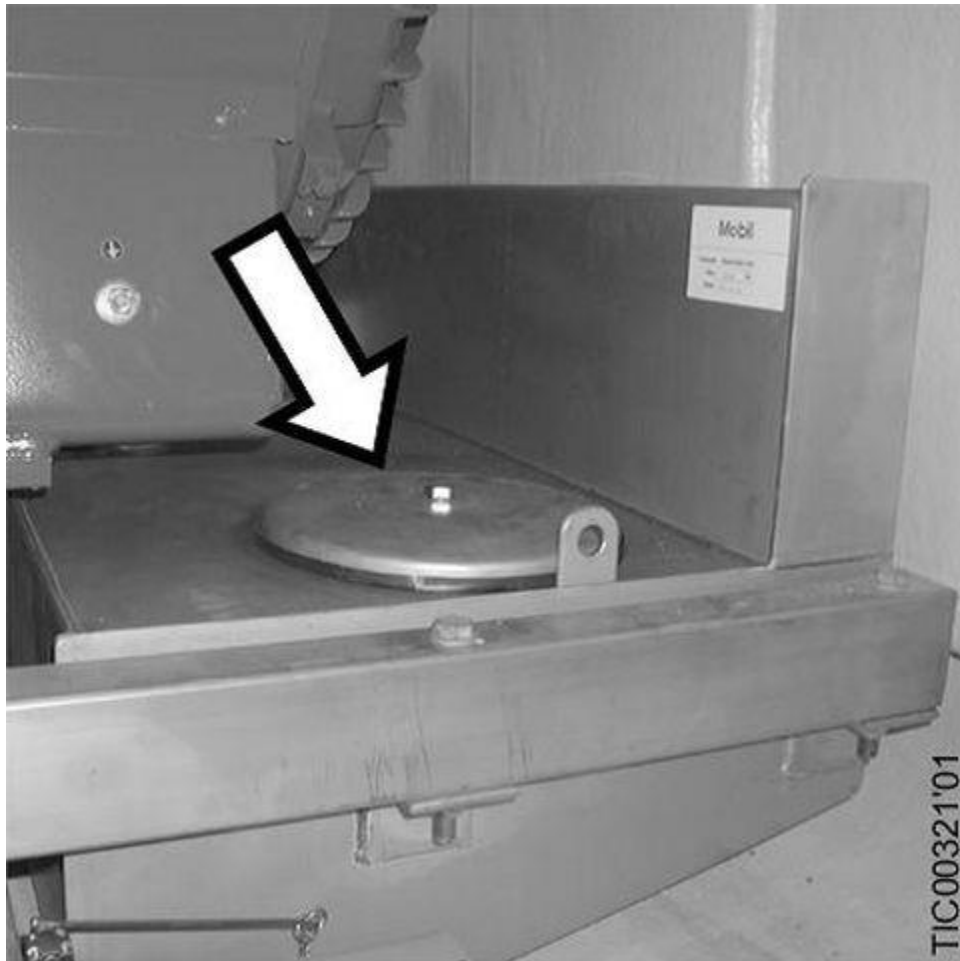
Mk1-2 turbines: Ensure the oil level is ~5cm from the lip on the tank.

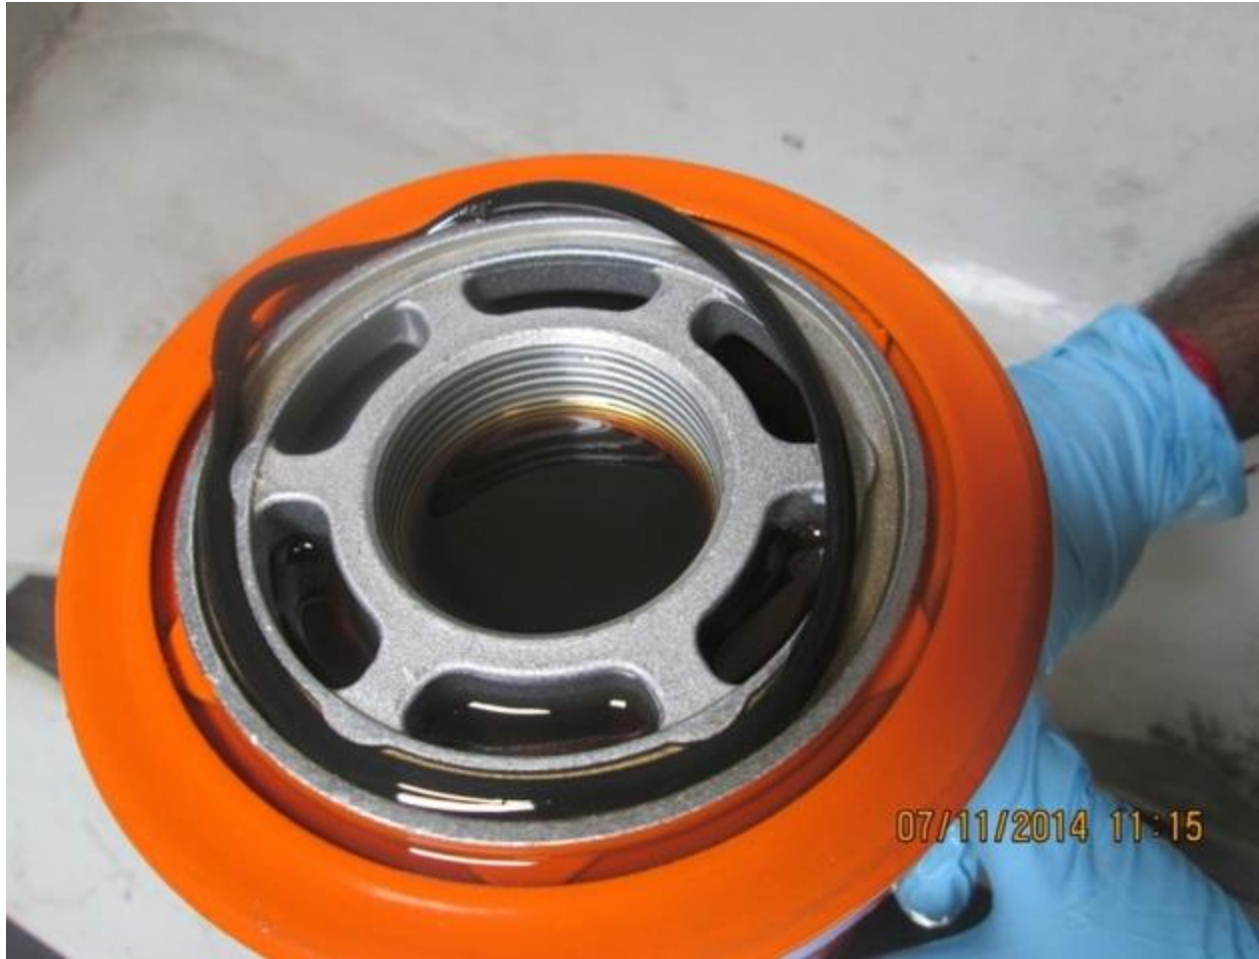
- Check low pressure filter at nacelle for 'O' ring dislocate or damage which might cause the oil leakage. Ensure the filter is assembled as per supplier recommendations. Failure seal to be replaced and filter to be assembled as per below guidelines.

- As per OEM as well as Vestas recommendation, these filters to be tighten with hand. Hence do not use ratchet or any type of tools for tightening which might cause over tightening issue which will damage the seal (O ring).

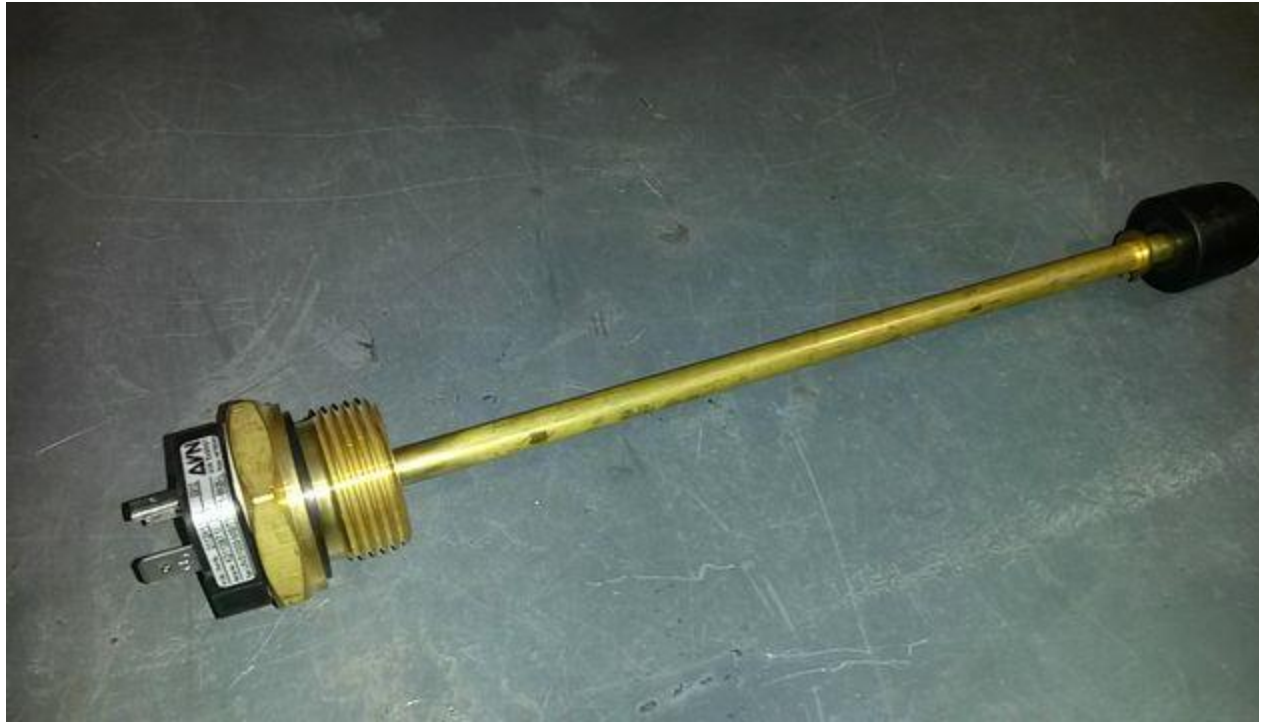
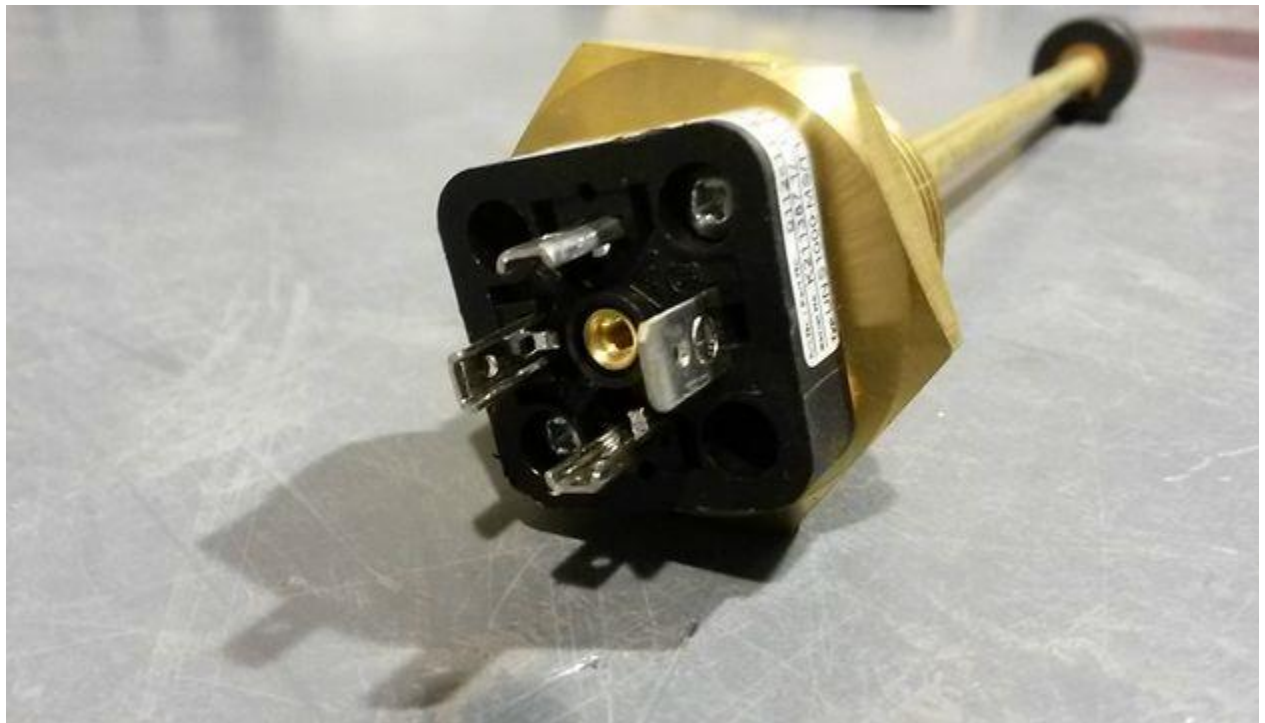
NEW STYLE FLOAT SENSOR:

**NOTE:** Older plastic versions of the sensor should be replaced with the new version whenever removed from the tank as the old sensor floats are susceptible to deterioration and can come off into the tank when attempting to remove.

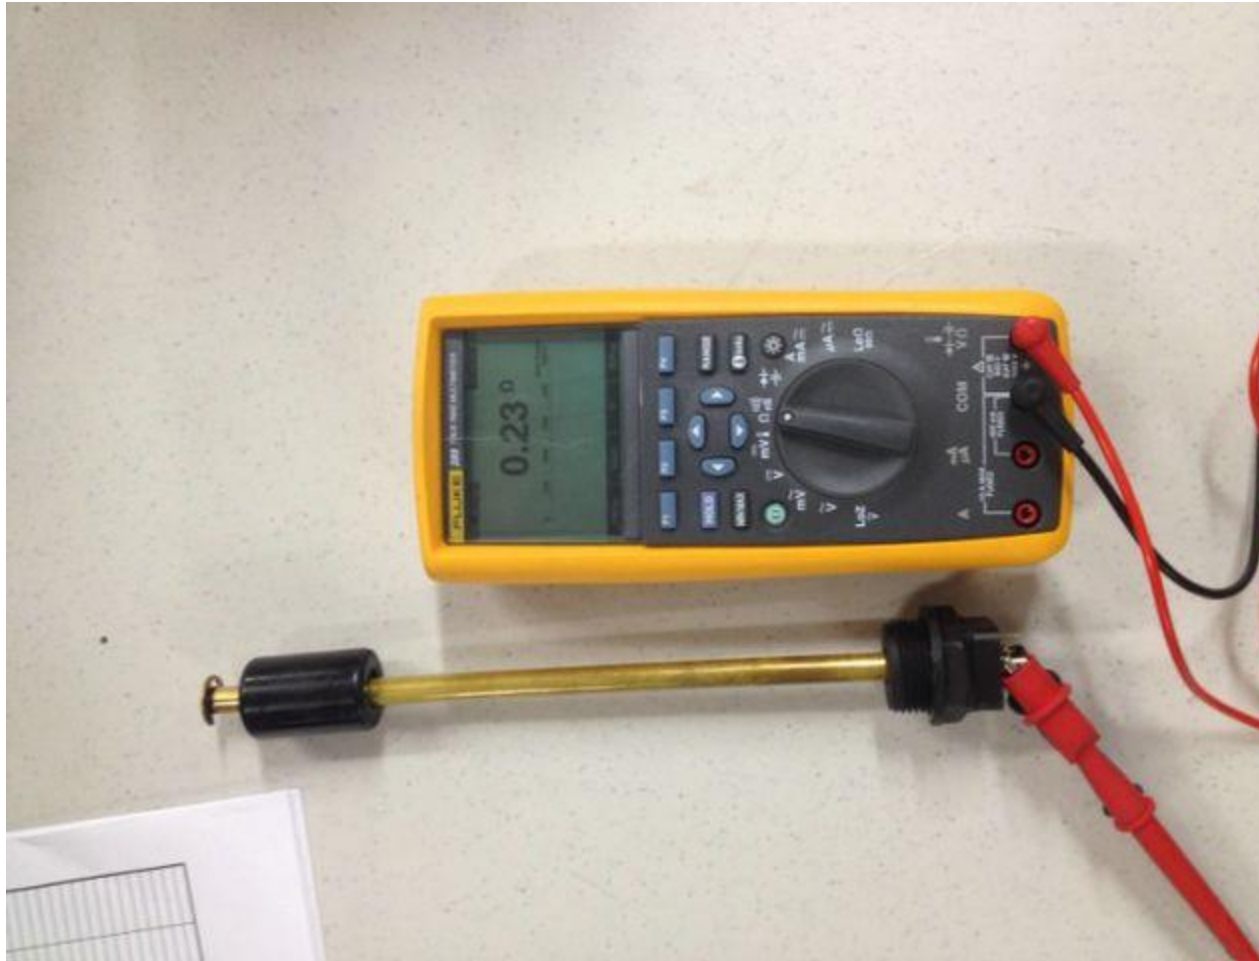
Slide the float up the sensor shaft a few centimetres

The value should change from OL to a low Ohm value when the float is in the position pictured.

If the value does not change or is unrealistic, replace the float sensor.

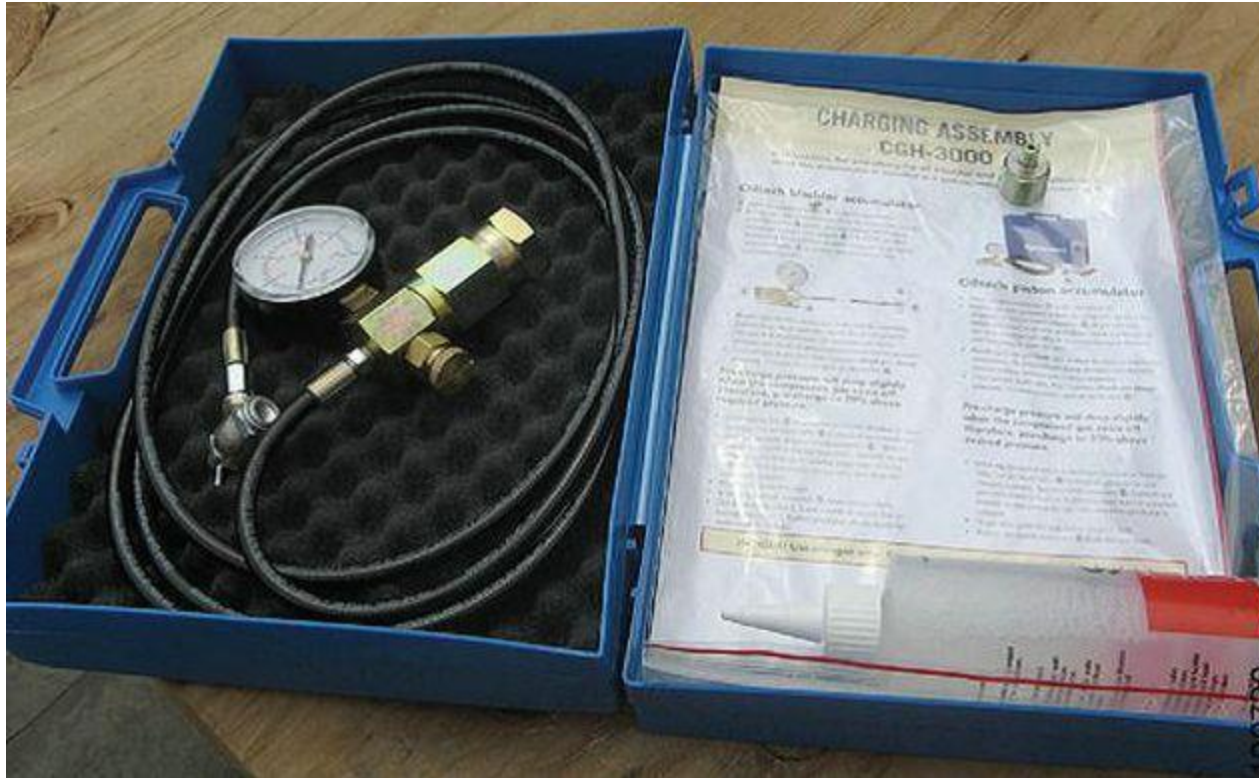
If oil level is not ok, and no external leakage is found, check pre-charge of accumulators in hub.

(Failed accumulators will consume much of the system volume of oil, as the nitrogen is not present in the bladders and cannot push the oil back to tank).
