## Troubleshoot generator speed sensor

## Generator speed sensor

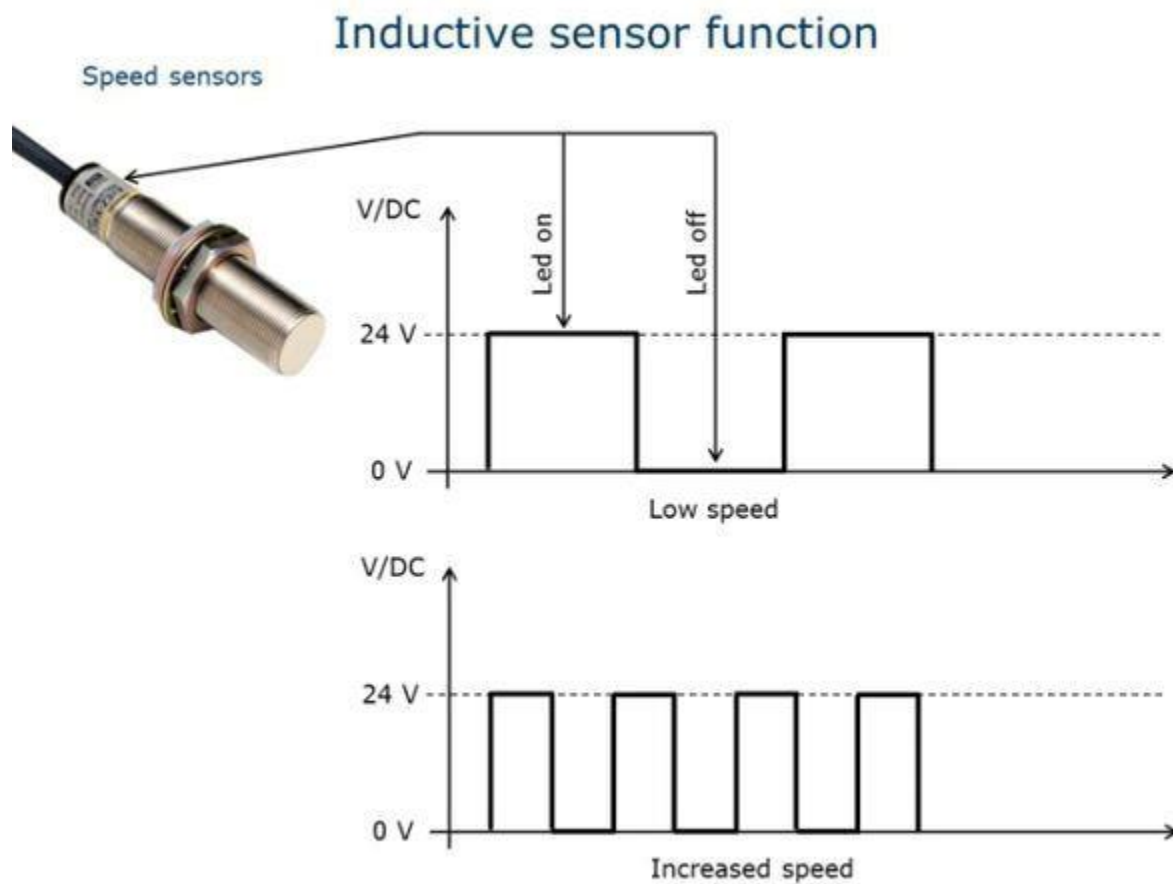
The generator speed is measured by an inductive proximity sensor which creates a pulse signal as a pickup point passes over it.

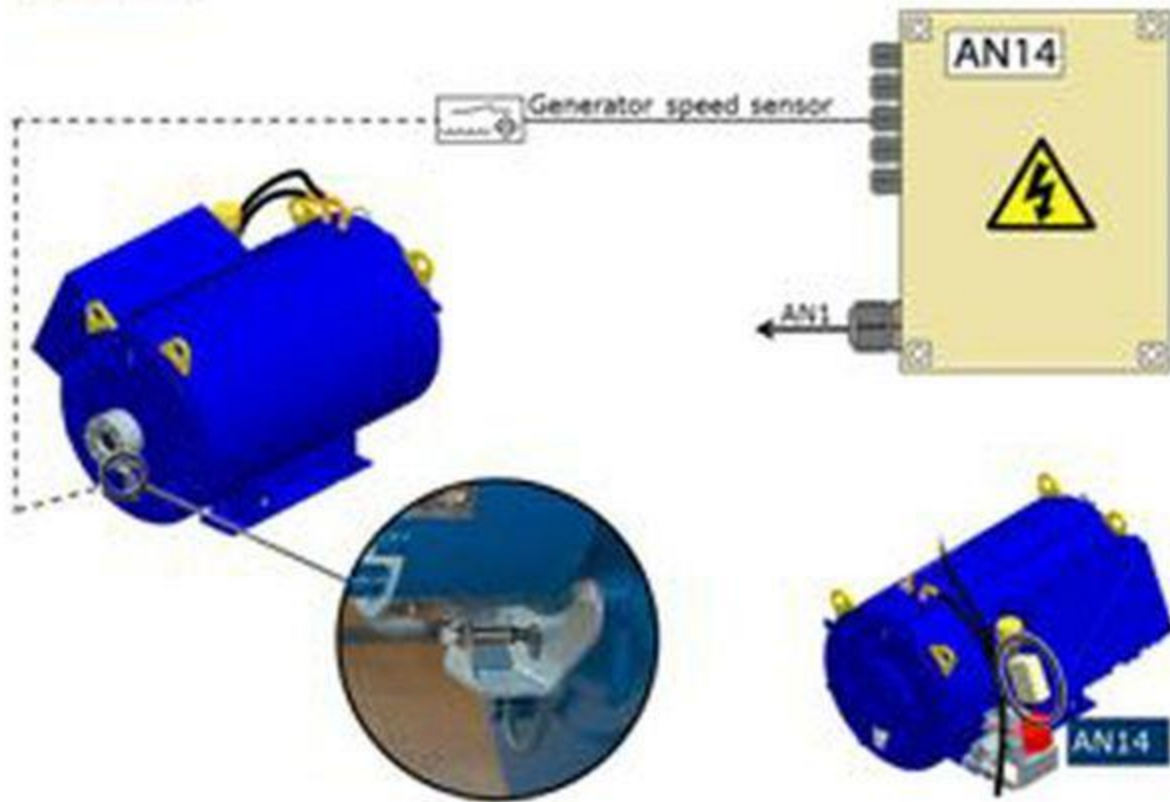
Speed sensors

In the case of the generator, there are seven pickup points for every rotation of the shaft therefore the speed is calculated as  $\# \text{ of pulses} / 7 = \text{generator RPM}$ . If the sensor is loose or failing it can "flicker" which will simulate a higher RPM than actual. The sensor can be tested by passing a screwdriver or other ferrous object past the sensor. If it consistently emits a light the sensor is likely operational. The sensor can also be tested by rotating the generator shaft and ensuring that the sensor emits a light when each of the (7) link element bolts passes over the sensor.

If the sensor does not emit a light each time a link element bolt passes over it, lock the shaft and check for correct sensor adjustment. Check the bolts on the speed sensor bracket and ensure that they are properly tightened. The end of the sensor should be within 1,5-5 mm from the pickup point. Adjust the sensor by loosening the nuts that clamp it to the mounting bracket and move it forward or back to achieve the required distance from the pickup point.

If after adjustment the sensor still does not light up, or lights up intermittently when passing the pickup point- replace the sensor (sensor and cable are combined-W509)

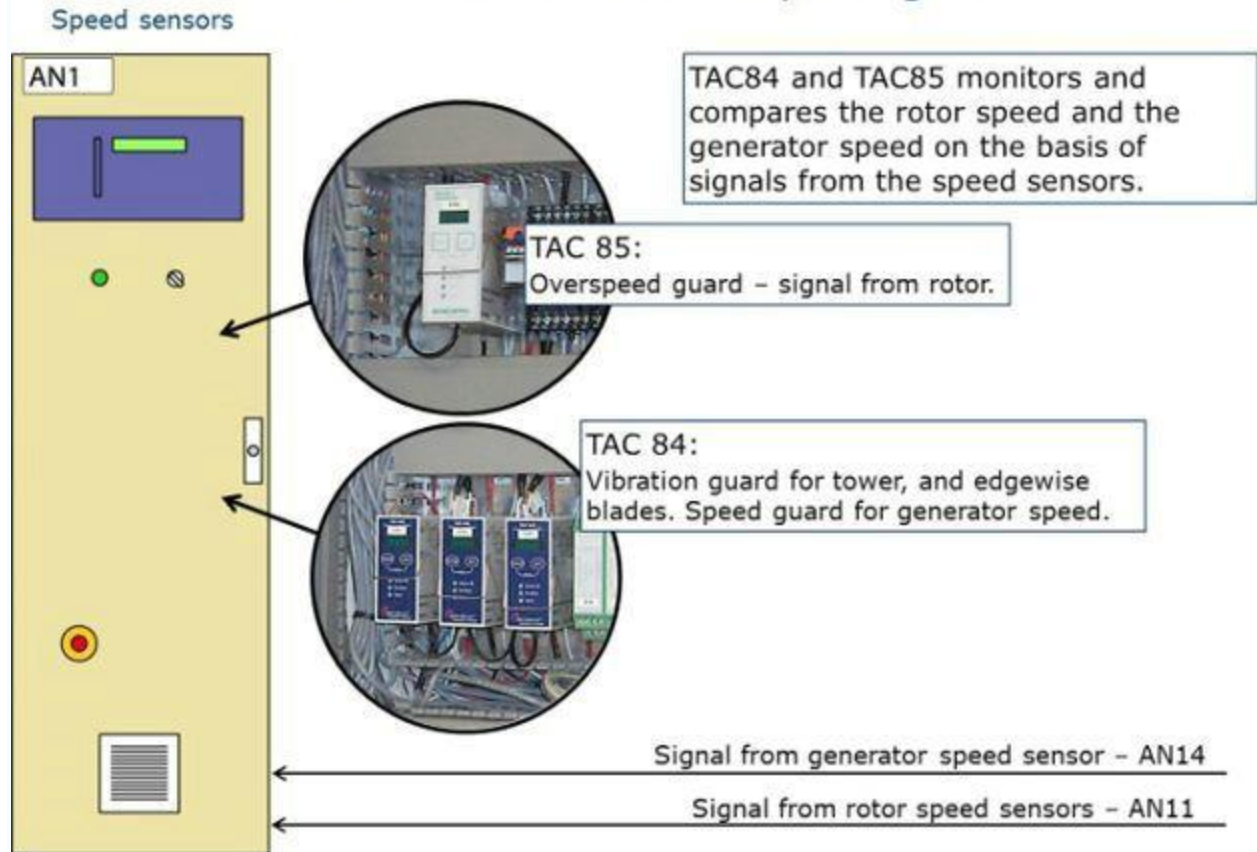
## TAC84 & TAC85 overspeed guards

The signal is transmitted to the TACII controller and the three Vibration/overspeed guard modules.

Before replacing the sensor or components, check the circuit for loose connections.

Check for loose sensor terminations in the AN14 panel. (The AN14 terminal panel exists only in V82 1.65 Mw. NM72/82 1650Kw generator speed sensor cables terminate directly at the AN1 Top Box).
