870 -Pt100 fault gear bear. rear - NM72,NM82,V82 Mk1-5

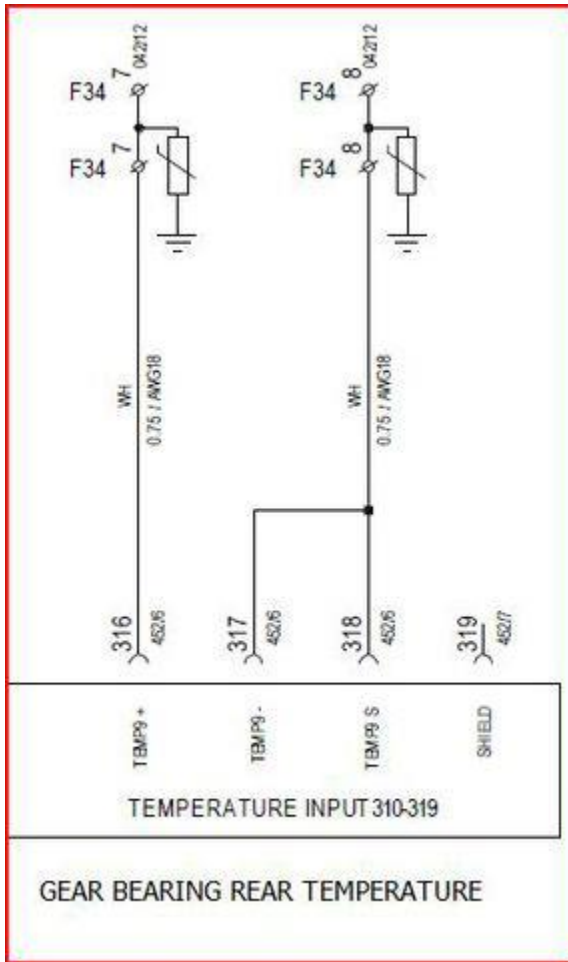
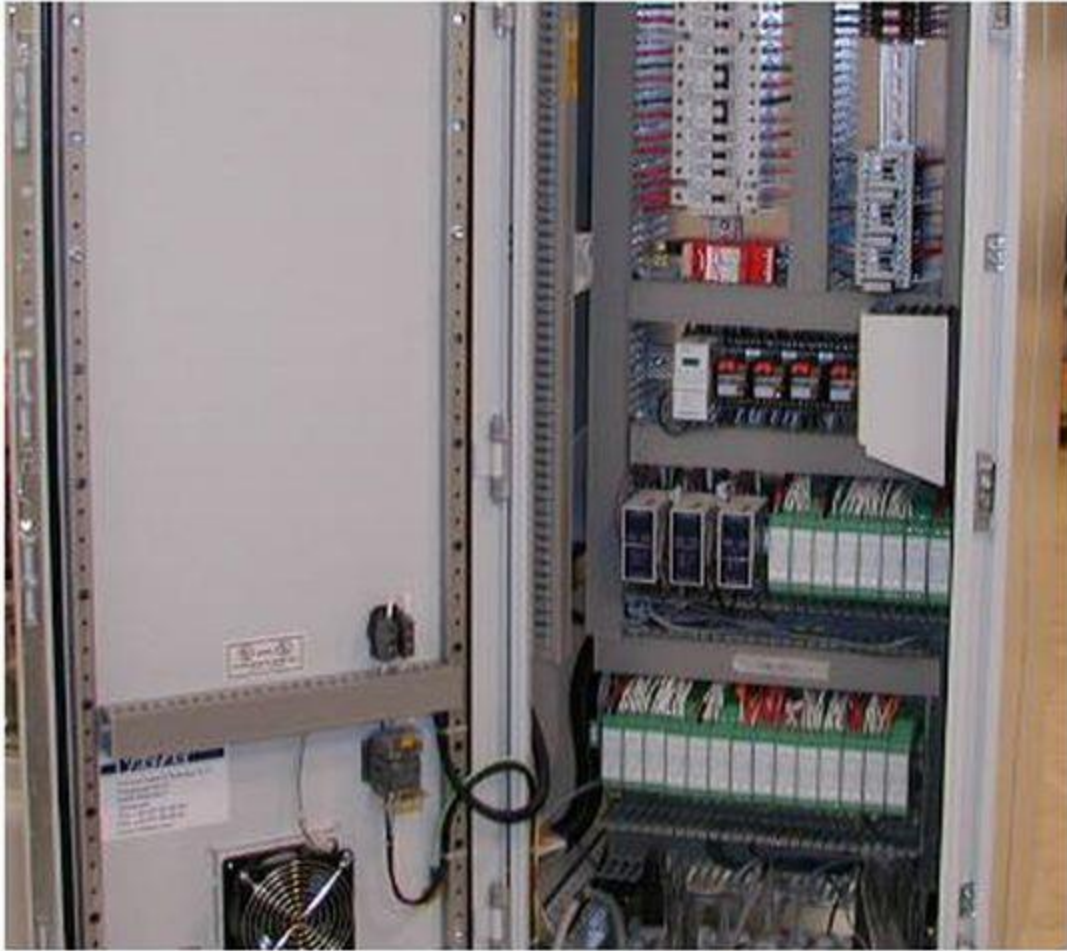
IN THE AN1 CABINET:

Varistor box (MkIII and above = F34/MkII and below = F10) can be tested individually by placing a multimeter (set to measure Ω) lead on the common (earth) side of the varistors and the other on the individual varistor terminals. The resistance value over the varistor should be ∞ or in the high M Ω range. If the resistance is lower, the varistor has been damaged by an over voltage in the circuit and must be replaced.

Replace the defective varistor
Does this solve the problem?

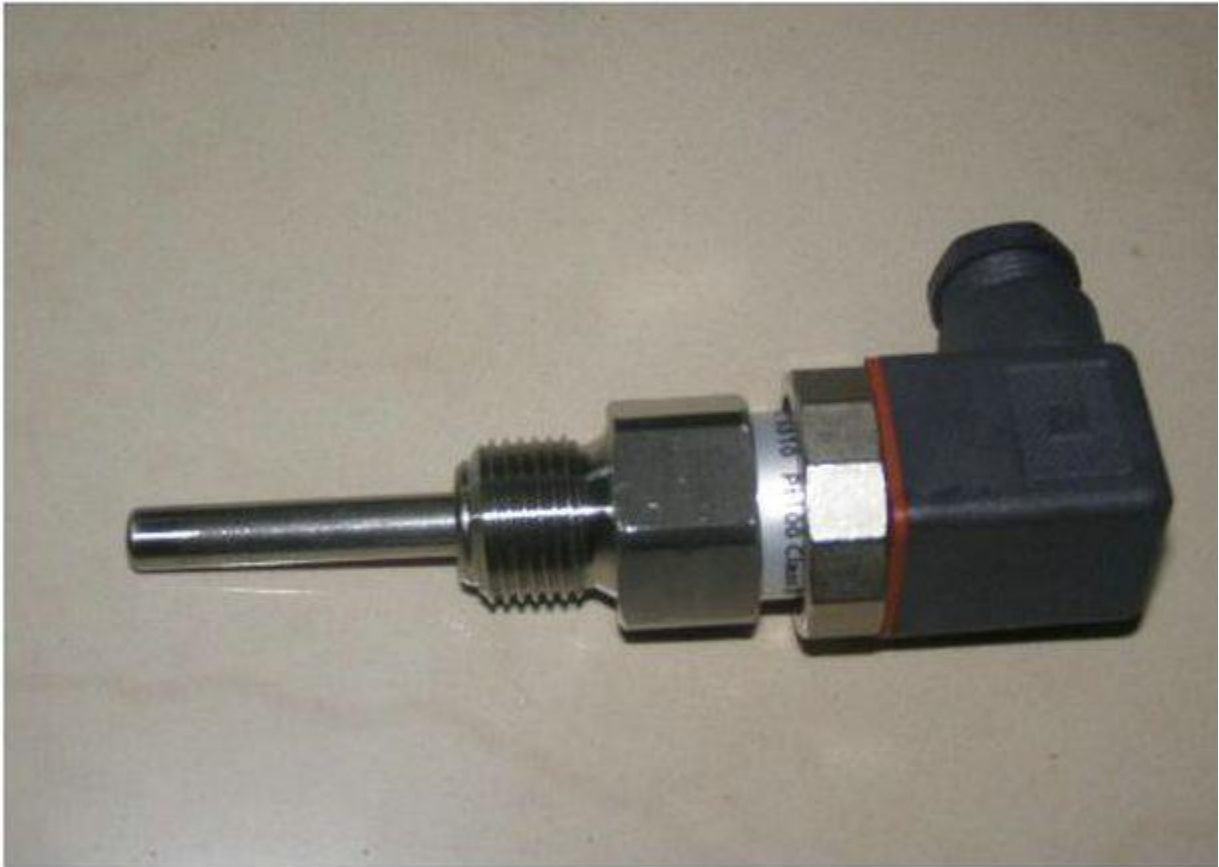
If the value is unreal (-40 to 200 °C), then the PT100 is faulty and must be replaced.

Replace the defective PT100 Sensor

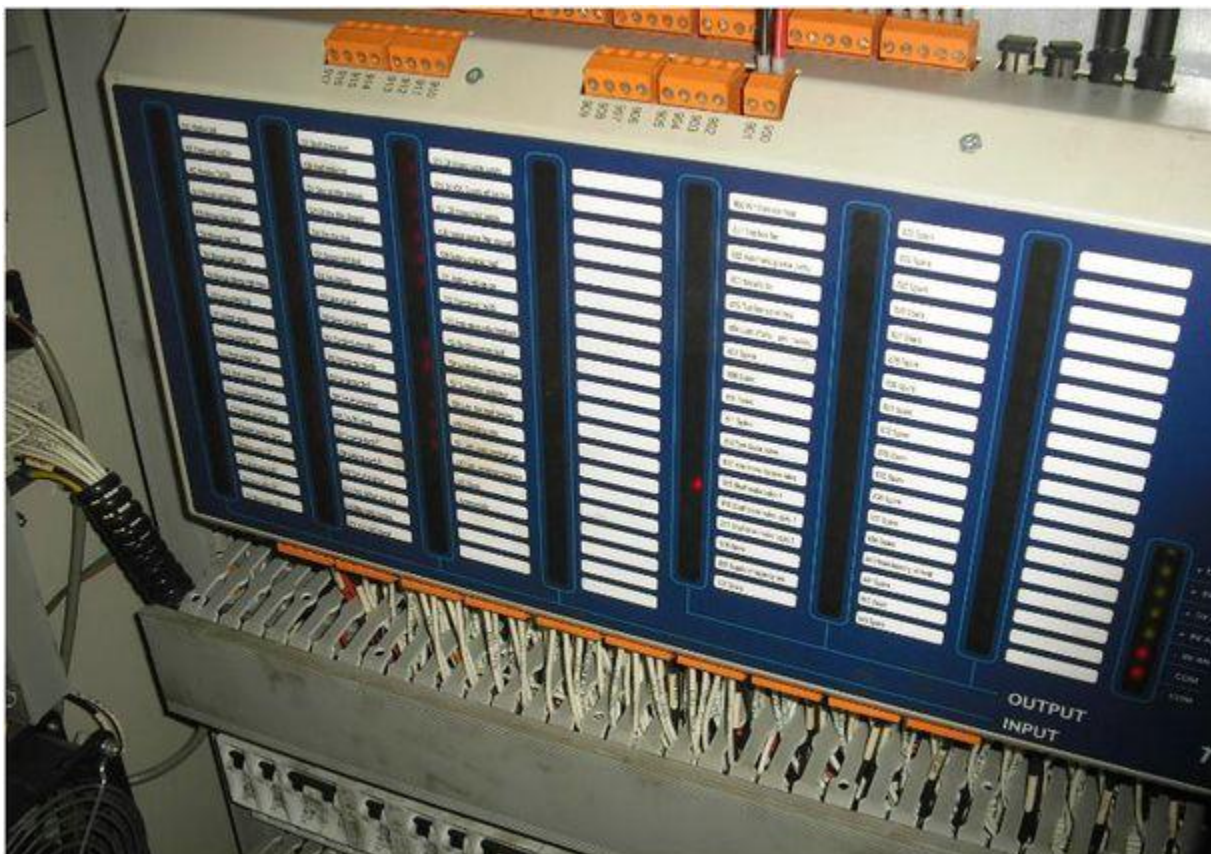
If the value measured by the meter does not match that taken from the TAC Temperature menu, then the cause is likely a faulty Nacelle TOI.

Replace the defective TOI
