Replace defective RS232/RS485 CONV I-7520 ICP

Property of Vestas Wind Systems A/S. This drawing must not be passed on to any person, nor be copied or otherwise made use of without our approval.			Date	Initials	Function RS485 comm. to +AT1 Top Panel							
			Designed	070628	FLT	Project title Control Panel +AT2 V82-1.65MW Mk5 50Hz							
			Approved	070628	FLT	Comments							
			Revised	070628	IN	Rev.	-	Drawing no.	934704	Cont. sheet	505	Sheet	50
			VESTAS PROPRIETARY NOTICE

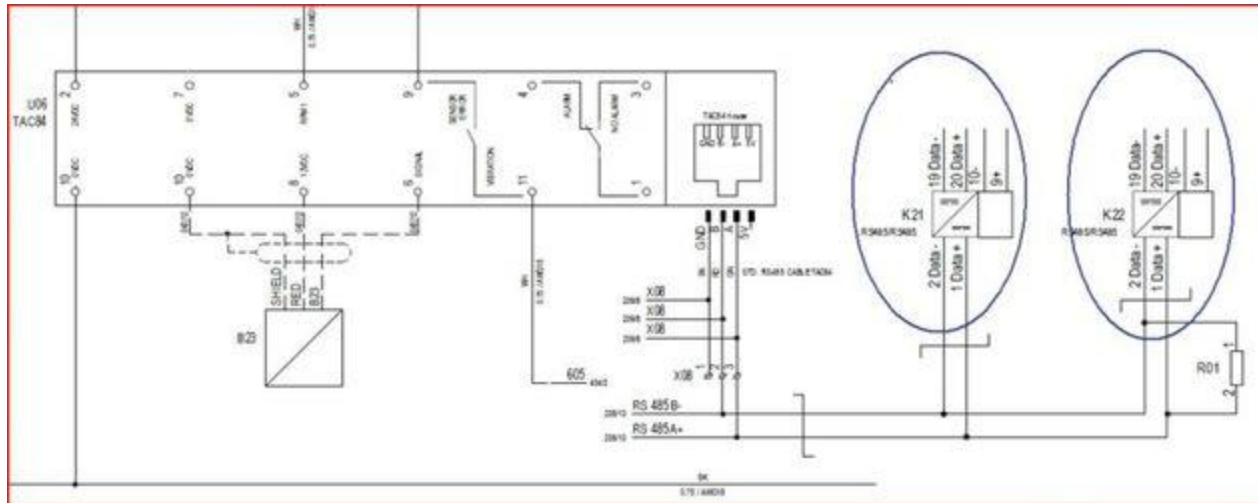
Check the connections at the ICP RS485 repeaters (K21 & K22) in the AN1. Check for loose wires and plugs or corrosion at the repeater.

Check the resistor loose connection and value and replace if any deviation

If there is still no communication, switch the ICP RS485 repeaters to see if the communication returns. If communication returns when the repeaters are switched, replace the faulty repeater.

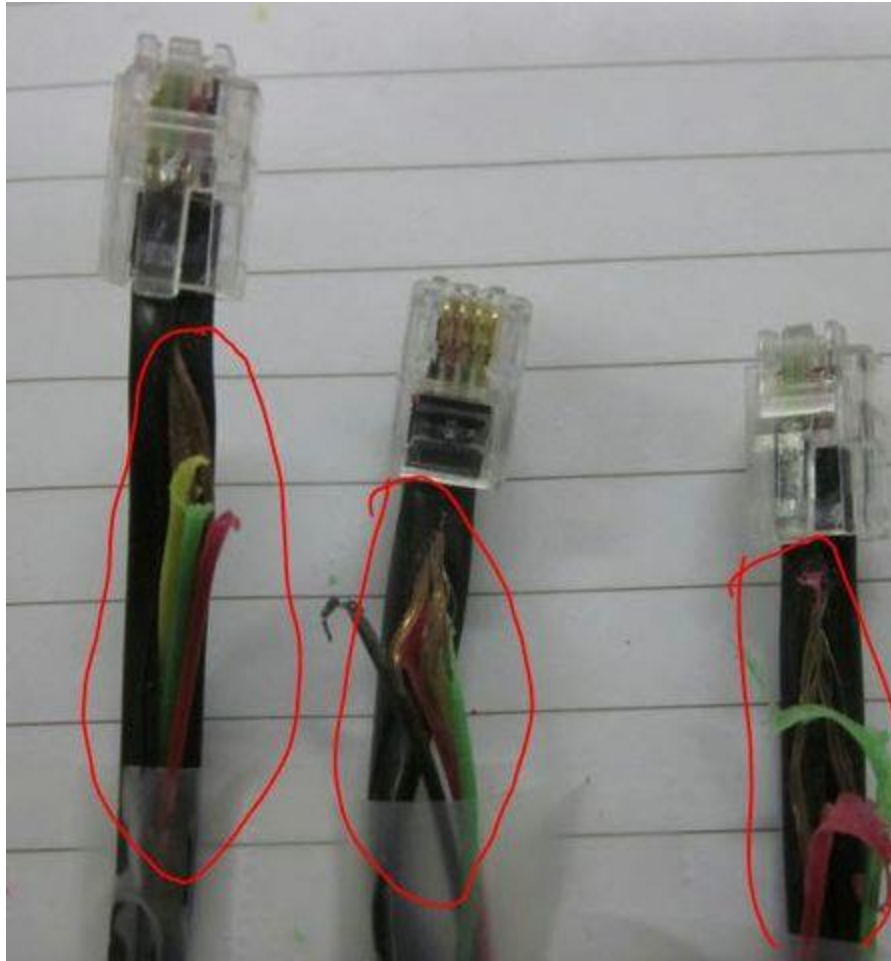
Wiggling the wires may cause intermittent communication caused by damage with in the wire. After replacing the wire cut the old one apart to see if there are any broken wires.

Broken internal wires on RS485 cable

Check RS485 comm. Cables to the UO3 (TAC 84), UO4 (TAC 85), UO6 (TAC 84) and UO7 (TAC 84).

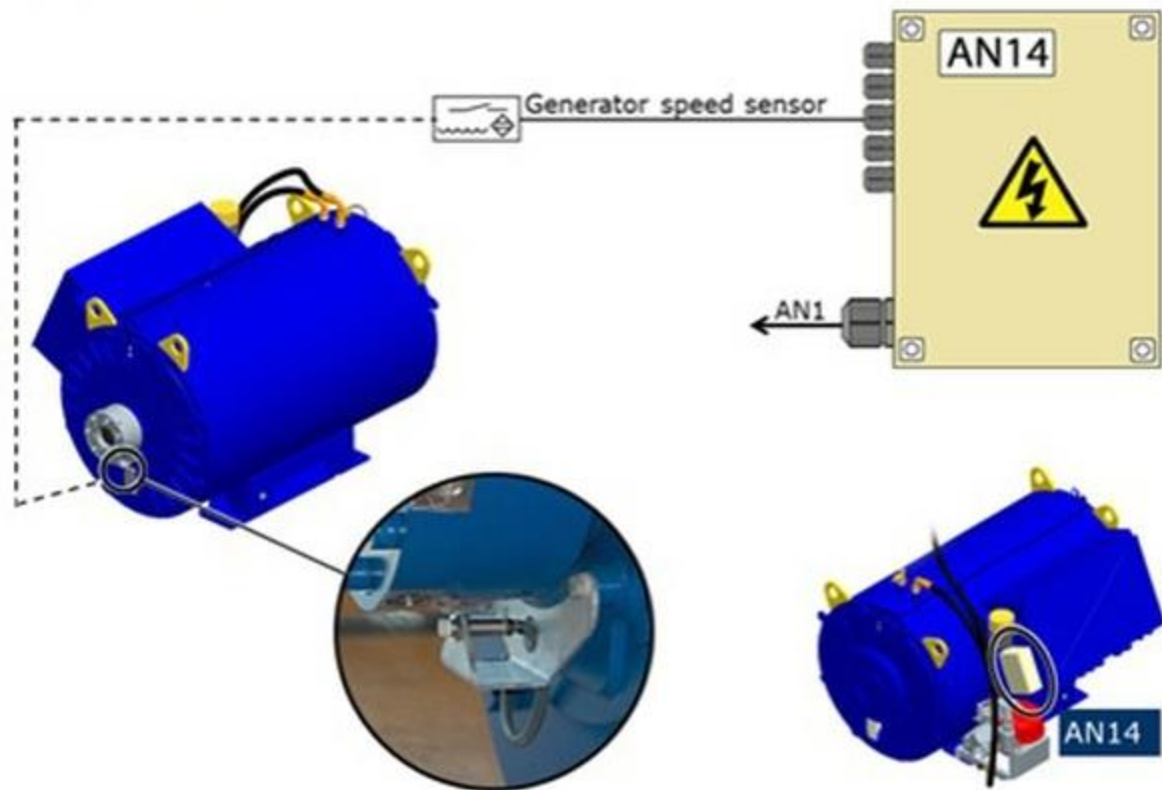
Speed sensors

The generator speed is measured by an inductive proximity sensor which creates a pulse signal as a pickup point passes over it.

In the case of the generator, there are **seven pickup points** for every rotation of the shaft therefore the speed is calculated as # of pulses/7 = generator RPM. If the sensor is loose or failing it can "flicker" which will simulate a higher RPM than actual. The sensor can be tested by passing a screwdriver or other ferrous object past the sensor. If it consistently emits a light the sensor is likely operational. The sensor can also be tested by rotating the generator shaft and ensuring that the sensor emits a light when each of the (7) link element bolts passes over the sensor.

If the sensor does not emit a light each time a link element bolt passes over it, lock the shaft and check for correct sensor adjustment. Check the bolts on the speed sensor bracket and ensure that they are properly tightened. The end of the sensor should be within 1,5-5 mm from the pickup point. Adjust the sensor by loosening the nuts that clamp it to the mounting bracket and move it forward or back to achieve the required distance from the pickup point.

If after adjustment the sensor still does not light up, or lights up intermittently when passing the pickup point- replace the sensor (sensor and cable are combined-W509)
