Service action must be taken without delay

A “Gear oil filter clogged” alarm shall be understood as a very serious malfunction in the turbine. A service action must be taken without delay.

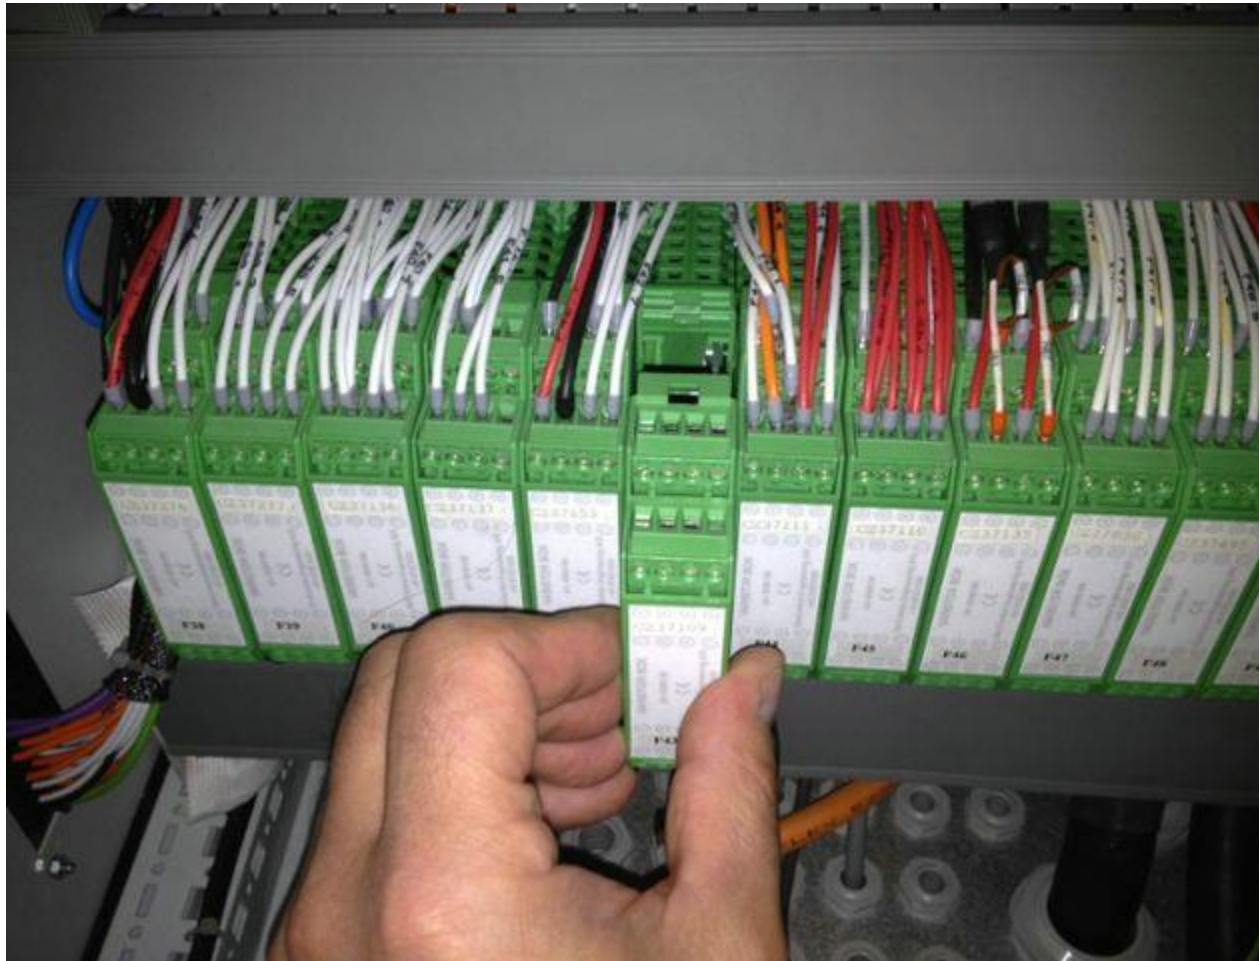
VARISTOR BOX F34:

Varistors (F34) can be tested individually by placing a multimeter (set to measure Ω) lead on the common (earth) side of the varistors and the other on the individual varistor terminals. The resistance value over the varistor should be ∞ or in the high M Ω range. If the resistance is lower, the varistor has been damaged by an overvoltage in the circuit and must be replaced.

The varistor box is made up of eight varistors and has provisions for 16 wire connections (protection for 8 signals)

Replace the defective varistor and tighten the loose wires

Press the clip on top and bottom of the varistor box and remove the varistor assembly from the housing:

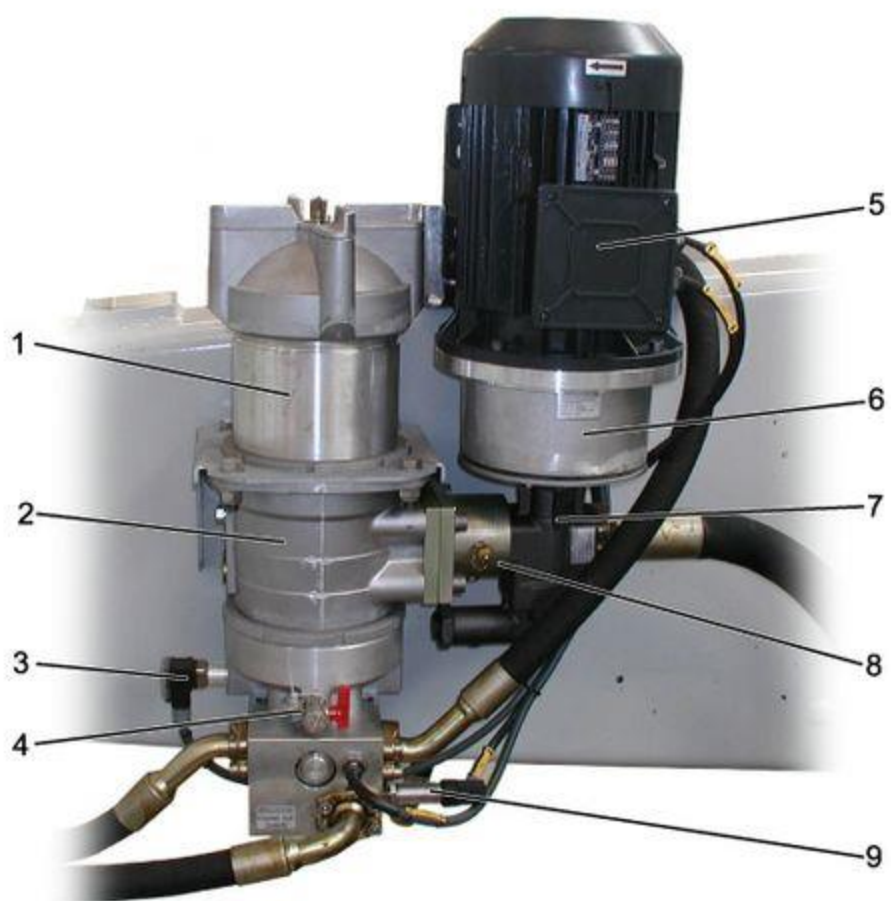
1. Filter Housing
2. Filter Housing
3. Transmitter
4. Drain valve
5. Motor
6. Coupling housing
7. Pump
8. Test connector
9. Transmitter

Replace the defective filter clogged switch or TOI unit

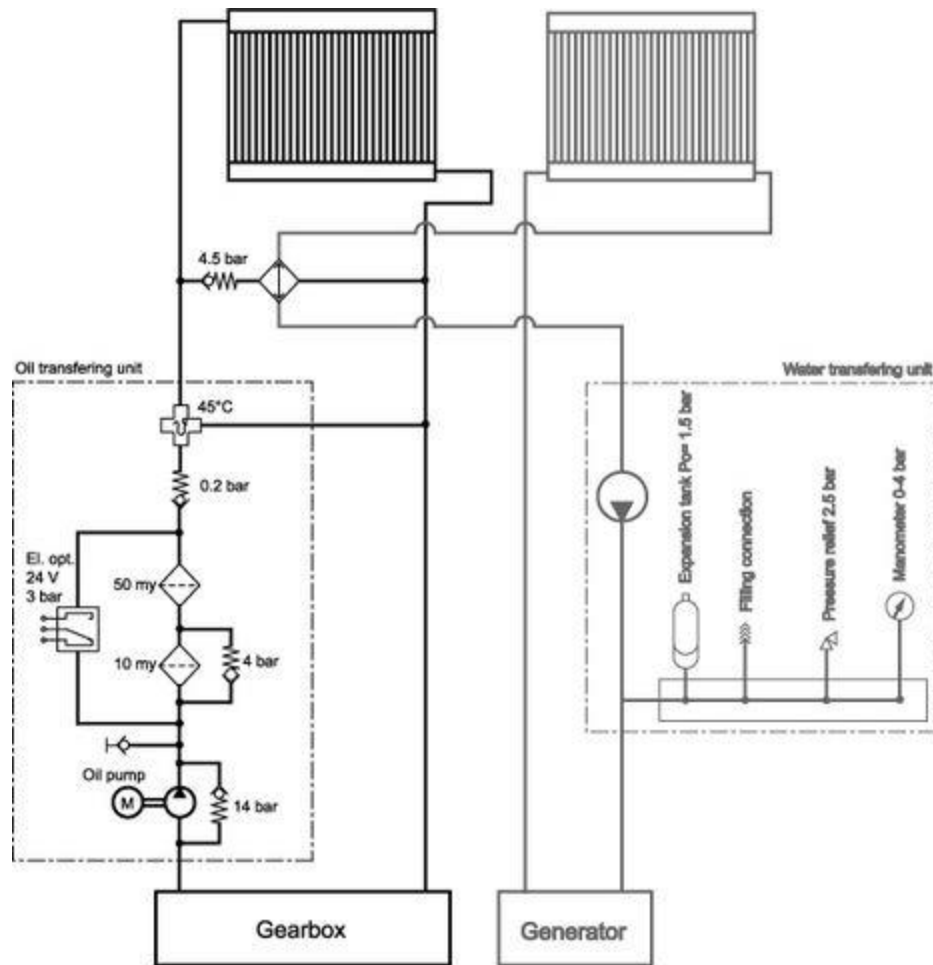
GEAR OIL CIRCUIT:

The switch is placed in the gear oil filter unit. In case oil flow is clogged in the filter, the pressure differential will operate the switch and the signal to TOI is cut off then the alarm will arise. The LED light indication in the switch is also OFF.

Check the filter clogged switch light indication and operation of the switch.

If the switch is found to be defective or damaged, a new switch must be installed.

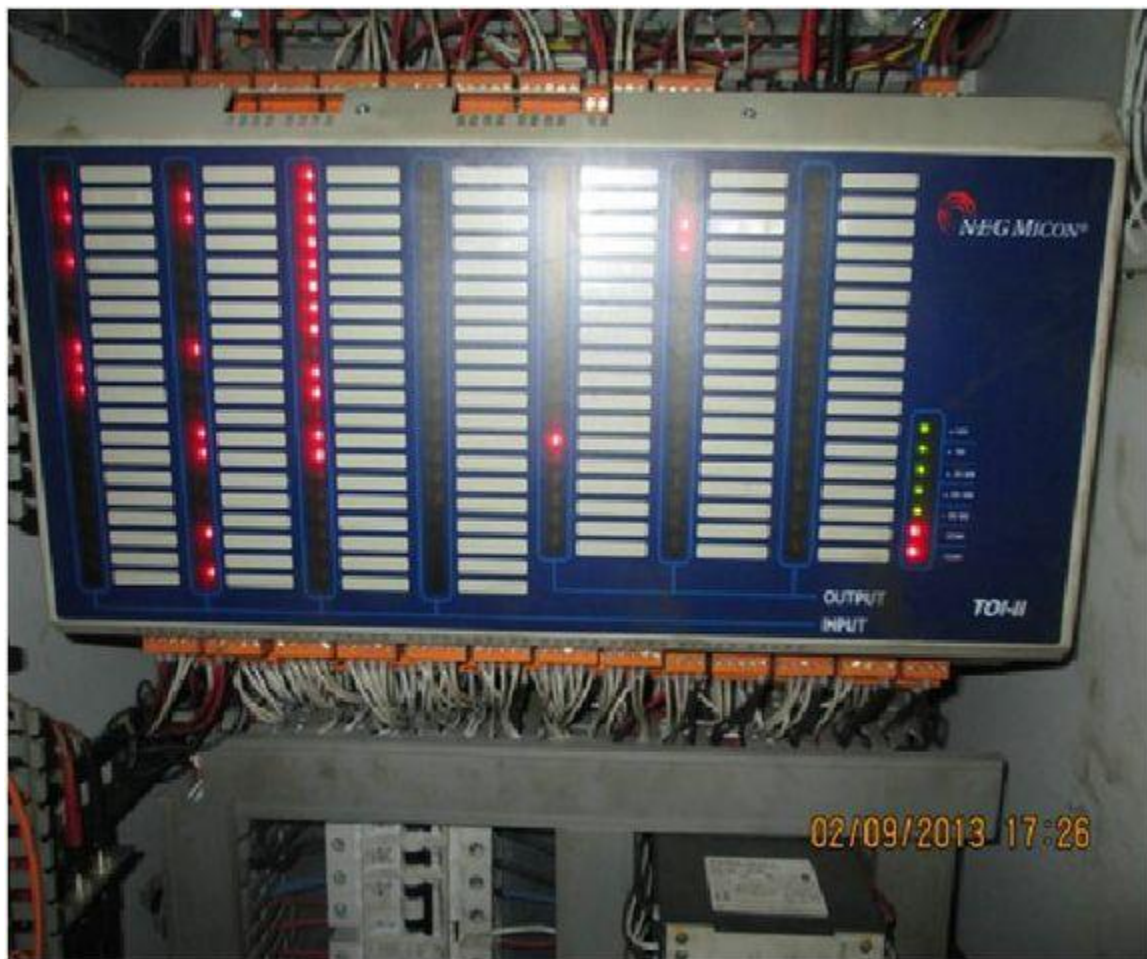
IN THE AN1 CABINET:

If the filter clogged switch and connections are normal, but the filter clogged switch is active in the controller then the likely cause is a faulty nacelle TOI.

Replace the defective TOI unit.

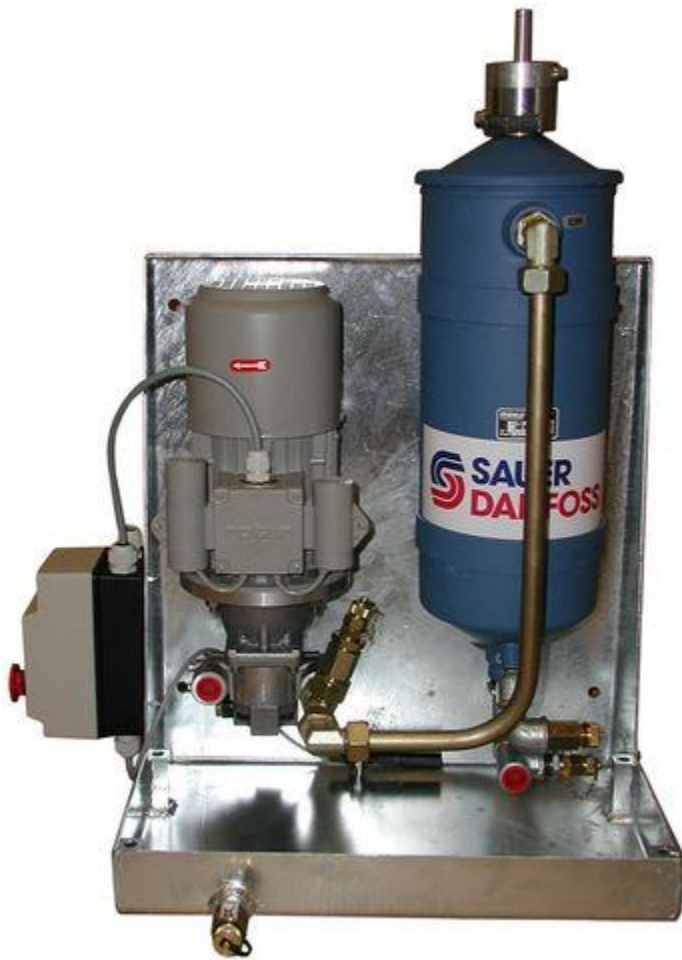
If metal particles found in the filter, clean the filter unit and install new filters.

If equipped, check the operation and oil flow of the offline oil filter unit.

Inspect the filter and replace the filter if necessary.

Replace any defective components.

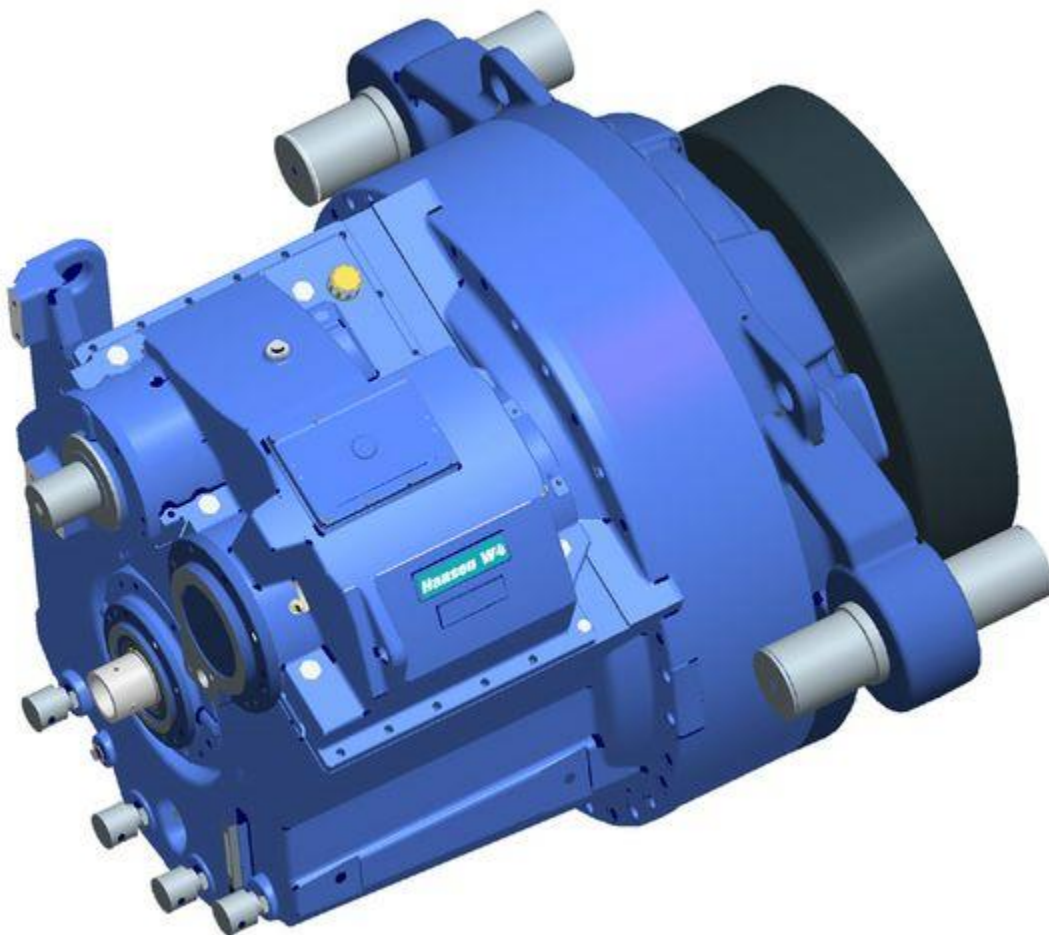
GEAR BOX Inspection:

Inspect the gearbox rear PT100 sensor tip for signs of wear.

If there is wear on the tip, likely the outer race of the bearing has been rotating within the bore of the housing. Then proceed with repair solution with reference to CIM1312/CIM2217.

Prior to repairing the gearbox, a measurement is taken of the gap between the housing bore and the outer race of the bearing. If during repairing the gap between the outer race and housing is >0.23mm, mechanical lock solution will be required to prevent the outer race from spinning. Contact local Engineering department for instructions if the measurement taken is greater than the allowable limit.

Inspect the Gear box and repair the gears

Open the inspection cover and check the inside of the gearbox and bearings for any sign of wear or damage.
