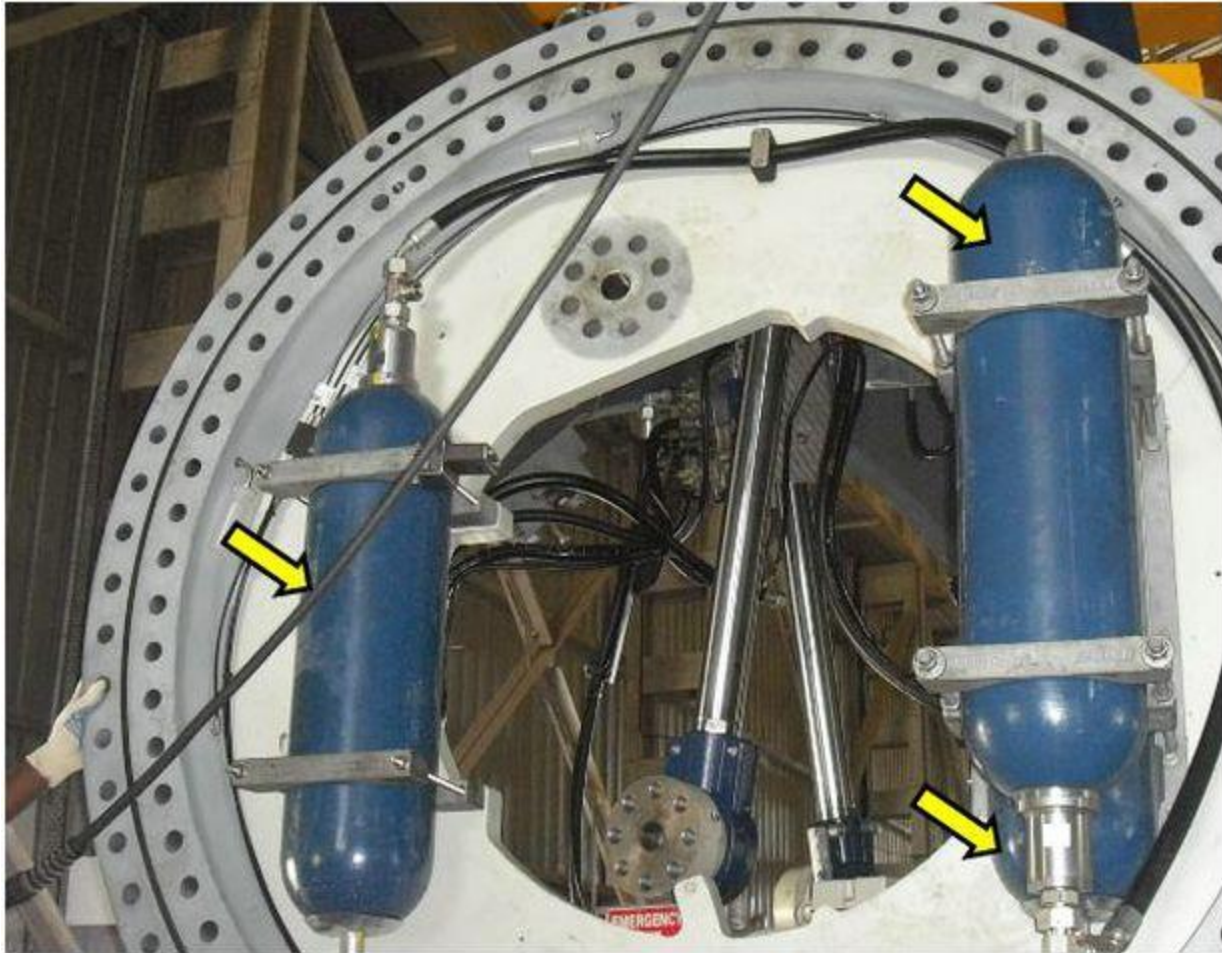
If the bladder in the accumulator has failed, replace the accumulator.

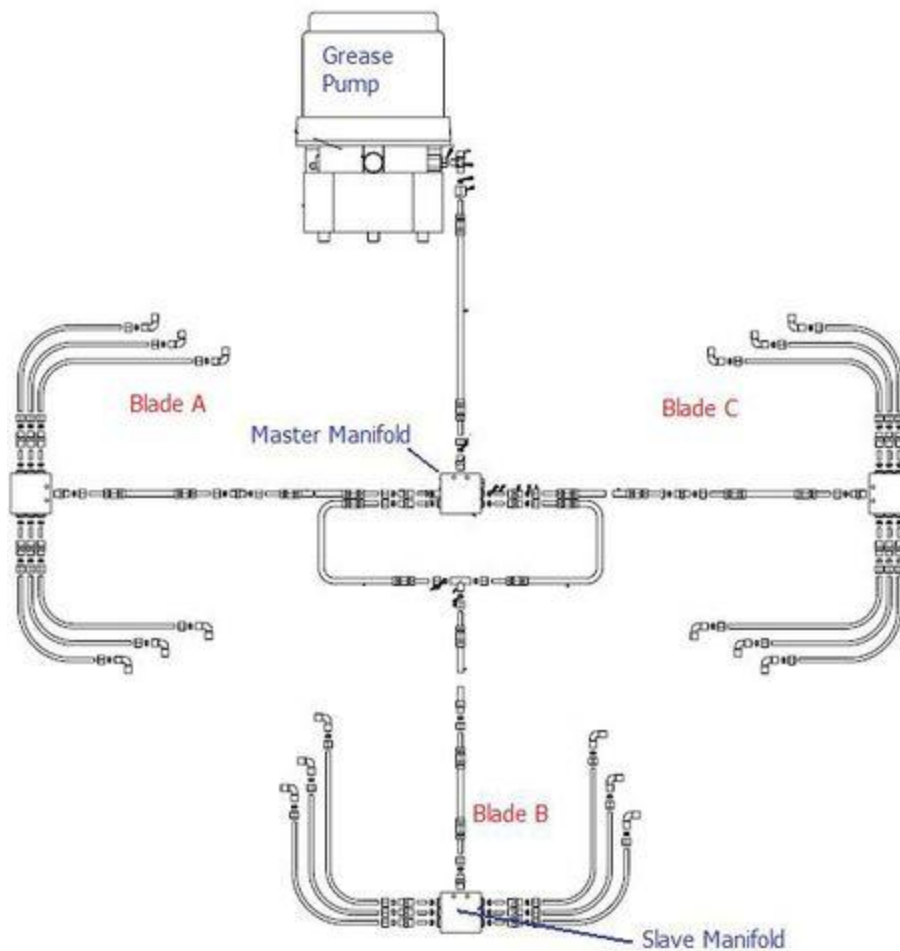
Blade bearing greasing system:

Inspect for any damaged hose fittings, manifold grease blockage or hose damage.

If necessary replace the manifolds and hoses.

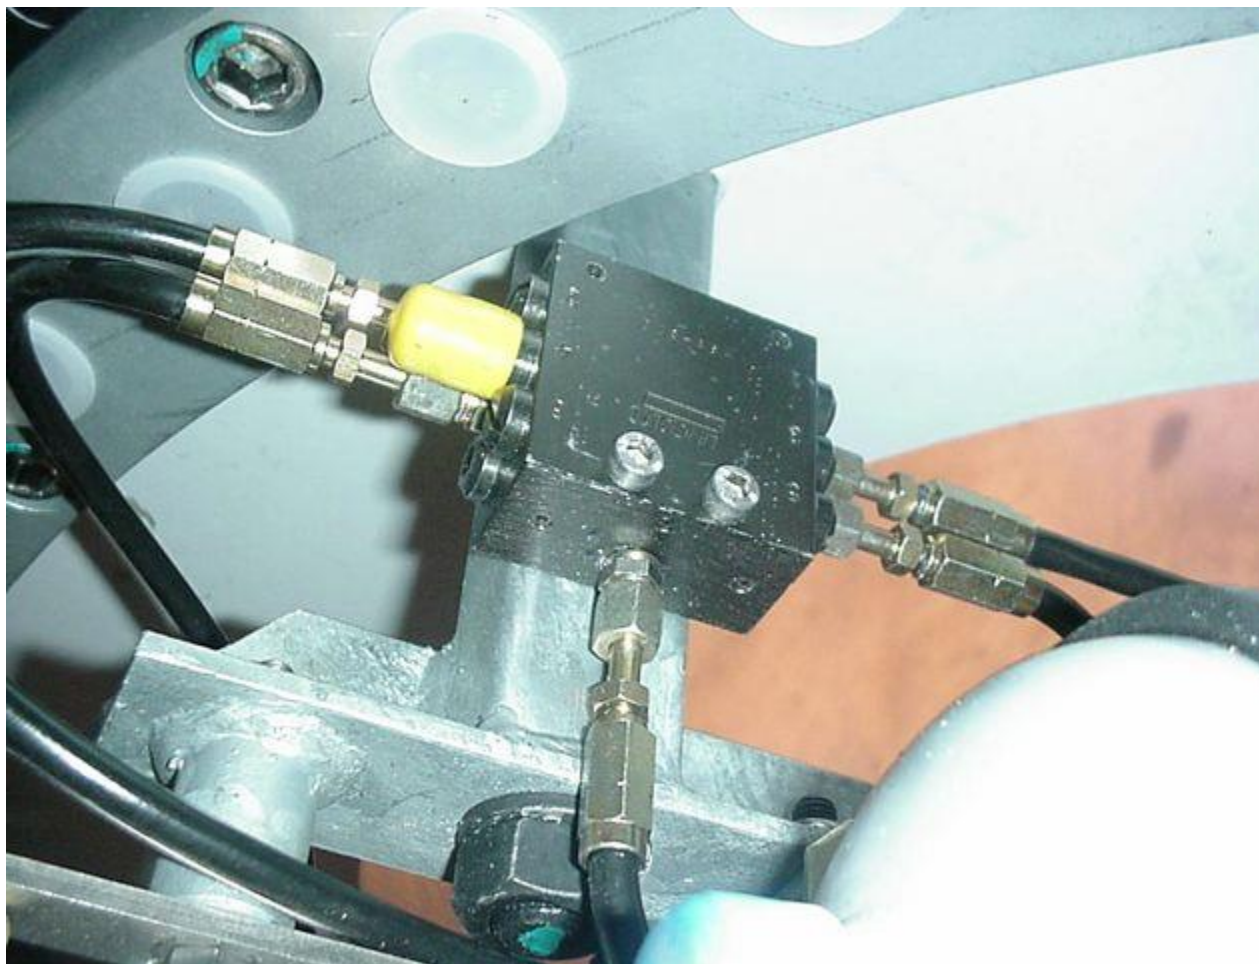
Check for blade bearing grease leaks:

Check blade bearings for any grease leak.

Check for grease or oil stains on the blades and spinner.

If there is any damage or heavy grease leak replace the seals.

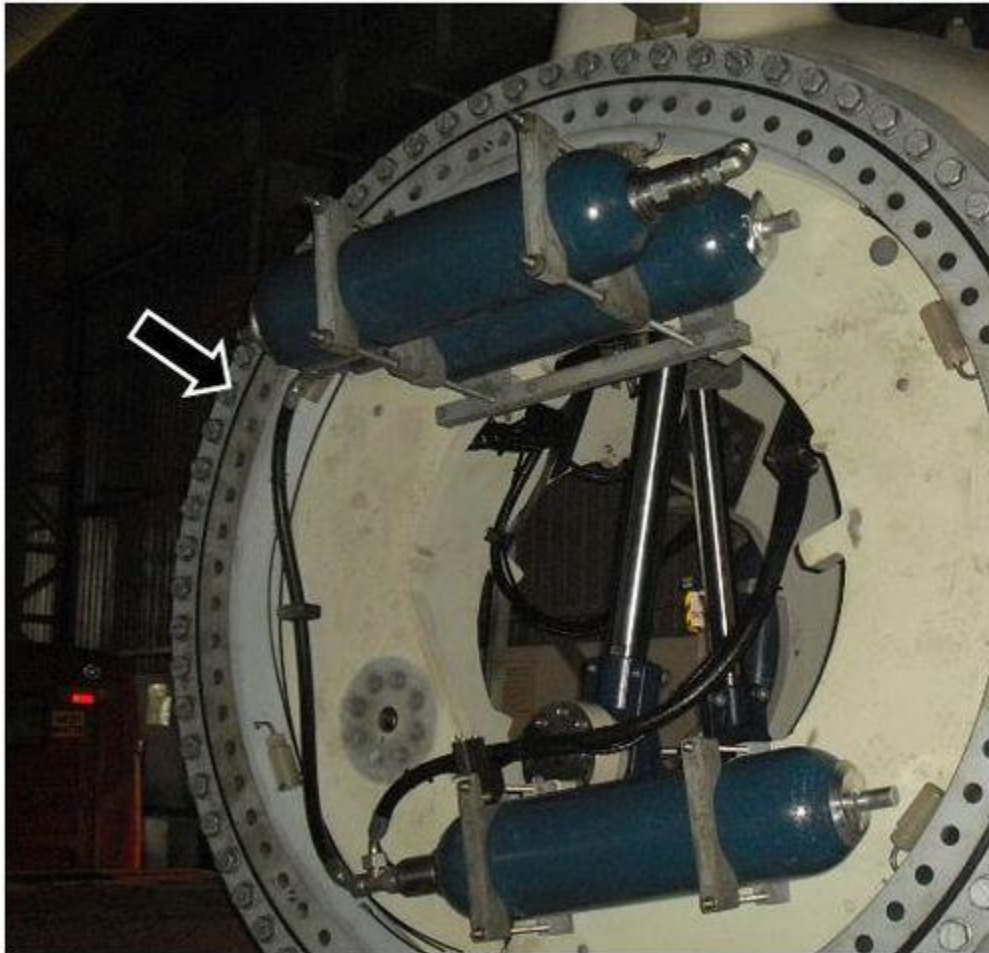
If manual greasing does not solve the issue, likely it is the cause of blade bearing failure. Consult the SBU Engineering group to determine course of action and correct item number for the applicable blade bearing.
