Clean or repair Slipring

Replace the defective components

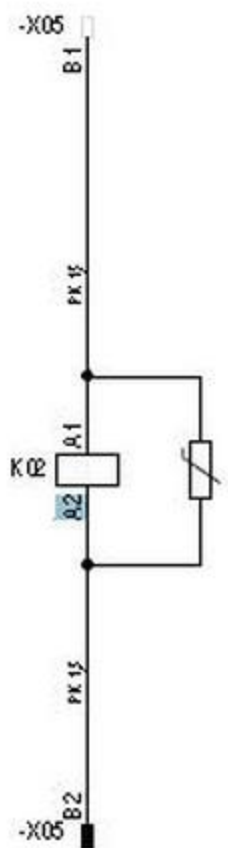
From drawing 6015908

Alarm was detected due to a loose contactor (K02) power supply connection (A2) in +AK4 hub computer panel :

Check the AK4:K02 is in the proper state, replace if it is damaged

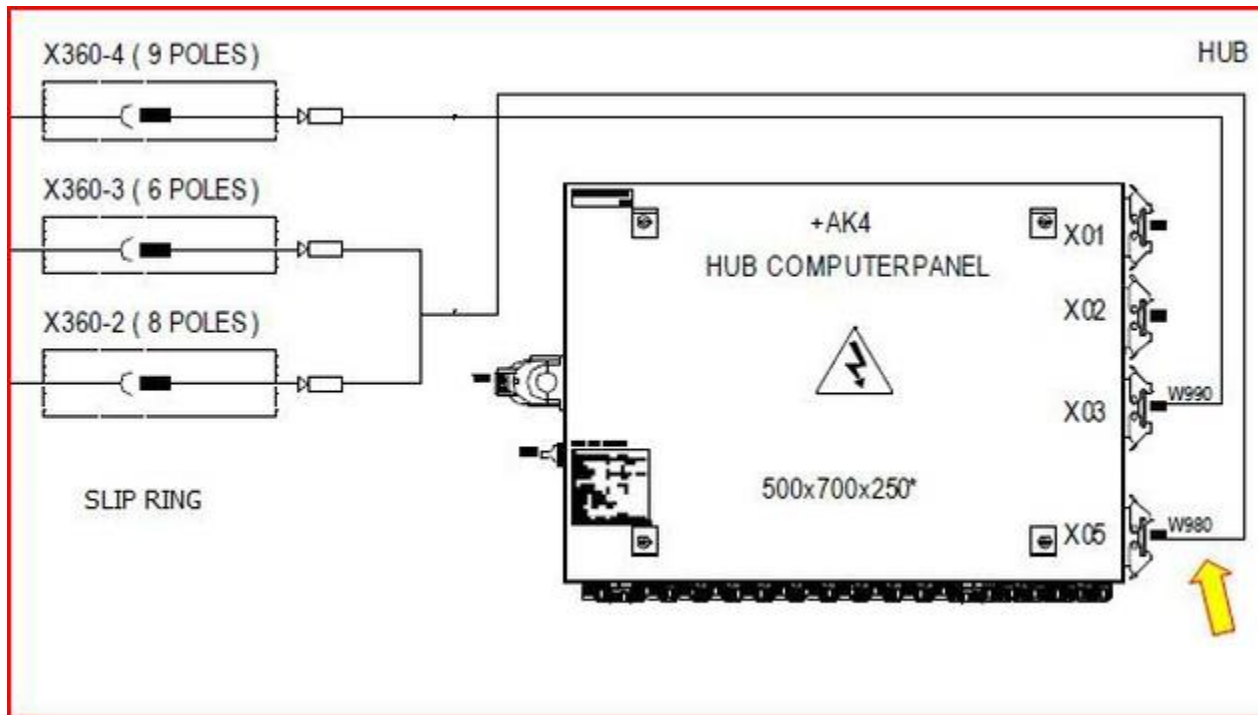
Check the condition of the –W980 cable in the hub.
Check for any cracks or wear on the cable.
Replace the cable if it is defective.

Description	Item No.
CABLE W980 IEC Supply	60021557

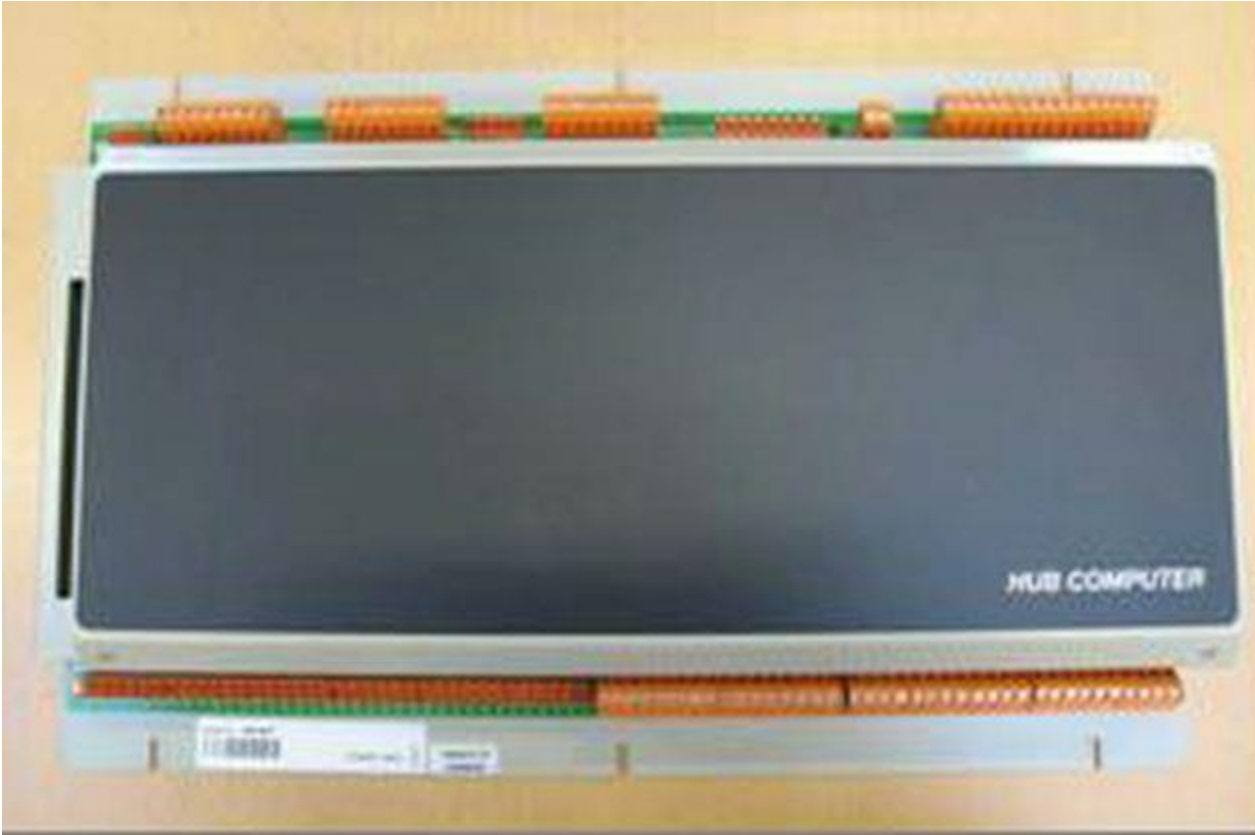
It has in many cases been seen that the plug connection have been overheated and burned as indicated on the below pictures.

Replace the hub computer if it is found to be defective.
