Test/Replace PT100

Clean grease from bearing

Inspect generator shaft Does this solve the problem?

Change the faulty TOI-2 Tower, Water pump motor and Contactor

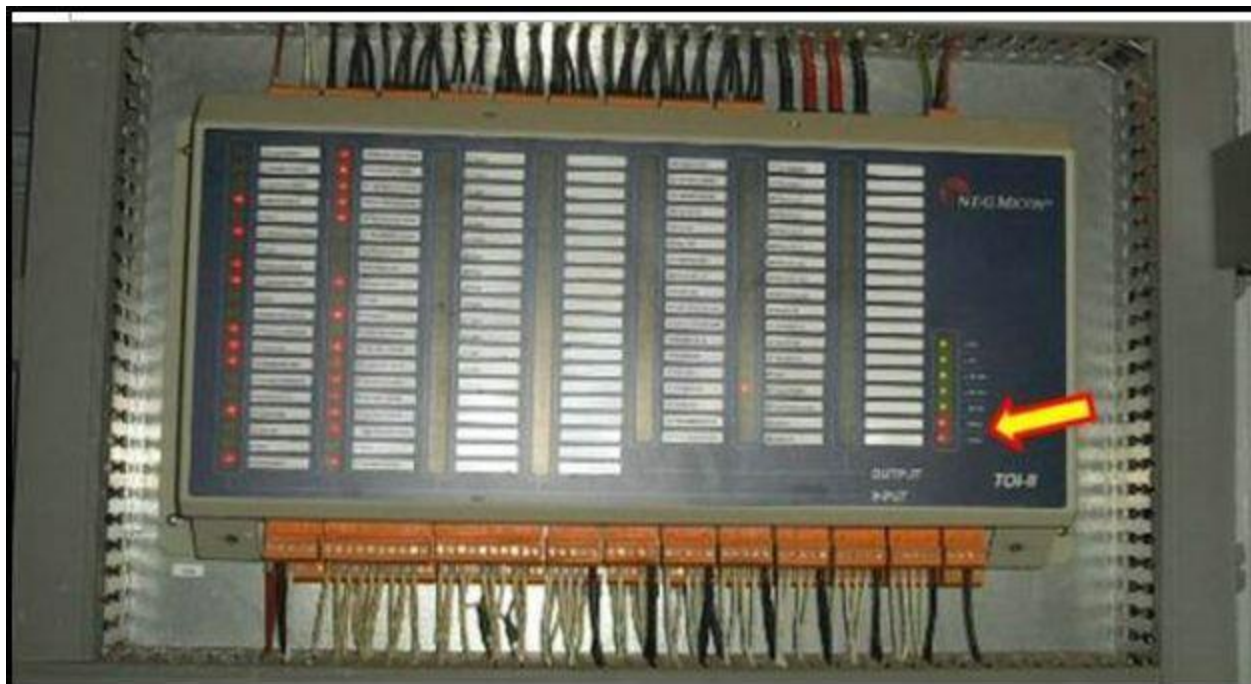
Relevant spare parts	
Description	Item No.
TOI-II INTERF NM1500 TOWER	51701501

AT2 Cabinet Check the TOI-2 Tower out put 810 Water pump, if there is no out put while testing change the TOI-2 tower Check the motor contactor Q8/K04 coil supply and terminal out puts and if there is not output change the conctactor.

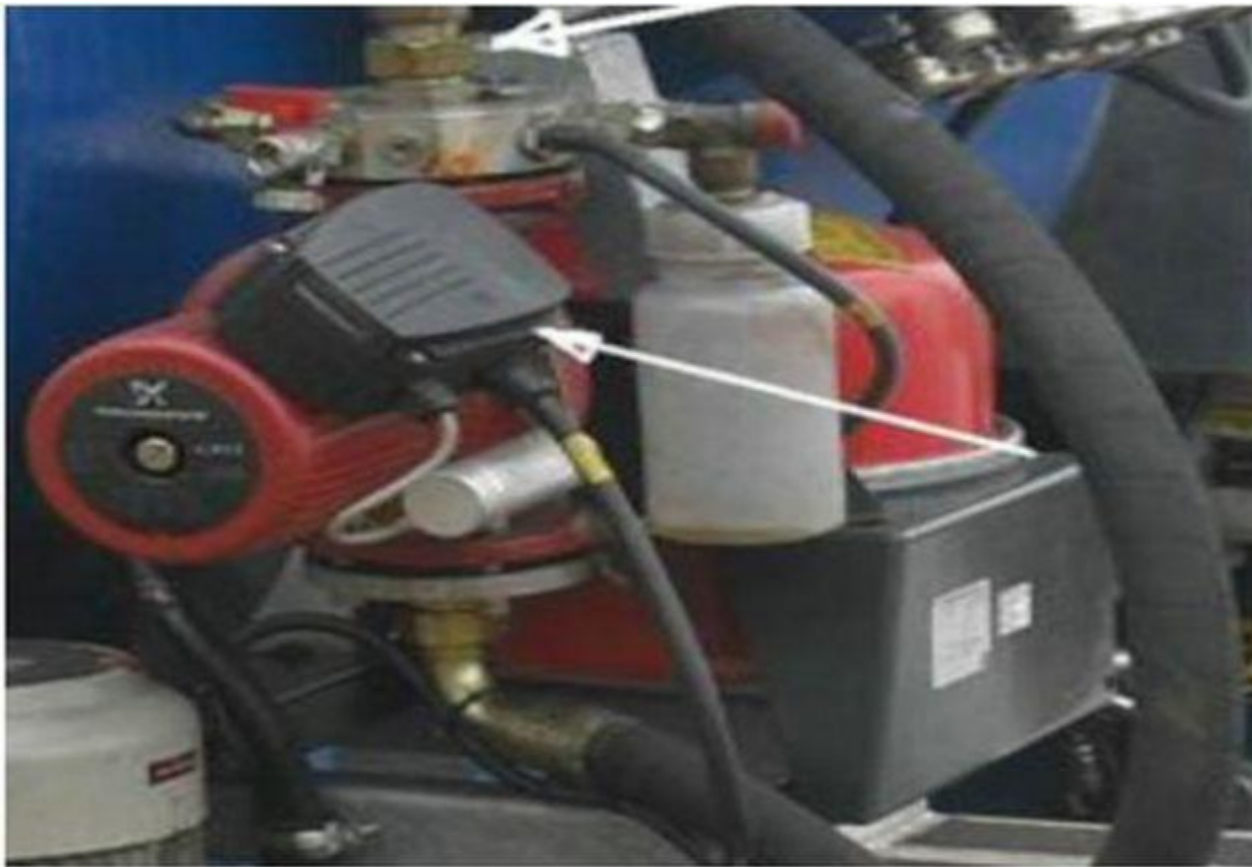
Relevant spare parts	
Description	Item No.
MOTOR WATER PUMP UPS40-180F	60061710

At Nacelle Check input voltage to the motor (M06) and supply voltage present but motor not run, stop the test function disconnect the supply voltage and check the winding continuity, if the motor winding opened, the breaker will not trip since single phase circuit not closed. No fault current flow. Change the motor.

Relevant documentation	
Description	DMS No.
Water pump motor replacement SWI	0023-9289
