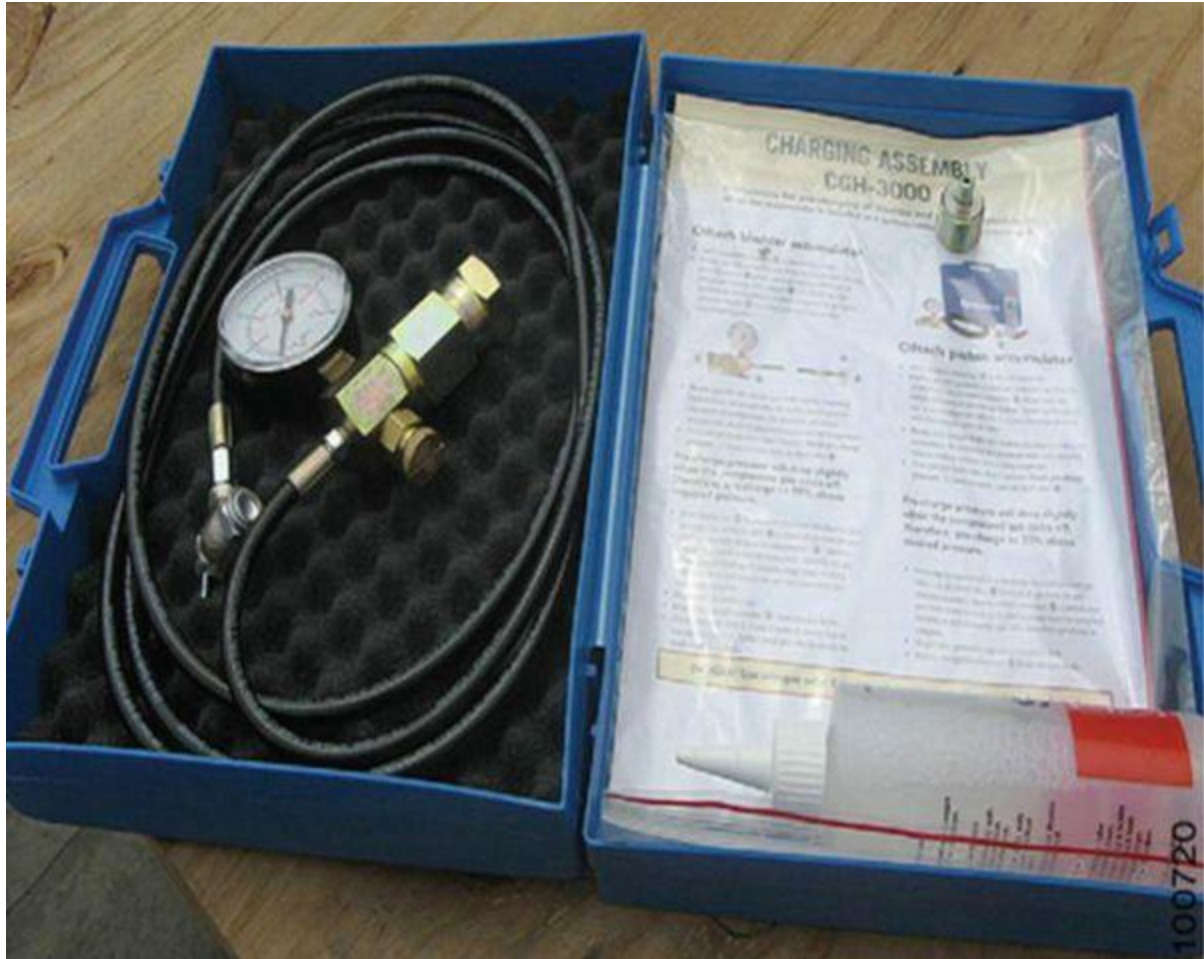
Re-charge accumulators as needed.

Test accumulators in accordance with 941918 Recharging of Nitrogen Accumulators.

Relevant spare parts	
Description	Item No.
V82 accumulator charge kit	222826

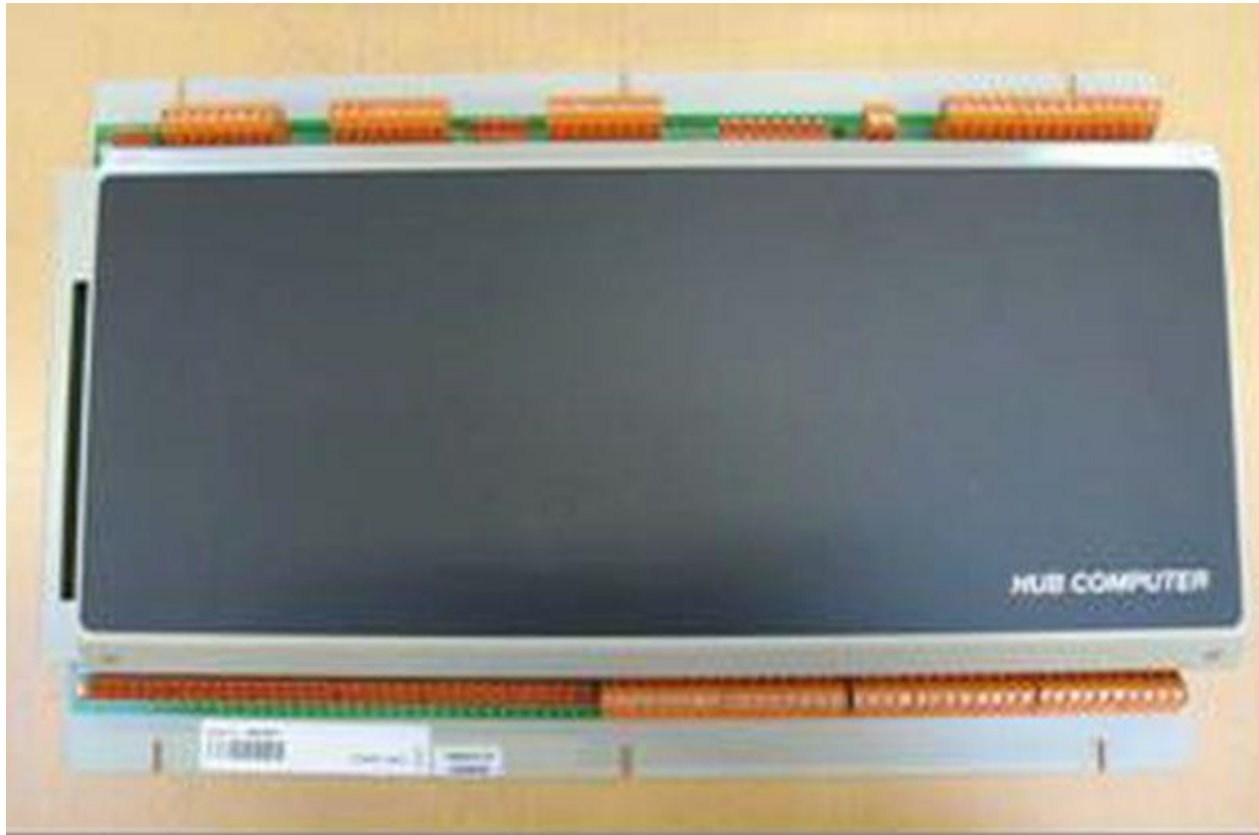
If after the blade calibration, any pitch angles deviate, or angle values show constant when pitching the blades, the hub computer may defective.

Replace the defective hub computer

Relevant spare parts	
Description	Item No.
SIF HUB COMPUTER CABINET EVOII	51701801
