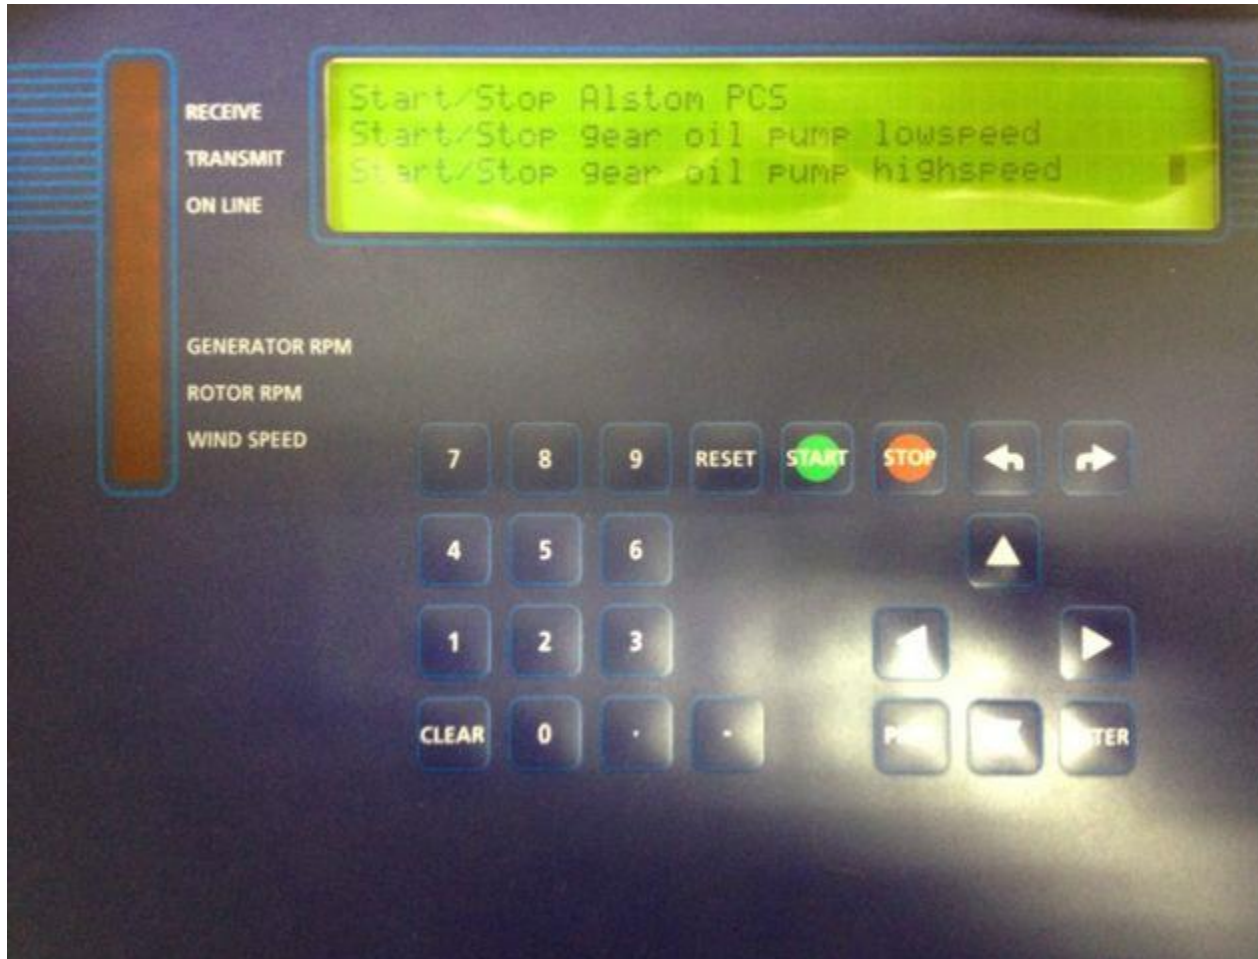
In the TACII start the gear oil pump in low speed:

Status=> Service=> Manual Test=> Start/Stop Gear oil pump low speed=> Enter

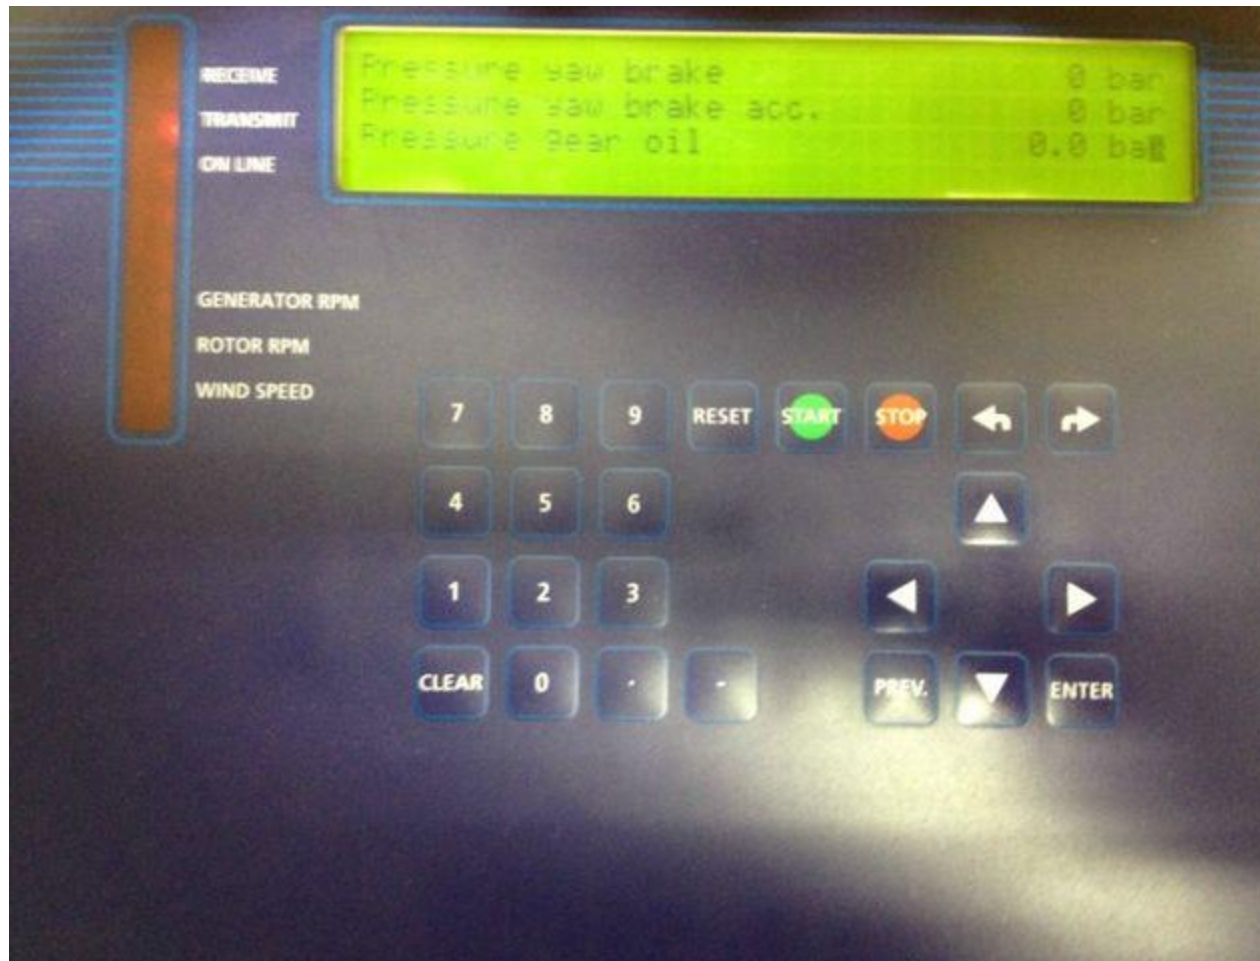
In the TACII check the gear oil pressure:

Status=> Pressures=> Pressure gear oil

Allow system pressure to build for several seconds. Observe that the pressure rises in the TACII controller. If the pressure does not rise or shows negative, replace the pressure transmitter.
