Replace defective RS232/RS485 CONV I-7520 ICP

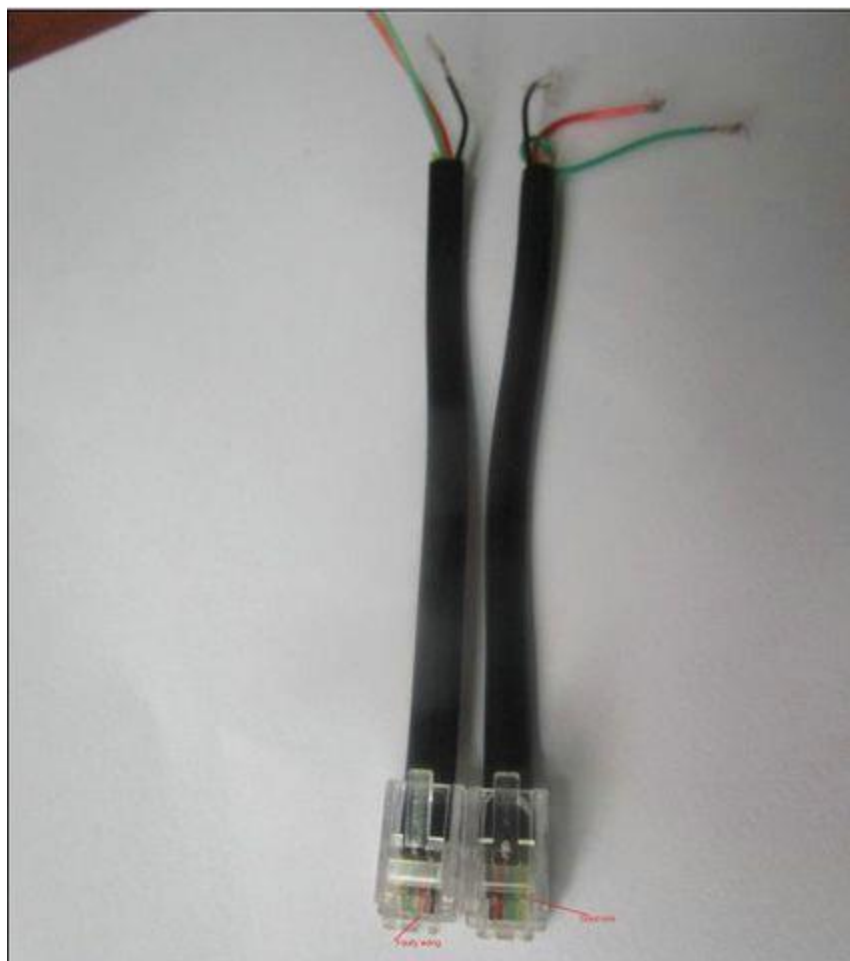
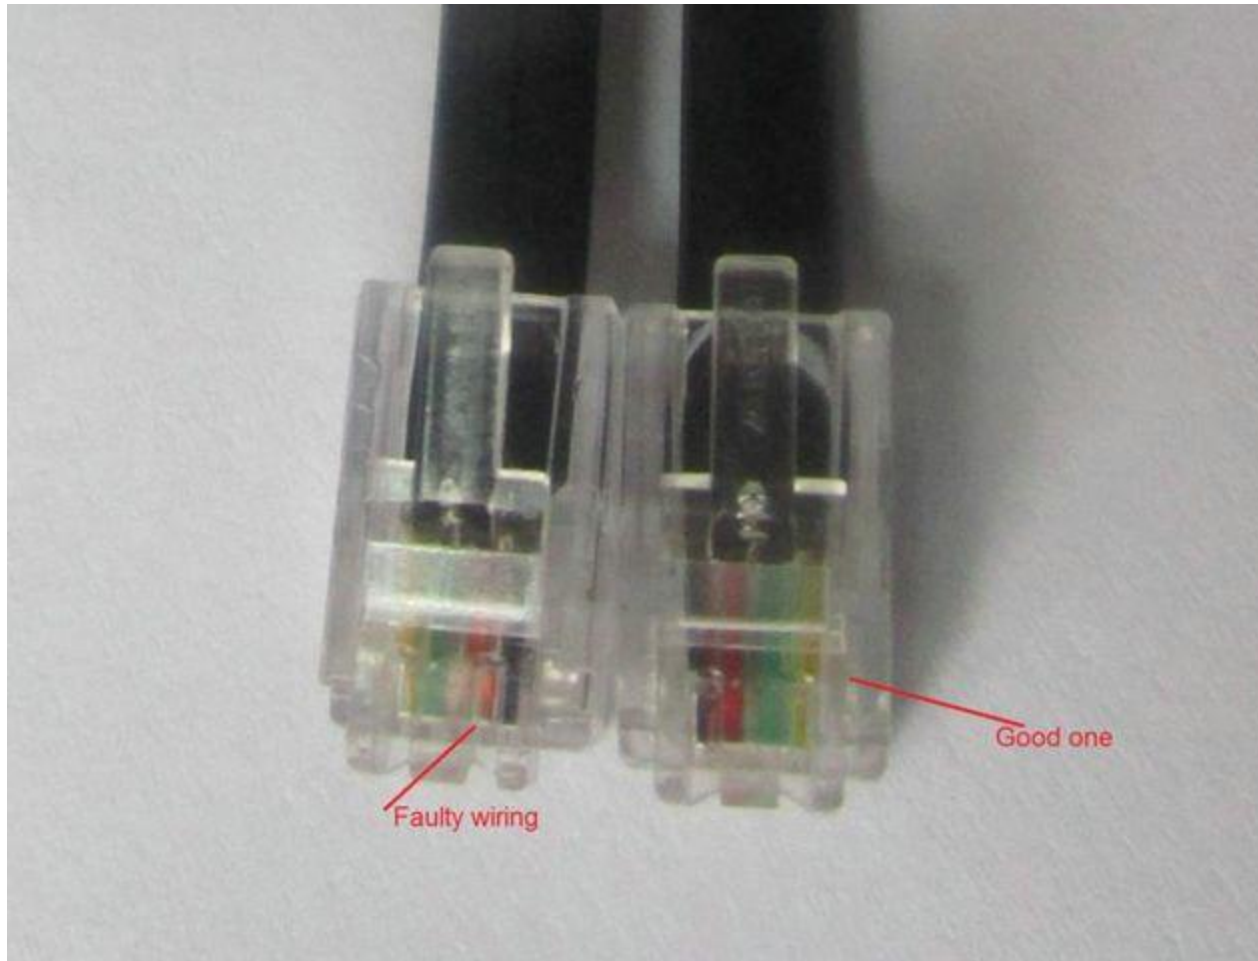
Check the continuity of B3 & B4 cores in cable W500 and replace with spare core, if no continuity.

If found cables interchanged, then this should be corrected at the other end at connector terminals.
