Replace Thyristor

In this failure mode the alarm normally trips at 1000/1200rpm when the turbine connects to the grid. There are also current asymmetries in this failure mode which can be observed in the TAC display panel.

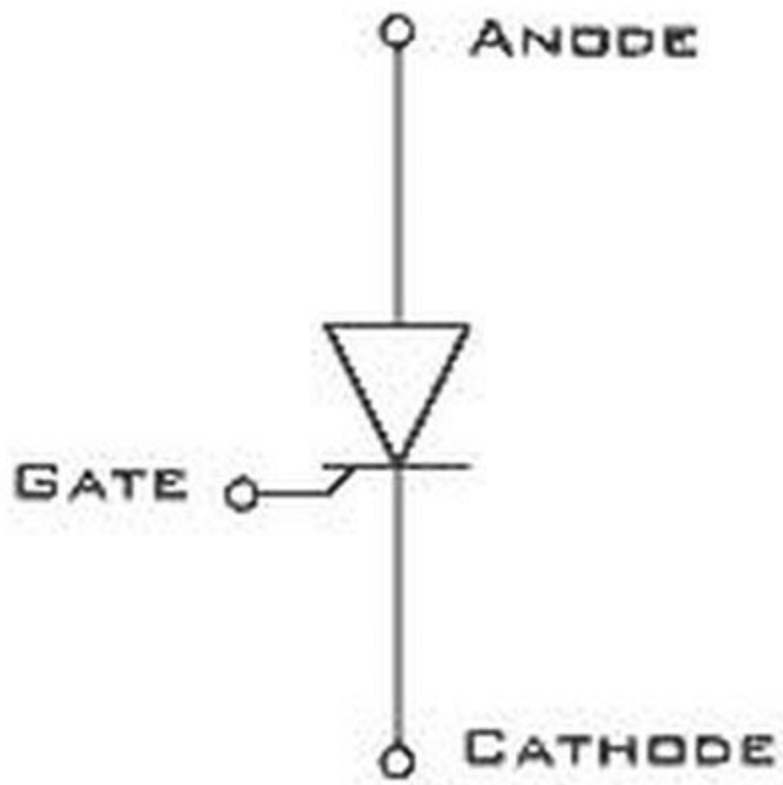
Example:

Please, note the names of the wires, they start with "A" and "K" ©.

We use double thyristor as one diode can only conduct in one direction.

Note the connections marked with A, AK and K.

AK is the center of the two thyristors.
