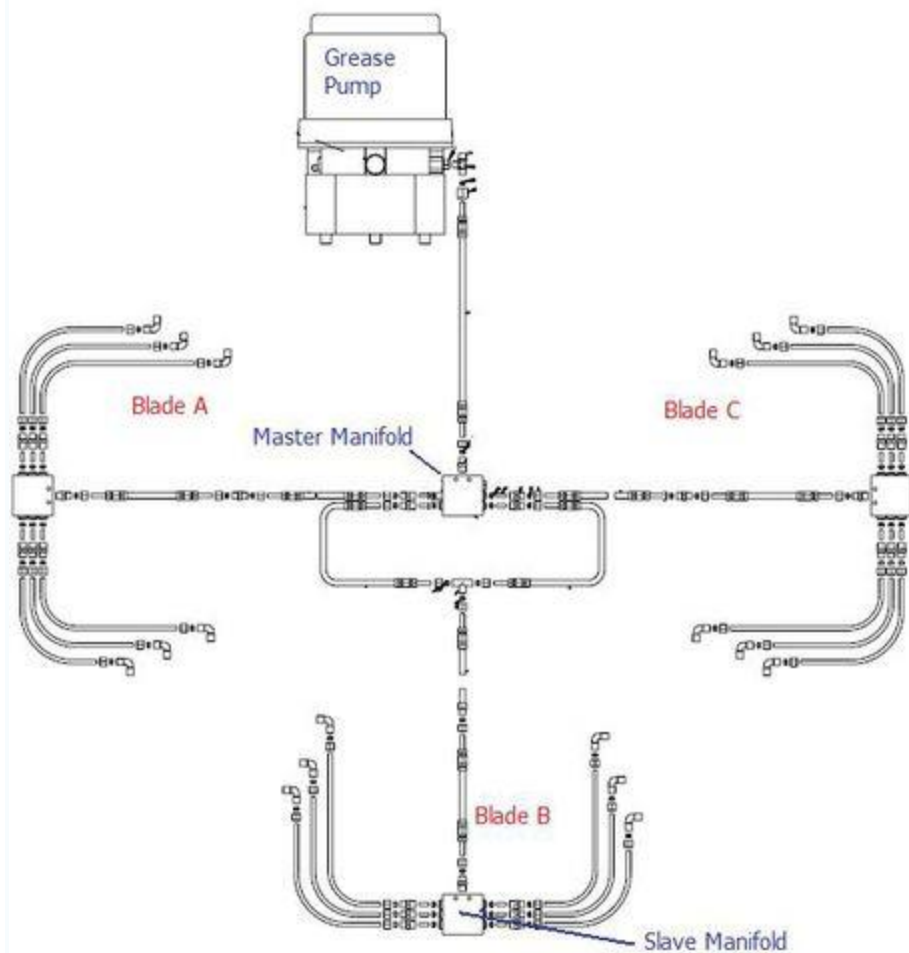
Blade bearing greasing system:

Check for any improper hose fitting, manifold grease blockage and hose damage.

If necessary replace the manifolds and hoses.

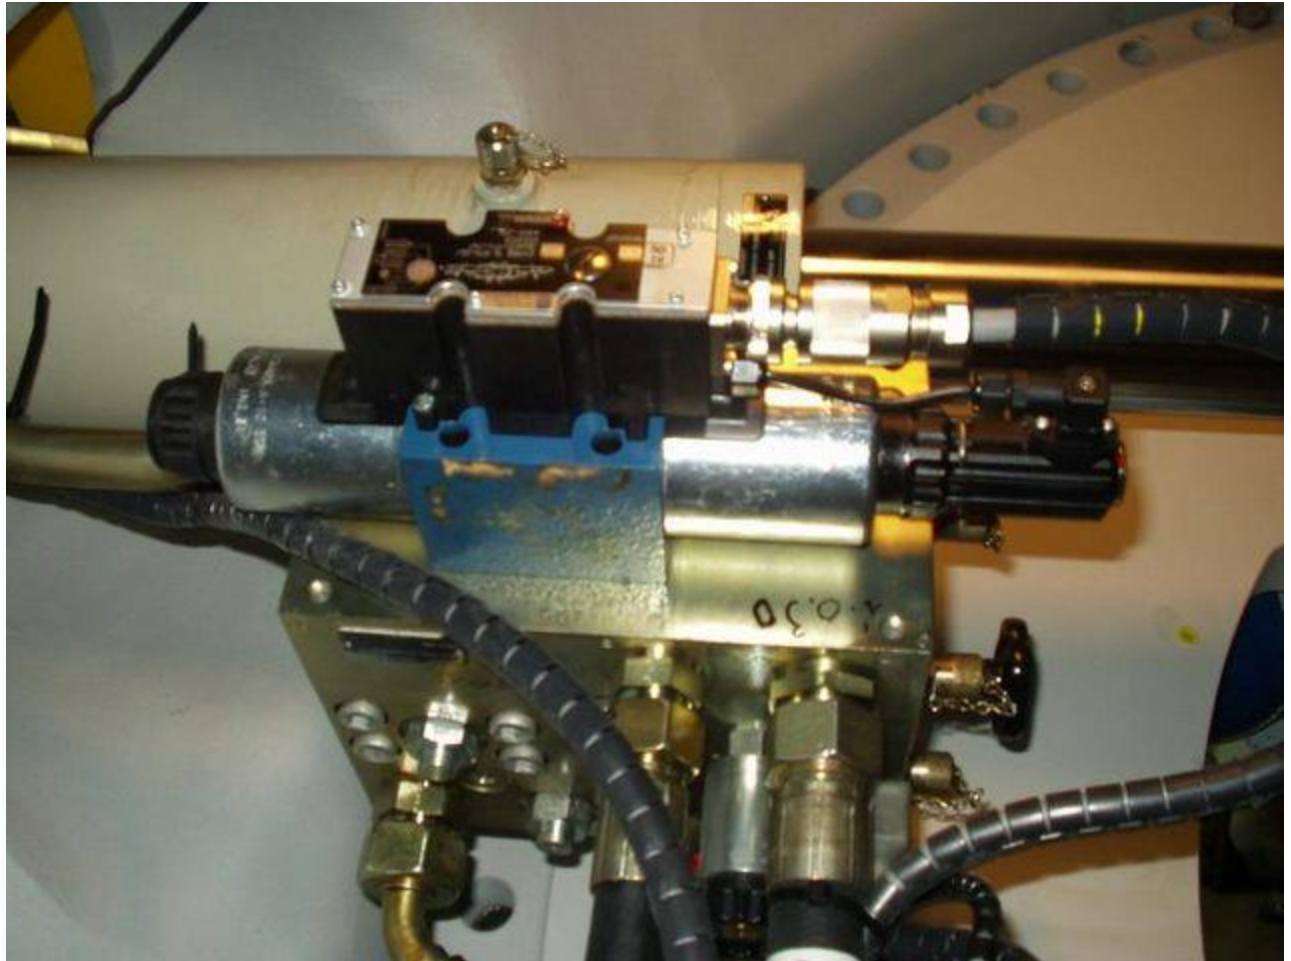
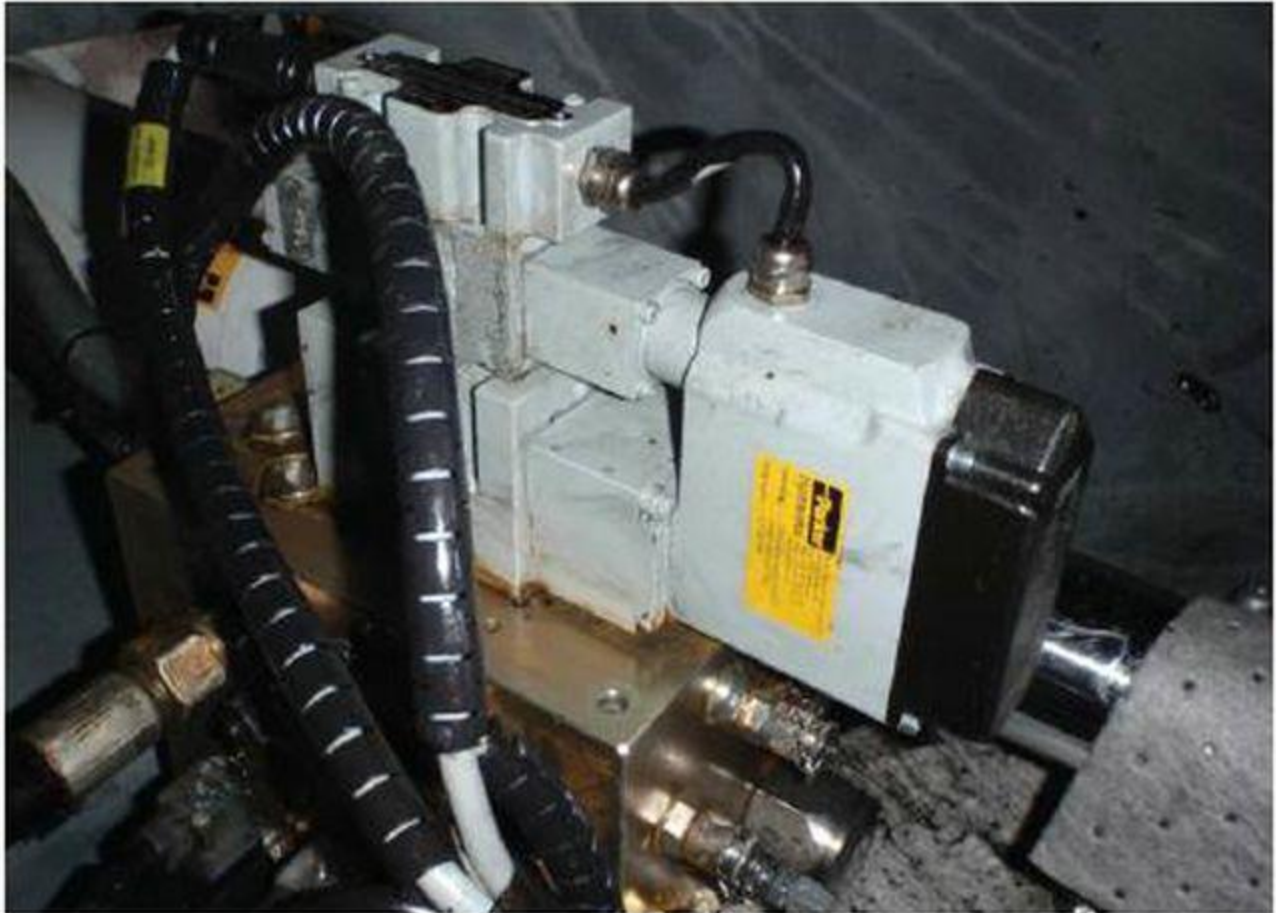
If the alarm follows the valve to the other blade, the proportional valve is defective.

If it is red and there is pressure verified on test port MP, then the valve may also be defective.

Replace proportional valve using **SWI** below

Relevant documentation	
Description	DMS No.
Proportional Valve Replacement	0016-1690
