**Check the tower damper and top-up to required level**

**Replace the defective TAC84 module**

### Replace the defective accelerometer

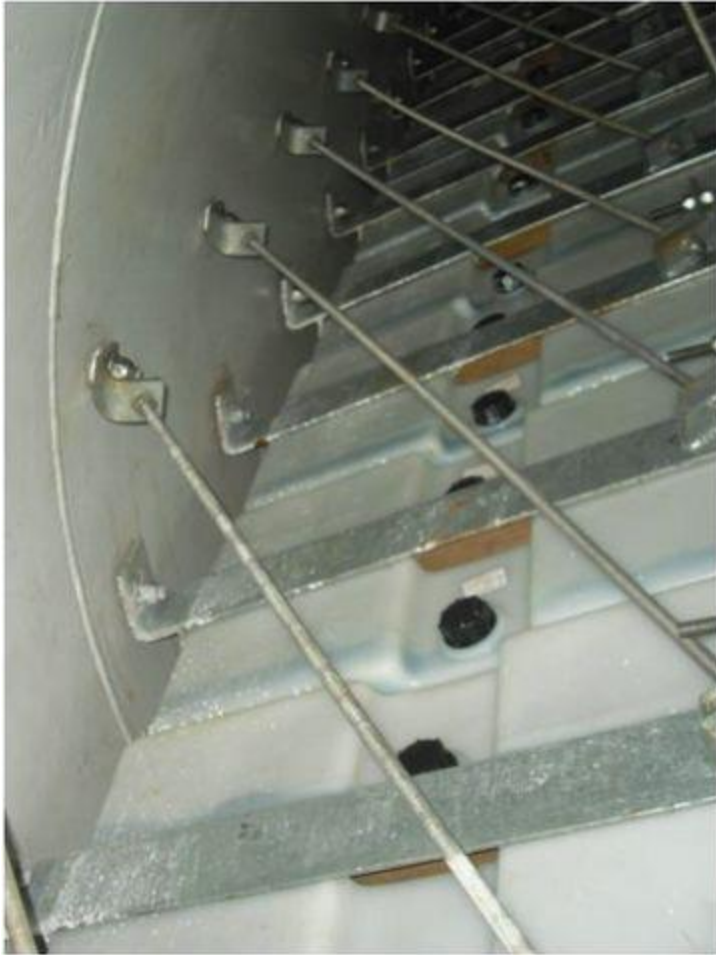
The tower dampers consist of a number of containers in the tower top arranged in two columns just below the top platform. The containers are filled with a predefined amount of liquid in each container,

NOTE: Number of containers in each tower varies from tower to tower.

Check the containers for any sign of leakage in the tank and the closing cap.

If any caps are found to be leaking or damaged - replace both the cap and seal.

Ensure the seal is properly seated.

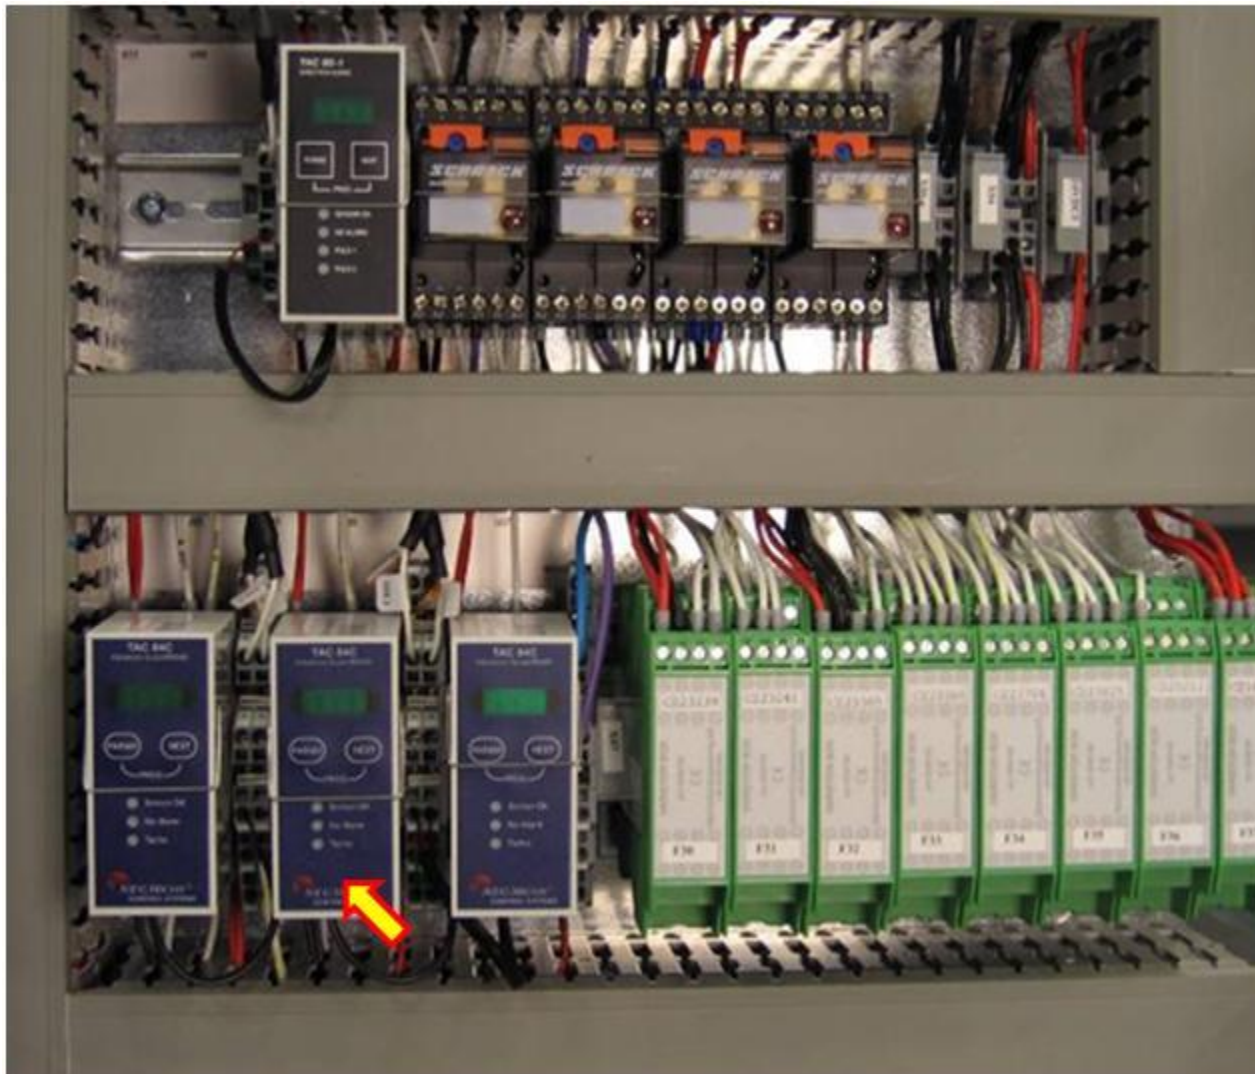
Vibration sensor and speed sensor signals are connected to the TAC84 module.

Check the TAC84 – Down wind module and related wiring for any loose connections.

Check the TAC84 module parameters as per instruction:

Test the TAC84 module as per Commissioning Instruction.

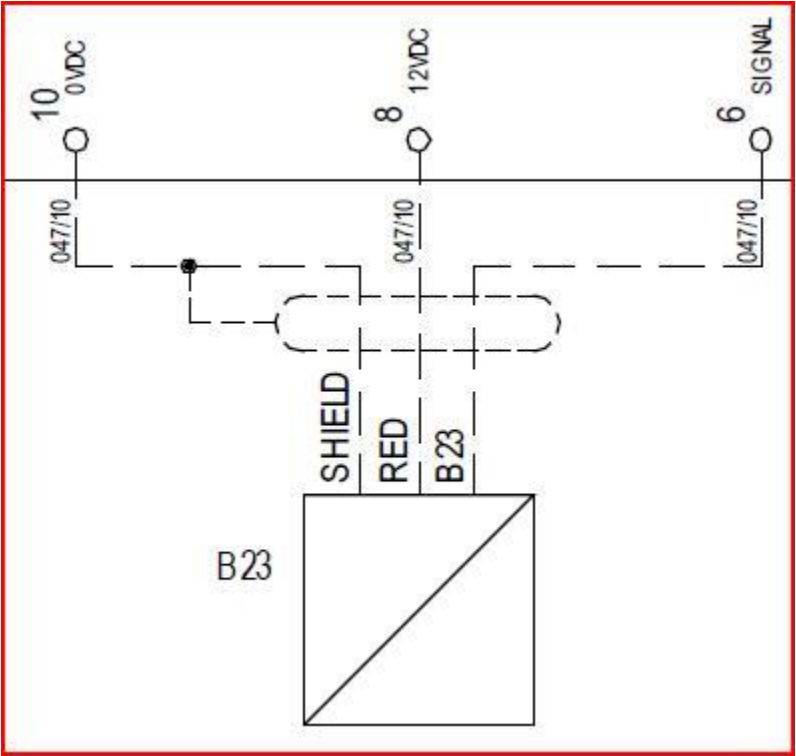
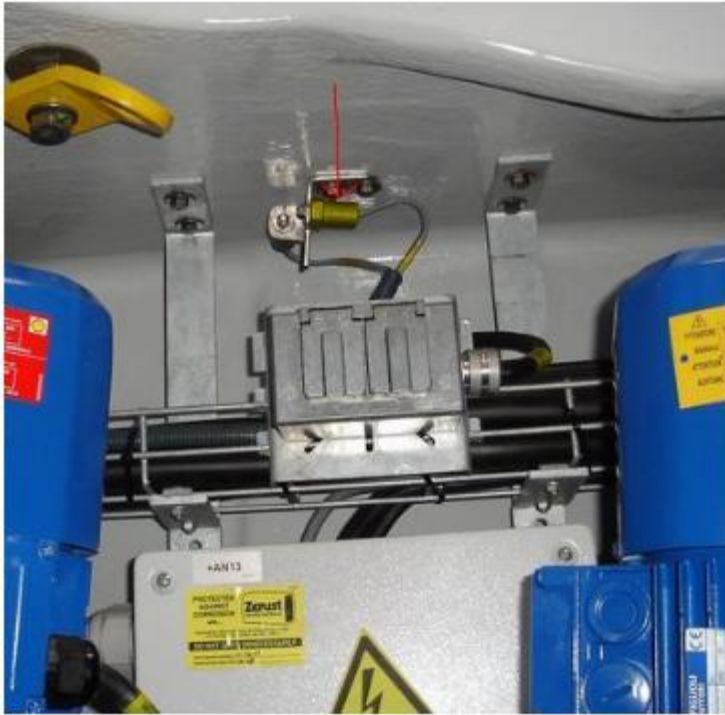
Simulate vibration by yawing or tap a screwdriver on the sensor and check that the vibration value is changing on the module. If the value does not change on the module, or is unreal, the accelerometer is likely defective.

#### Part Number for Vibration sensor:

51705401      VS05E ACCELEROMETER 12M
