Replace the defective PT100 Sensor

Replace the PT100 sensor and repair the bearing housing

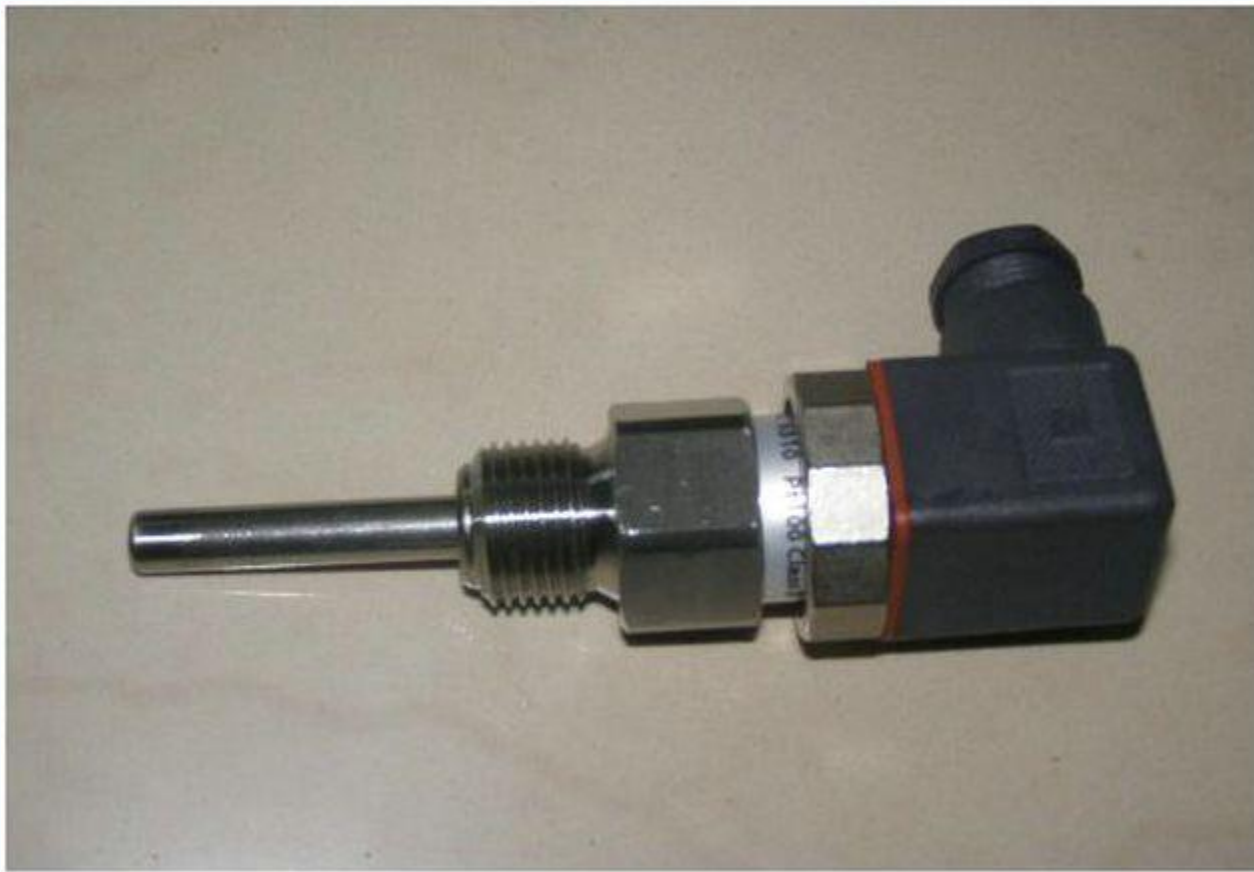
Use a multimeter set to read Ω and measure the resistance across the leads of the PT100.

Use the resistance/temperature conversion chart to determine the actual measured value.

If the value matches that taken from the TAC Temperature menu, then the circuit is working as designed.

If the value is unreal (-40 to 200 °C), then the PT100 is faulty and must be replaced.

Part number for PT100 Sensor	
Description	Item No
PT100 SENSOR FOR HANSEN GEARBO (HANSEN)	60102405
PT100 SENSOR,TOP PSC 1030 JAKE (JAKE)	60066565
