Replace the defective TAC84 module

- **Explanation**
IN THE +AN1 CABINET:

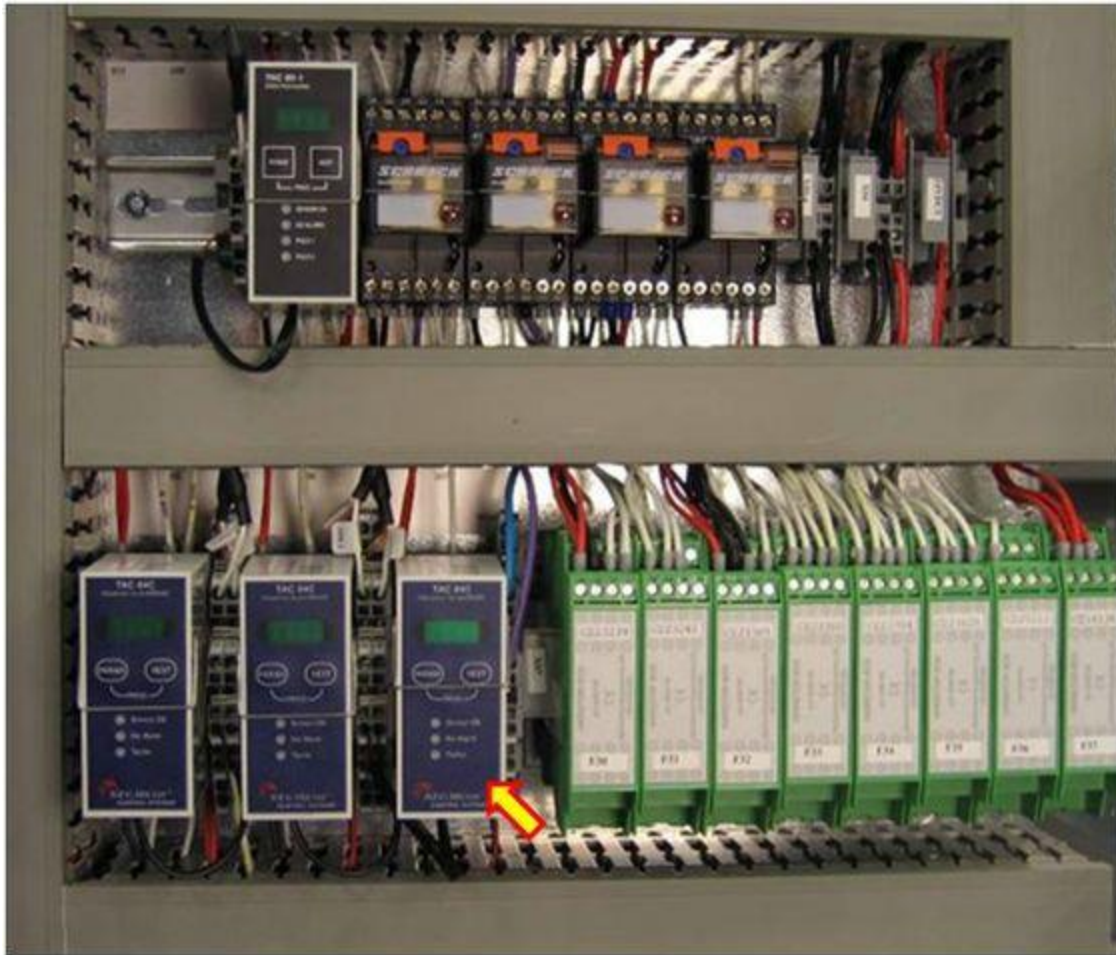
Check the TAC84 module parameters as per instruction:

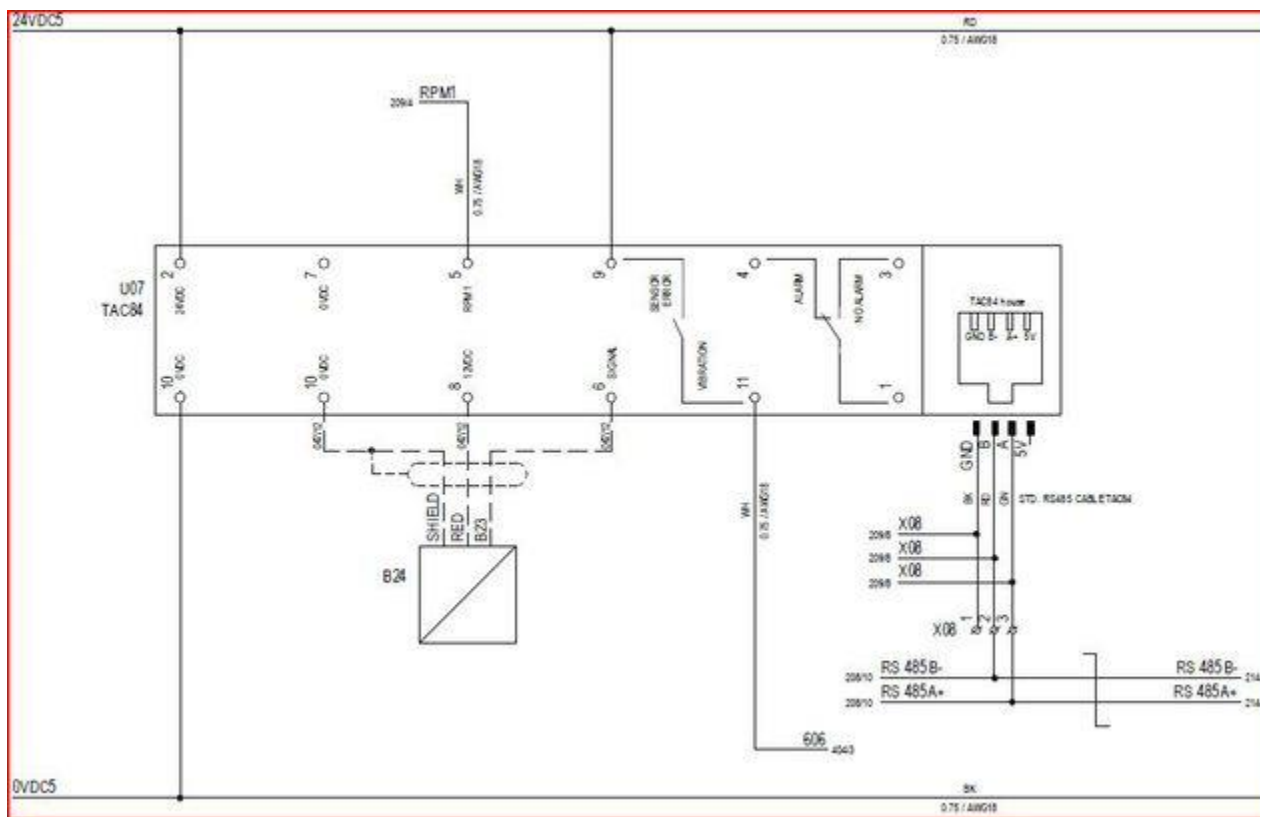
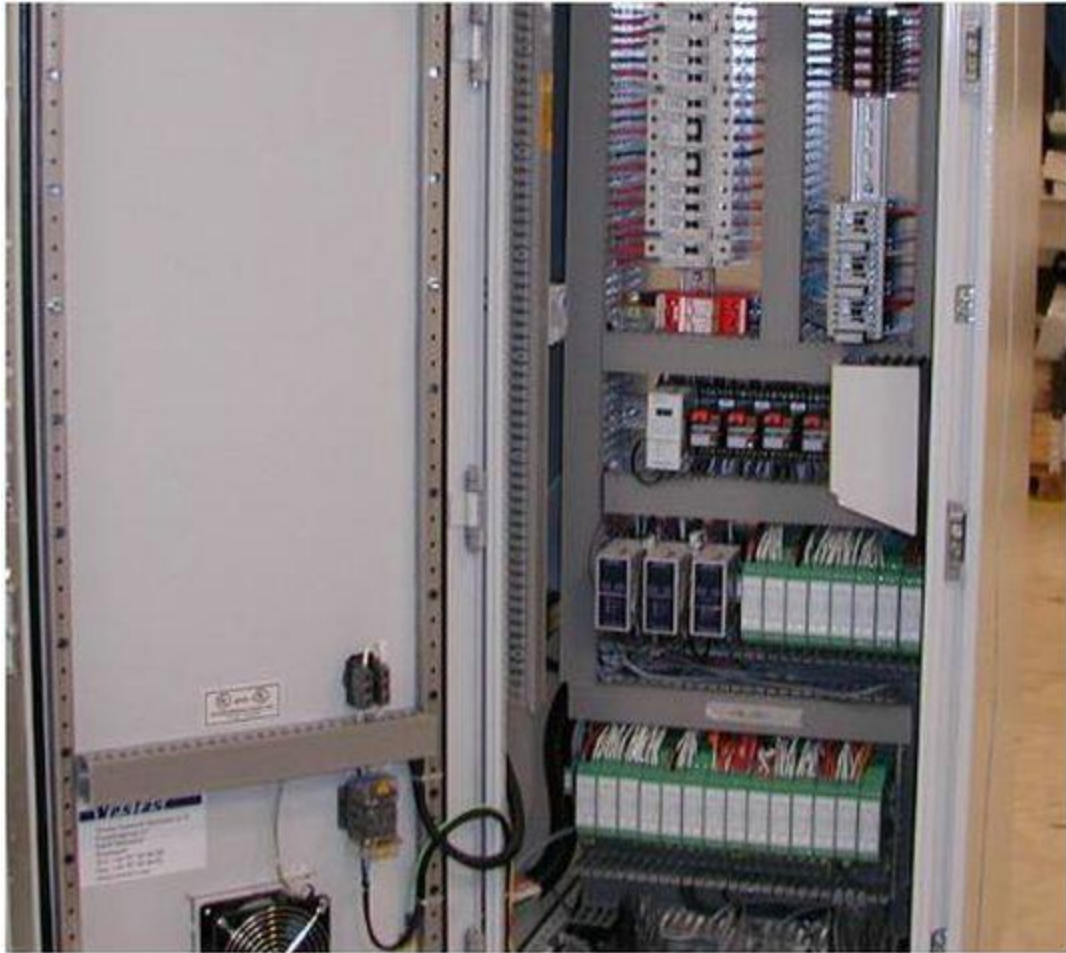
Check the TAC84 – Lateral module and related wiring for any loose connections.

Test the TAC84 module as per Commissioning Instruction.

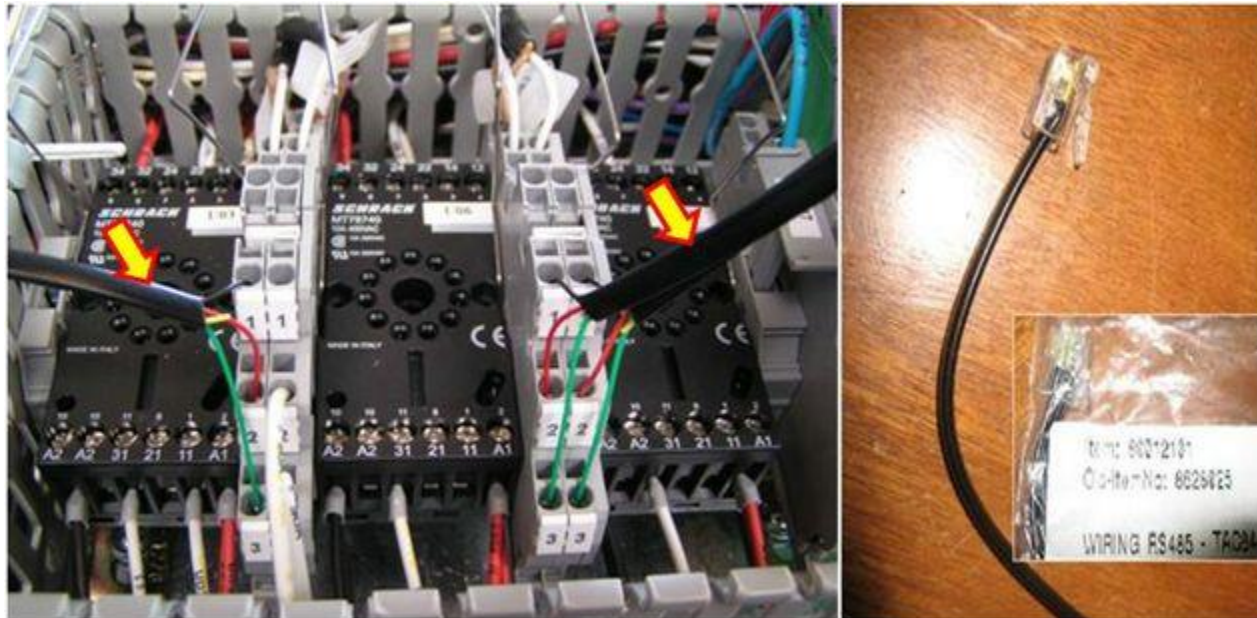
Check the RS485 cable for loose cable or damage.

If necessary replace the cable.

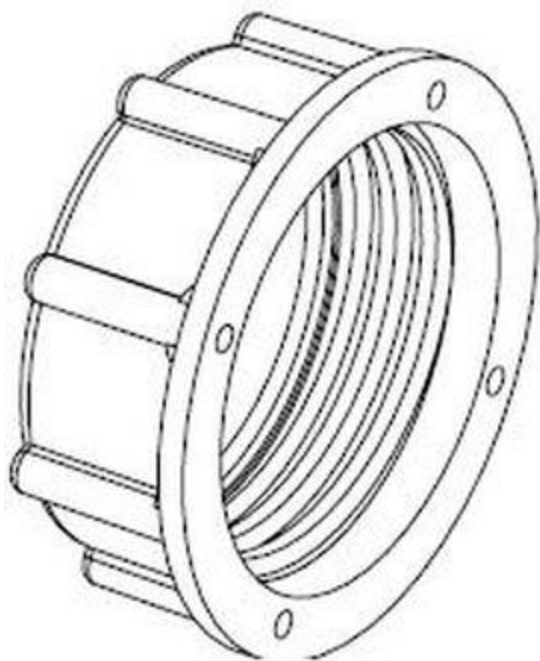
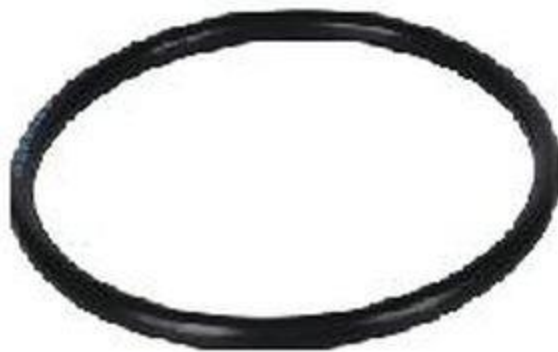
Part number for Cap and Seal:

Check the containers for any sign of leakage in the tank and the closing cap.

If any caps are found to be leaking or damaged - replace both the cap and seal.

Ensure the seal is properly seated.

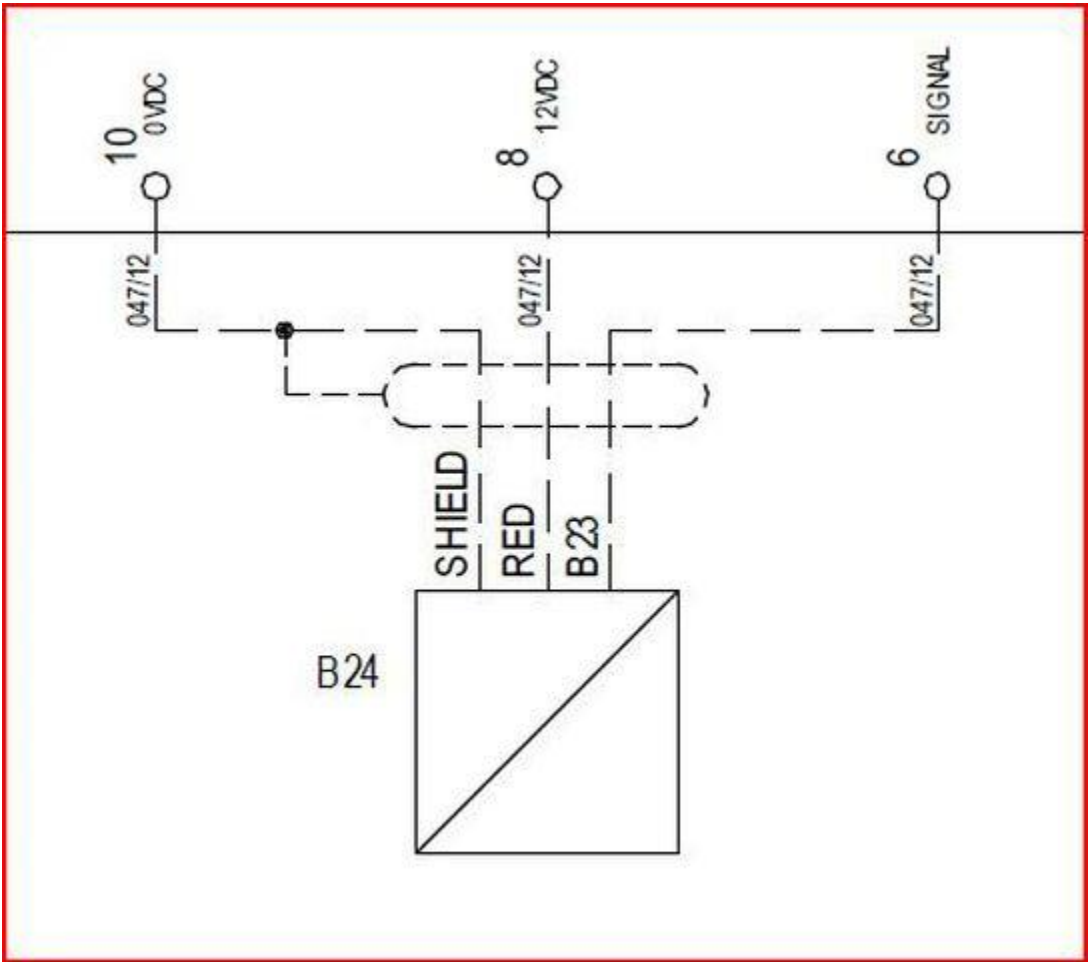
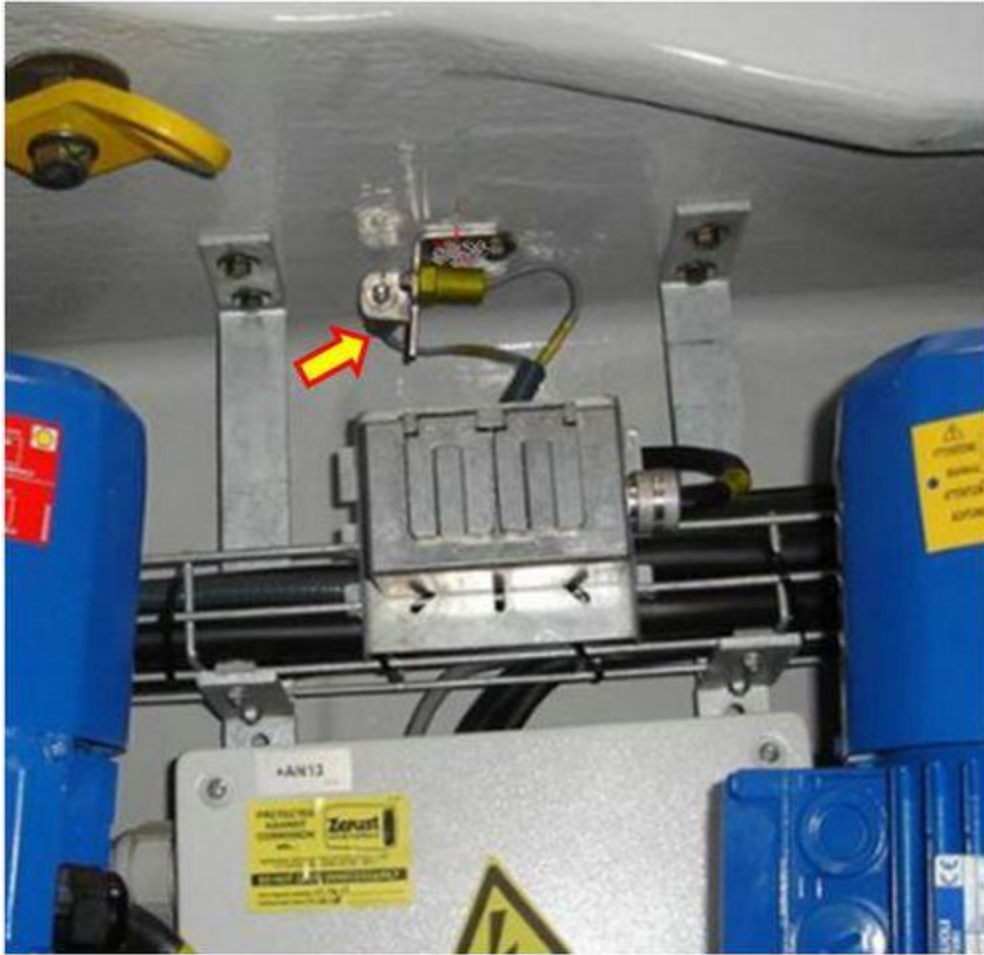
Check that the vibration is measured properly through TAC84 module.

Simulate vibration by yawing or tap a screwdriver on the sensor and check that the vibration value is changing on the

module. If the value does not change on the module, or is unreal, the accelerometer is likely defective.

Replace the defective accelerometer

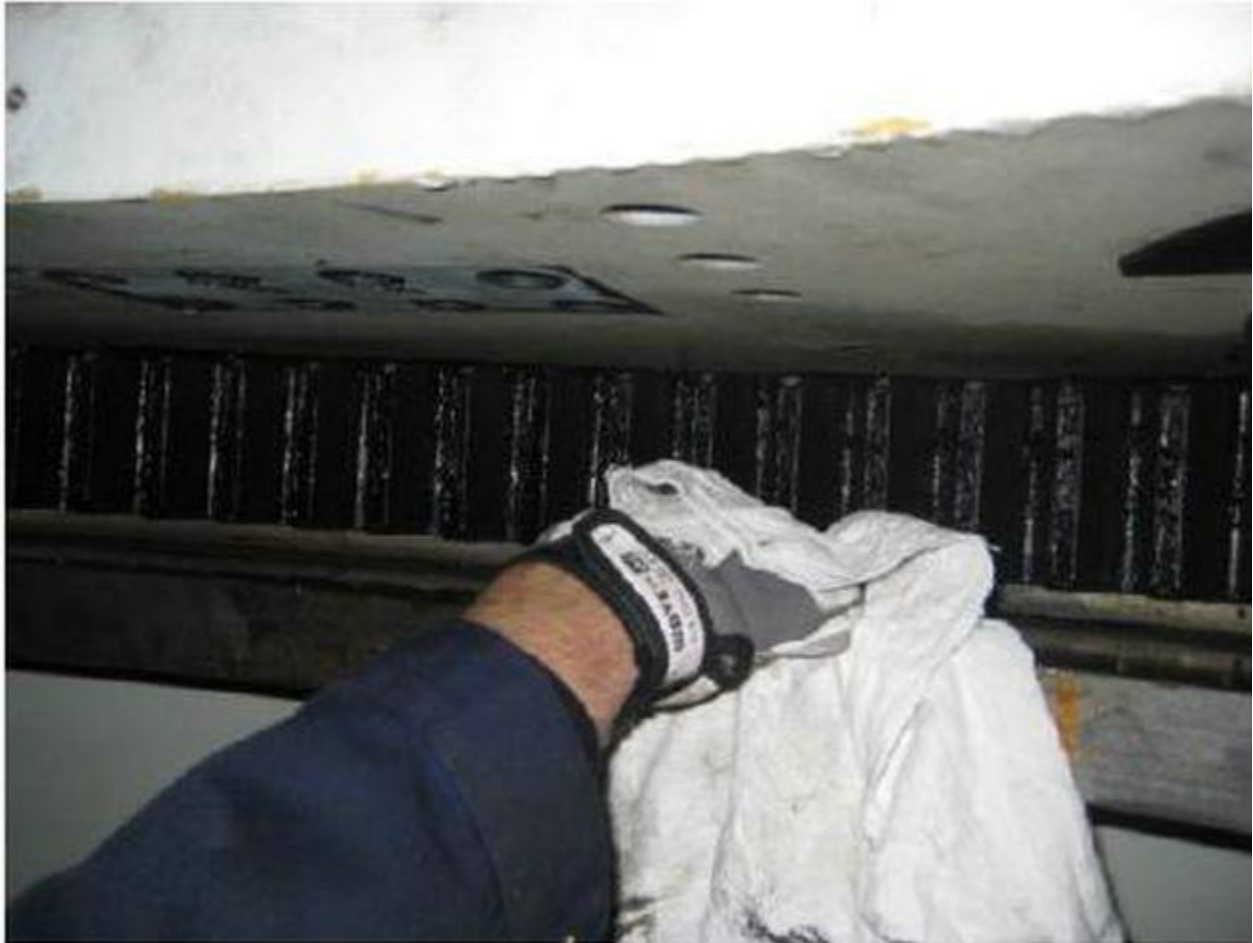
Check for abnormal noise from the yaw system.

If yaw callipers are found to be failing replace with new.

If any oil leaks are discovered in the yaw system clean as per SWI-
