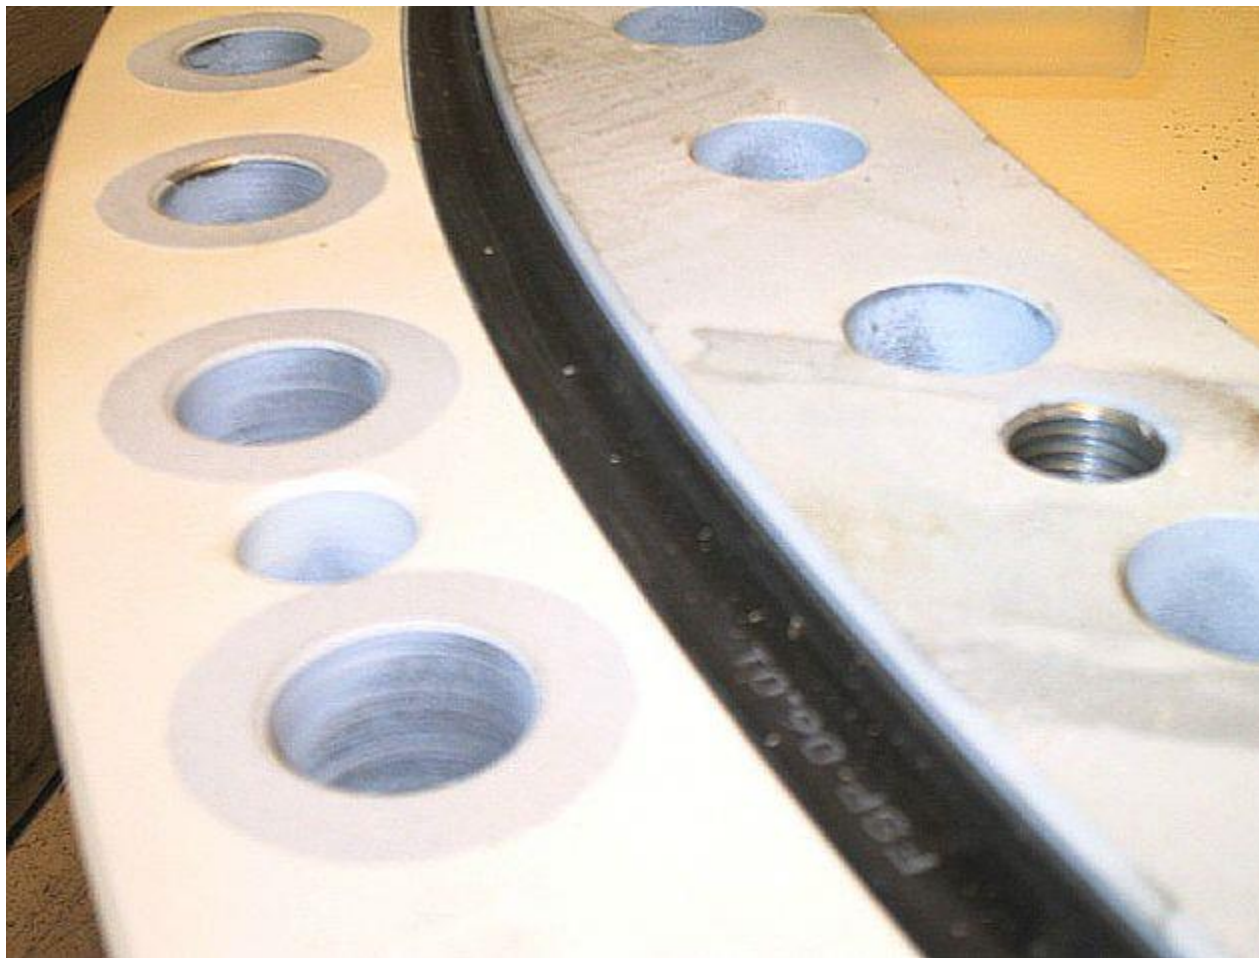
Check the inner and outer blade bearing seals.

If there is any damage or heavy grease leak replace the seals.

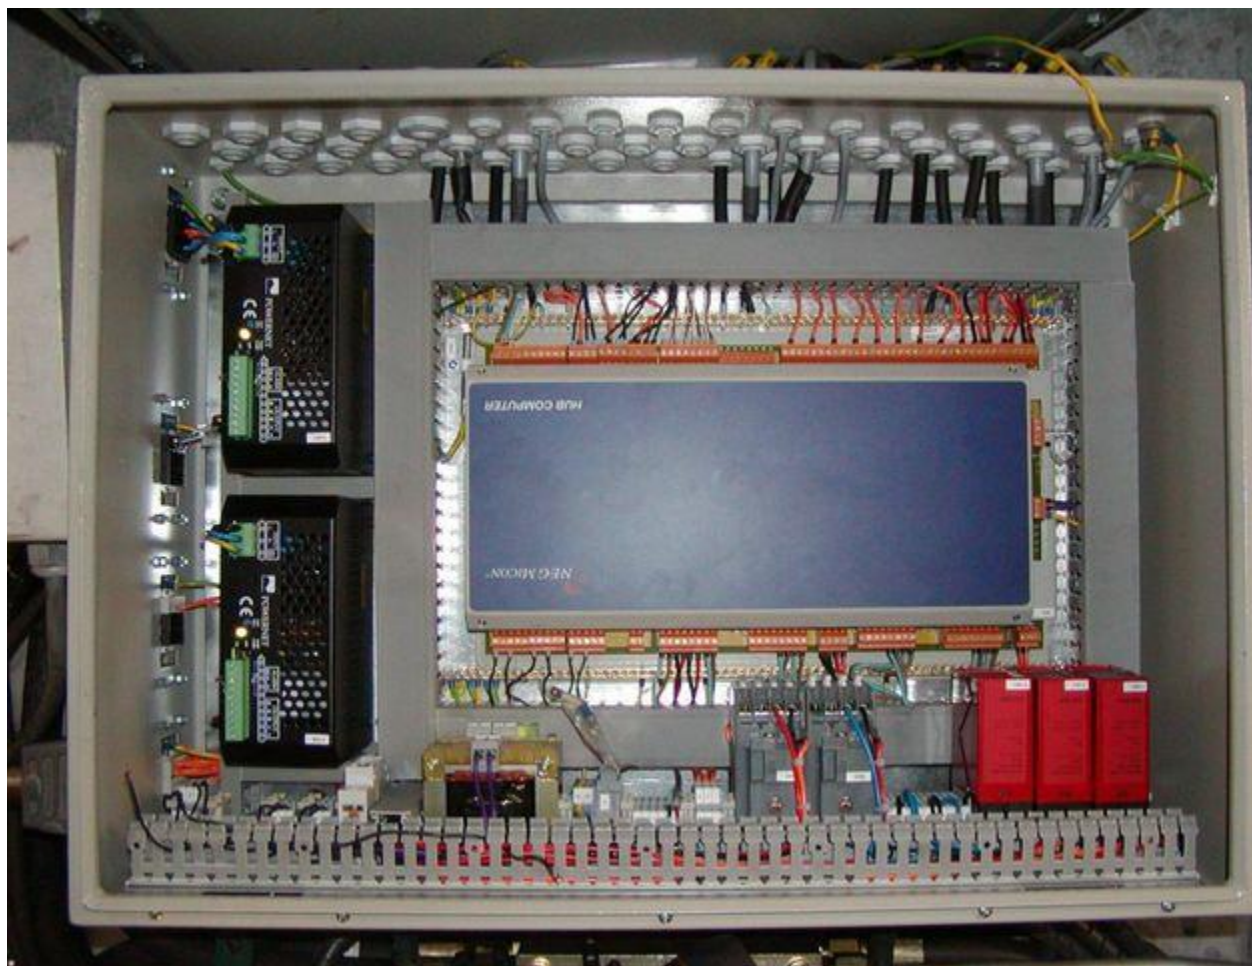
If the fault follows to the new blade then the fault is either in the proportional valve or one of the cables.

First swap the signal wire to the proportional valve on the hub computer.
