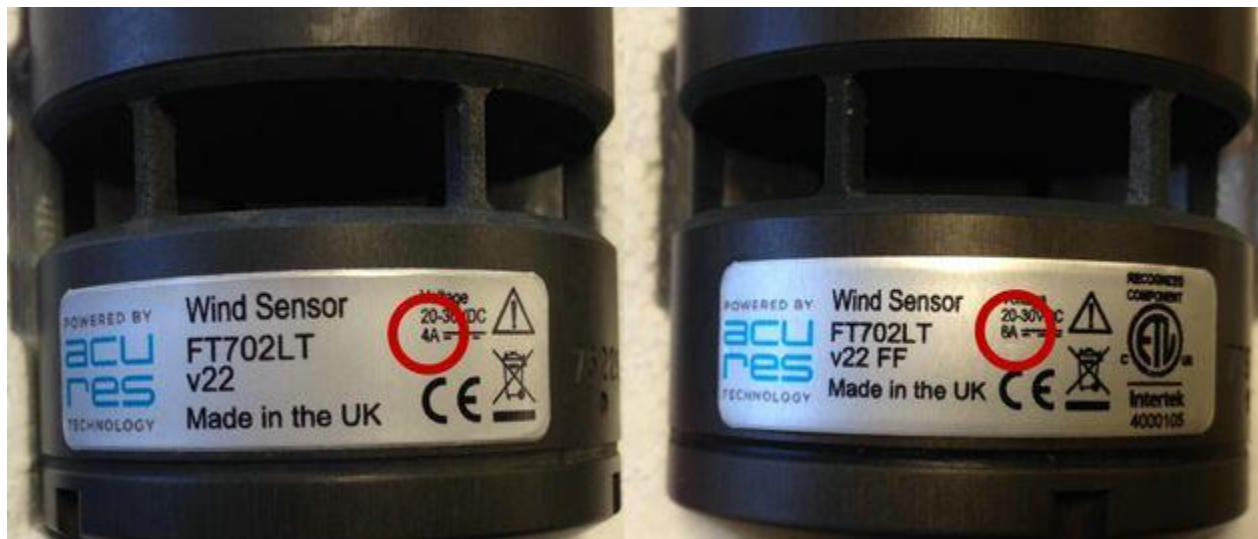
Check the amperage rating of the FT sensor. Typically the FT sensors supplied have been rated at 4 Amps, however in some sites have received sensors rated at 6 Amps.

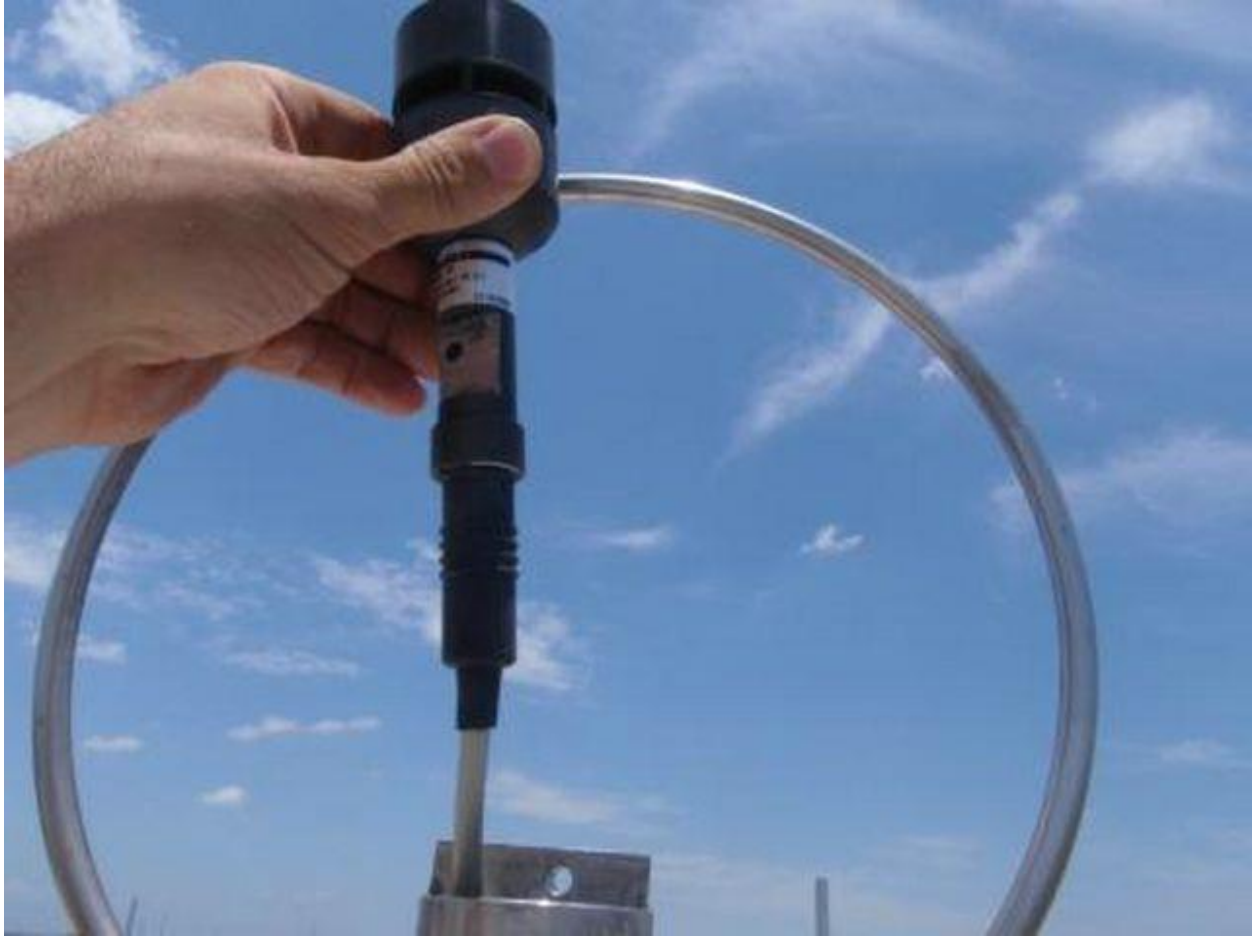
Proper instillation of protective boot:

The connector can easily be mounted incorrectly.

If the cable is mounted tight and it pulls in the sensor connector, it must be connected so that it is not pulling the plug.

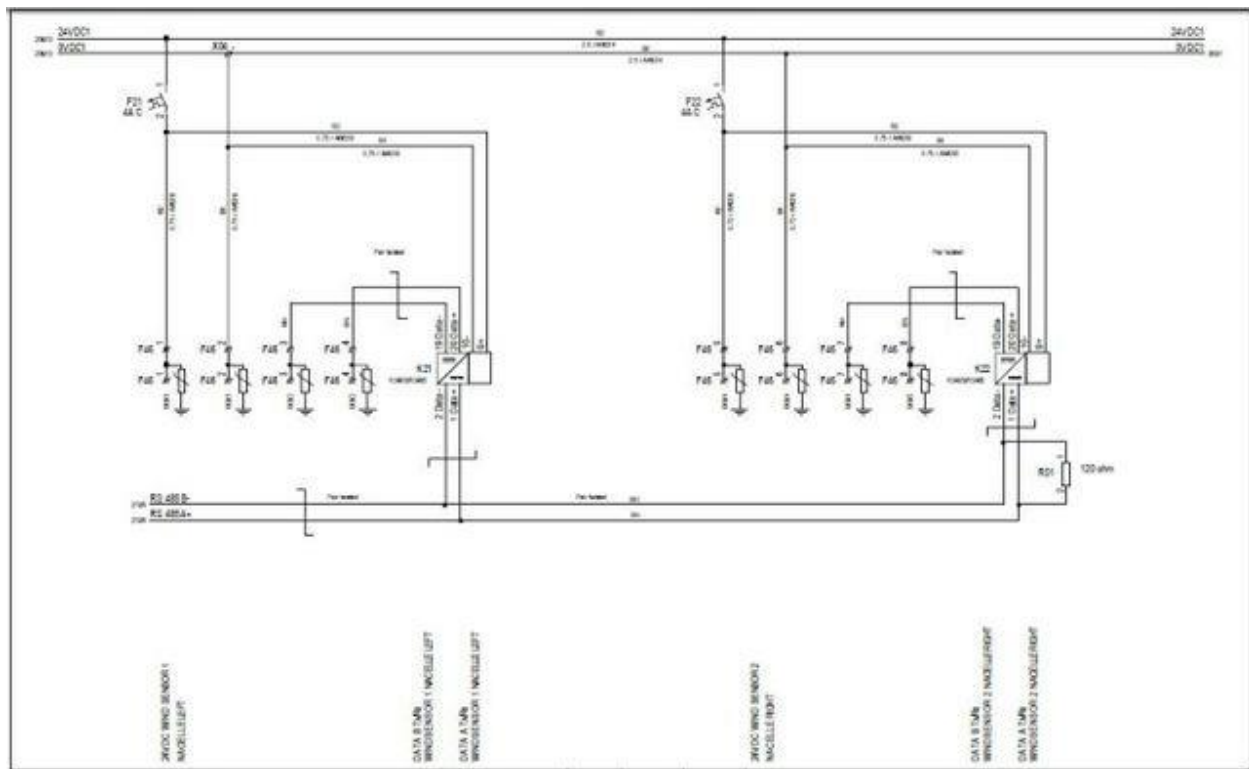
Circuit:

Check the circuit breakers F21 (sensor 1) and F22 (sensor 2) in the AN1 panel to see if they are open. In the AN1 measure 230 VAC on G06 Power Net power supply input and observe the green diode light. Measure 24 VDC on the power supply output, check for loose wires.

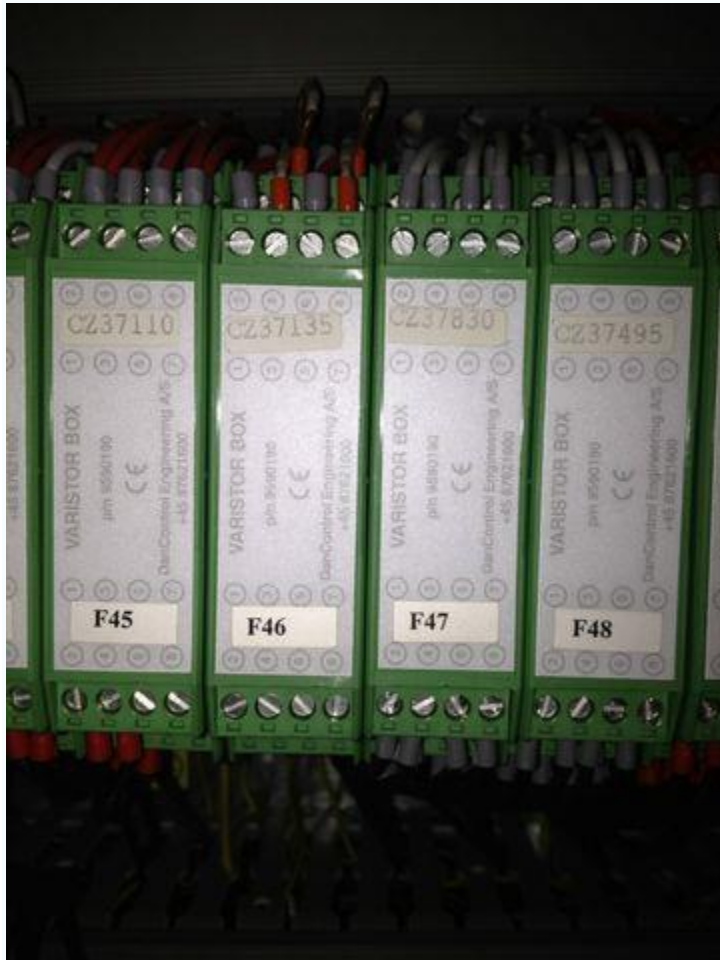
Varistor box F46:

If the FT sensor does not appear to be shorted, check the F46 varistor box for a failed varistor. Remove the wires from the varistor box and remove it from the housing.

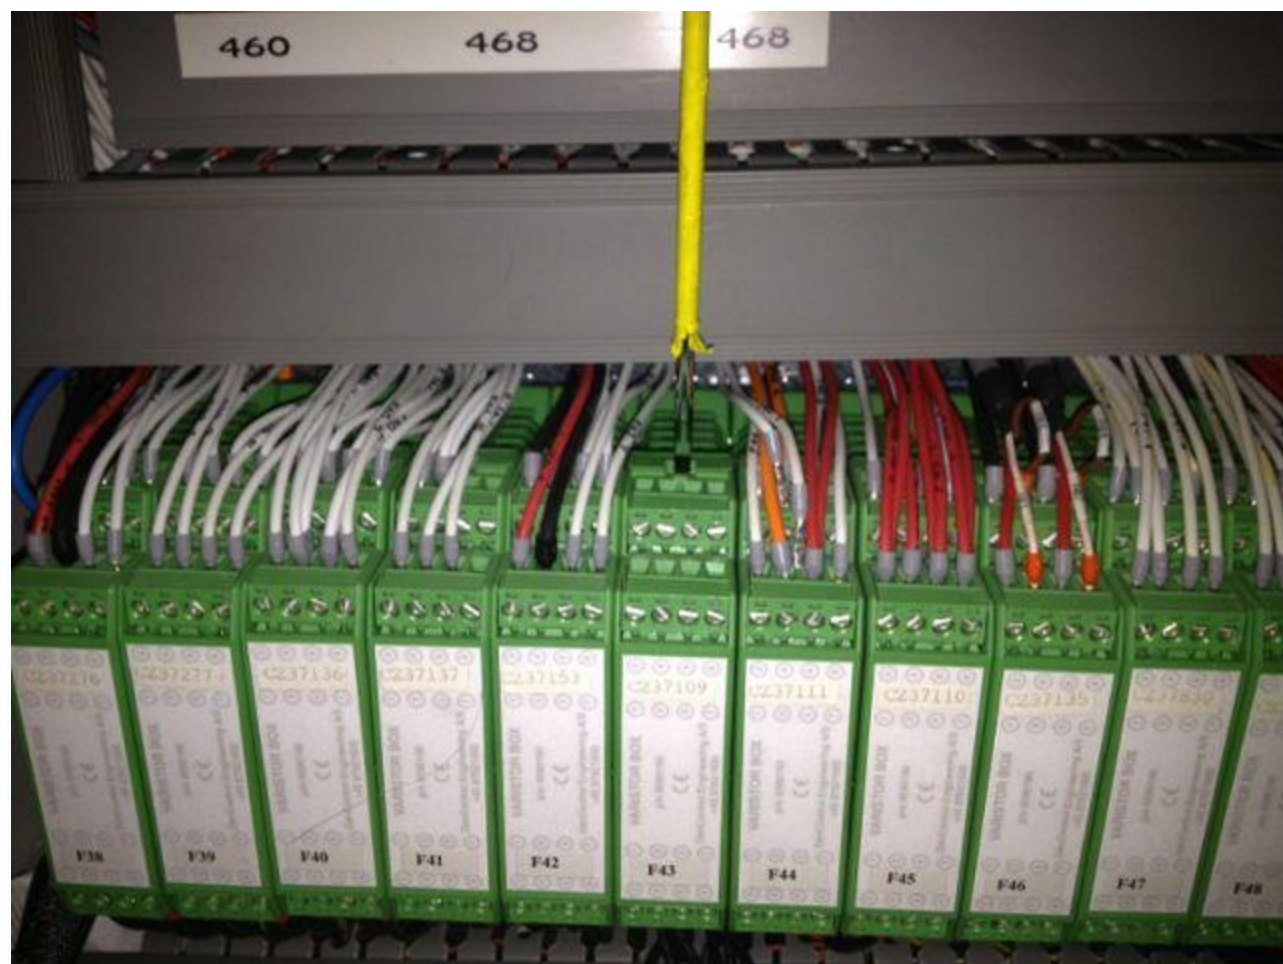
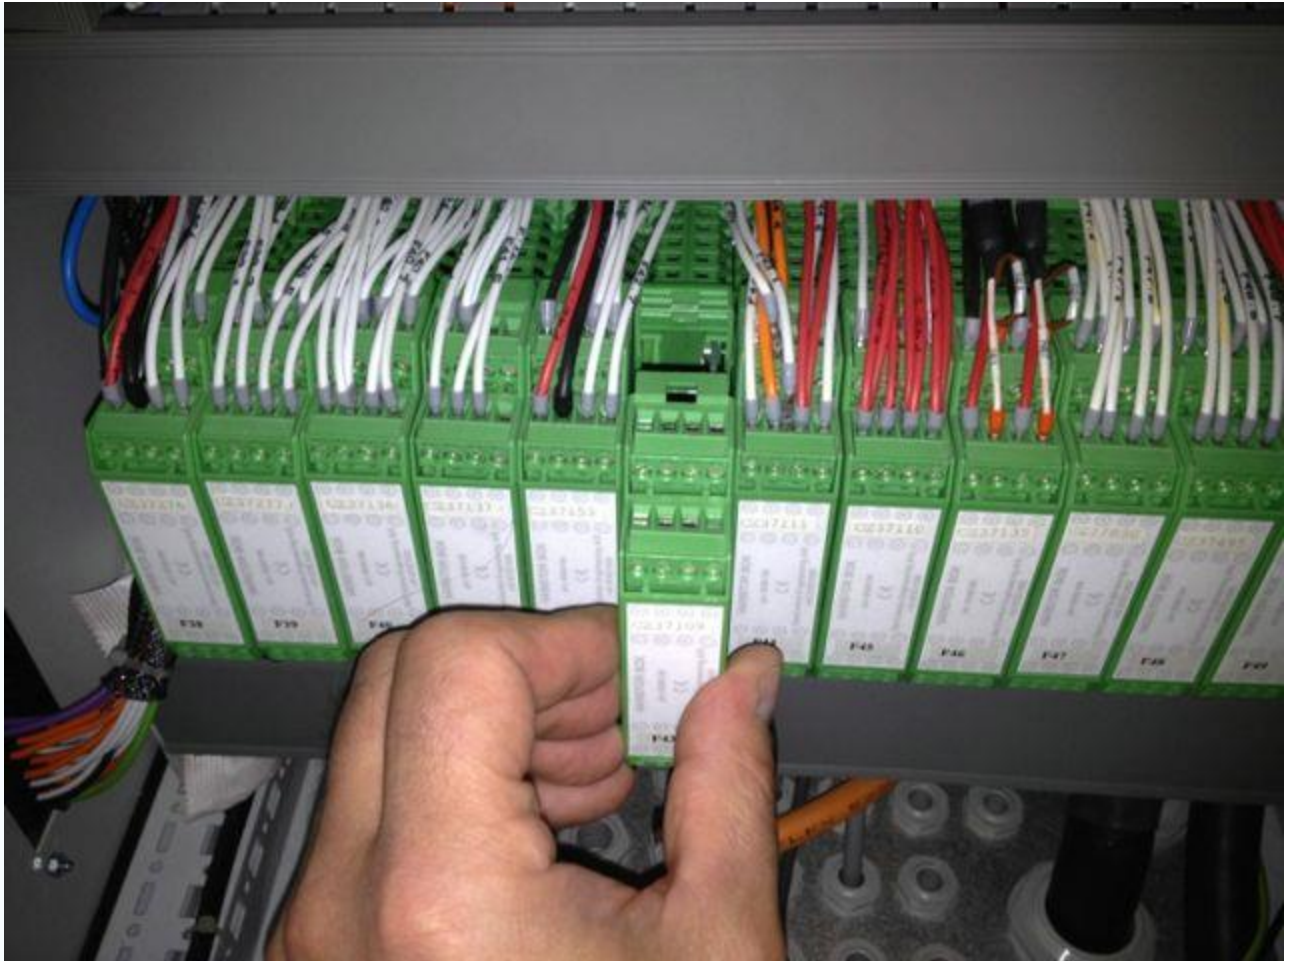
Press clip on top and bottom of varistor box and remove varistor assembly from housing:

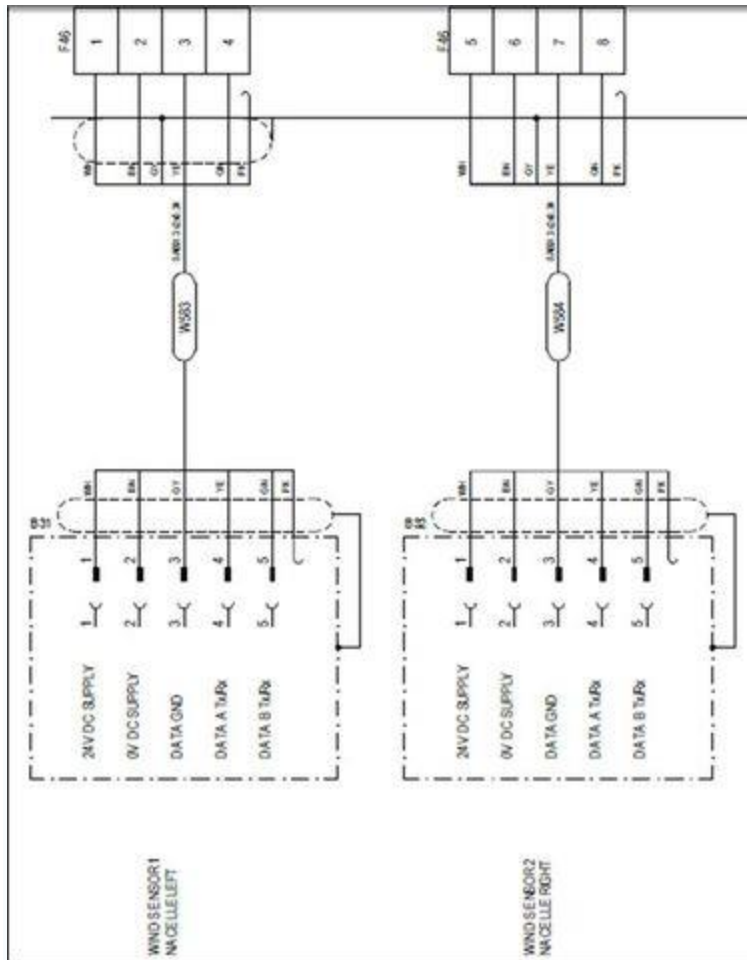
The varistor box is made up of eight varistors and has provisions for 16 wire connections (protection for 8 signals).

Both wind sensor 1 (left) and wind sensor 2 (right) use varistor box F46. Terminals 1-4 (top and bottom) are for wind sensor 1 and 5-8 (top and bottom) are for wind sensor 2.

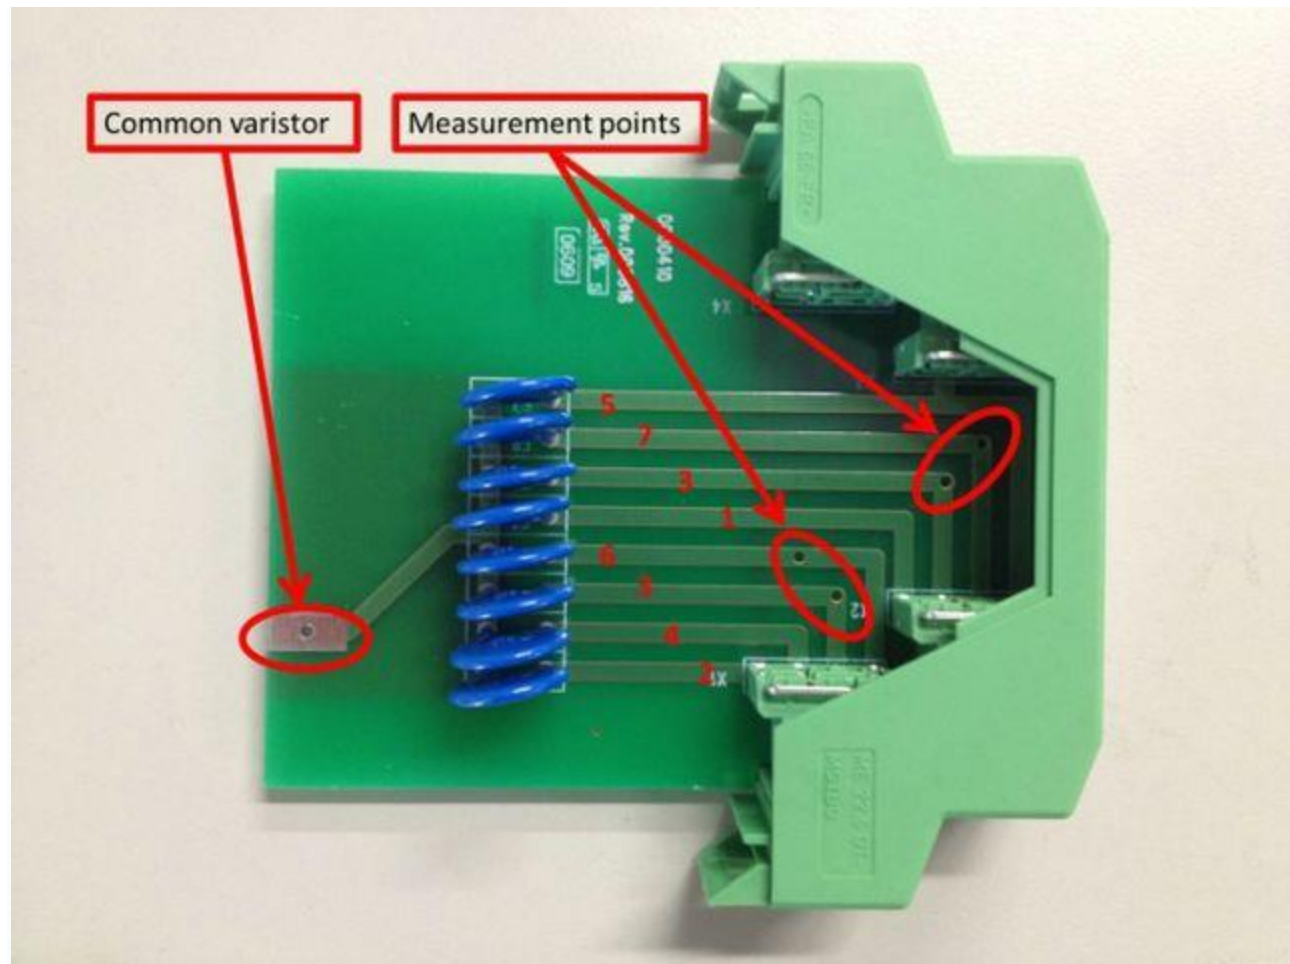
Varistor measurement points:

Varistors can be tested individually by placing a multimeter (set to measure Ω) lead on the common (earth) side of the varistors and the other on the individual varistor measurement points or at the terminals.

Measure resistance between the common varistor point and all other measurement points. Only four varistors can be measured by using the test points on the board, test the remaining four from the terminals. The resistance value over the varistor should be ∞ or in the high M Ω range. If the resistance is lower, the varistor has been damaged by an over voltage in the circuit and must be replaced.

The varistor will be damaged by an event and therefore should not be the cause but a consequence of the event. The cause of the failure may be due to lightning, fault in the power supply or short in the circuit.
