Calibrate Sensor

Verify and correct parameters in TAC II Controller

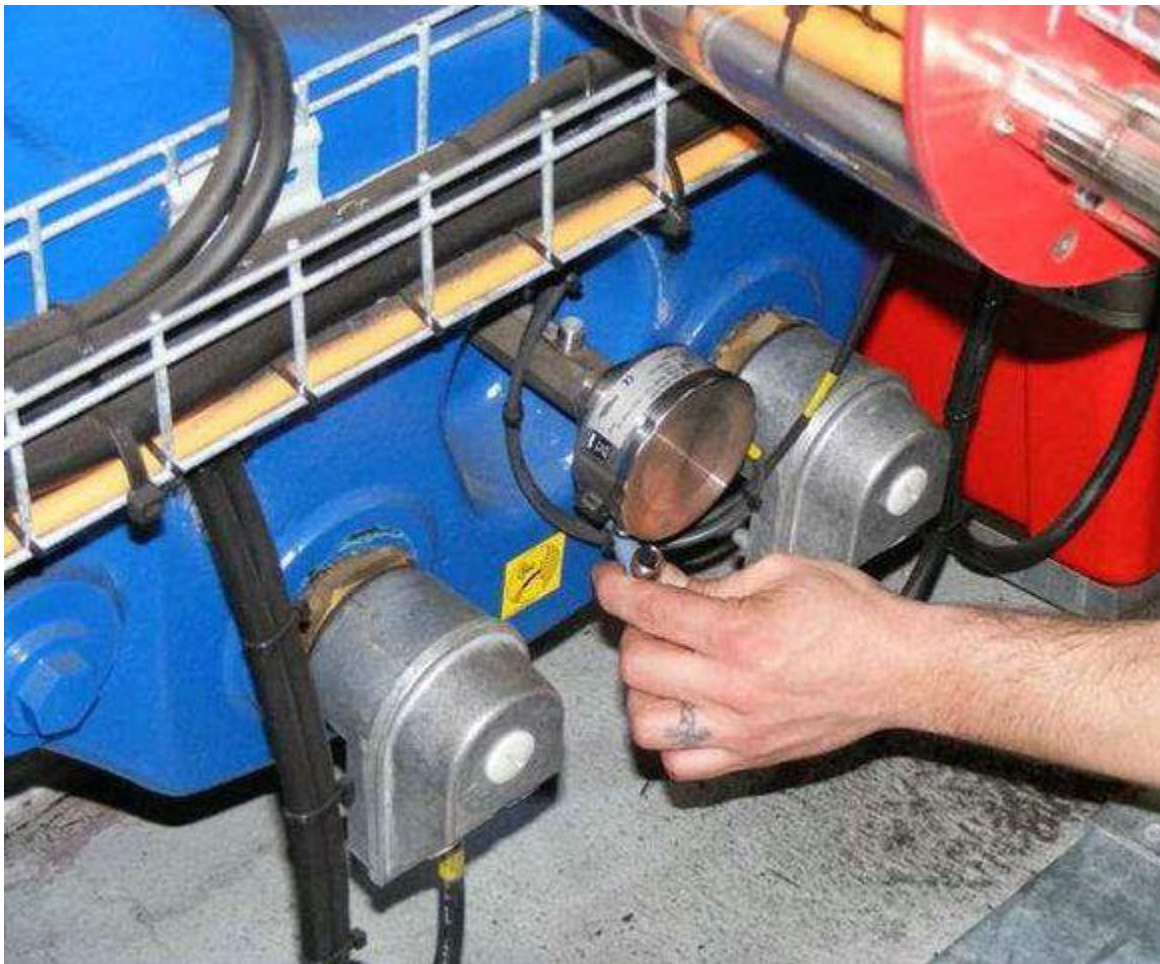
Auto zero the Flexbar oil level pressure sensor to atmospheric pressure at the turbine.

Disconnect W527 connector on the gear oil level pressure sensor.

DO NOT disconnect the W522 connector to the PT100 sensor.

Place rags or other absorbent material below the pressure head to absorb gear oil run-off.

Use a 27 mm spanner to hold the stem portion of the sensor.

Use the 41 mm spanner to remove the pressure head from the stem portion.
