Troubleshoot generator speed sensor

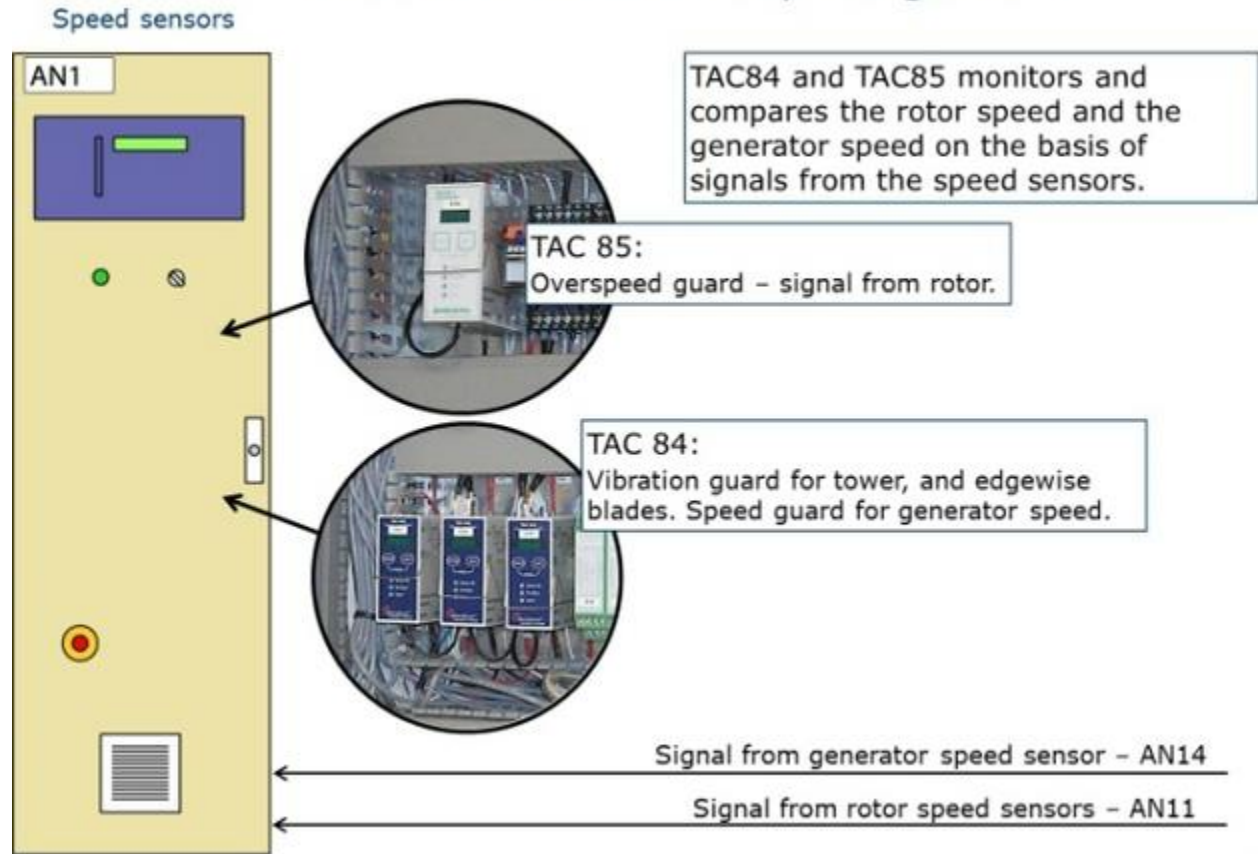
TAC84 & TAC85 overspeed guards

The signal is transmitted to the TACII controller and the three Vibration/overspeed guard modules.

Before replacing the sensor or components, check the circuit for loose connections.
