Why It Loosened — Even When Torque Was Right

*Field findings from 3 conveyor modules with vibration-induced loosening
How OEMs prevented downtime — without redesign
(Reference: DIN 65151, ISO 898-1)*

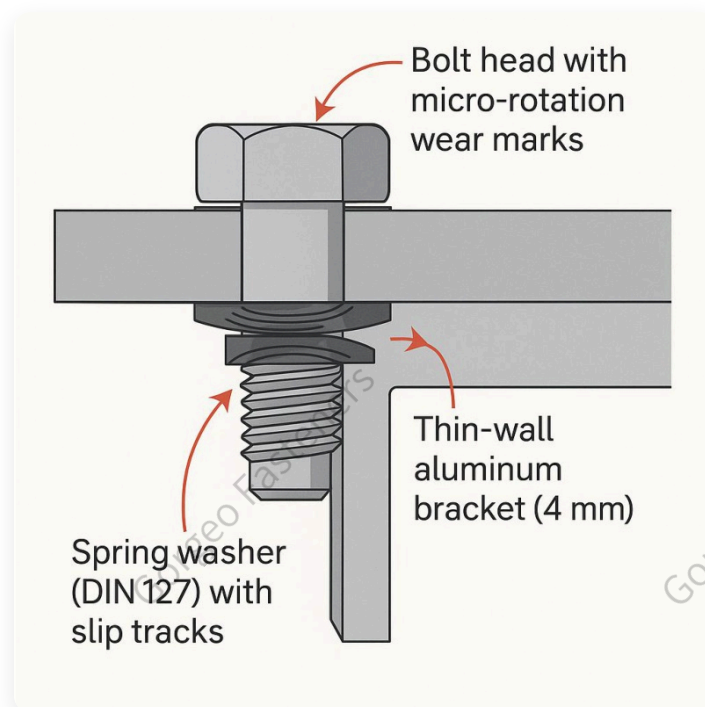
- Bolt heads with micro-rotation wear marks
- Washers with circular polish tracks
- Thread bores ovalized after multiple cycles

Vibration creep under DIN 65151 test conditions.

-

No anti-rotation geometry under bolt head
-

No shoulder or spacer to limit axial movement
-

Only thread friction resisting ~4000 rpm micro-shocks

When thread friction is your only defense, even a perfect torque value can't hold against vibration-induced slip.

This was a classic case of self-loosening, not preload loss.
