VOLTE的分析方法及主要问题

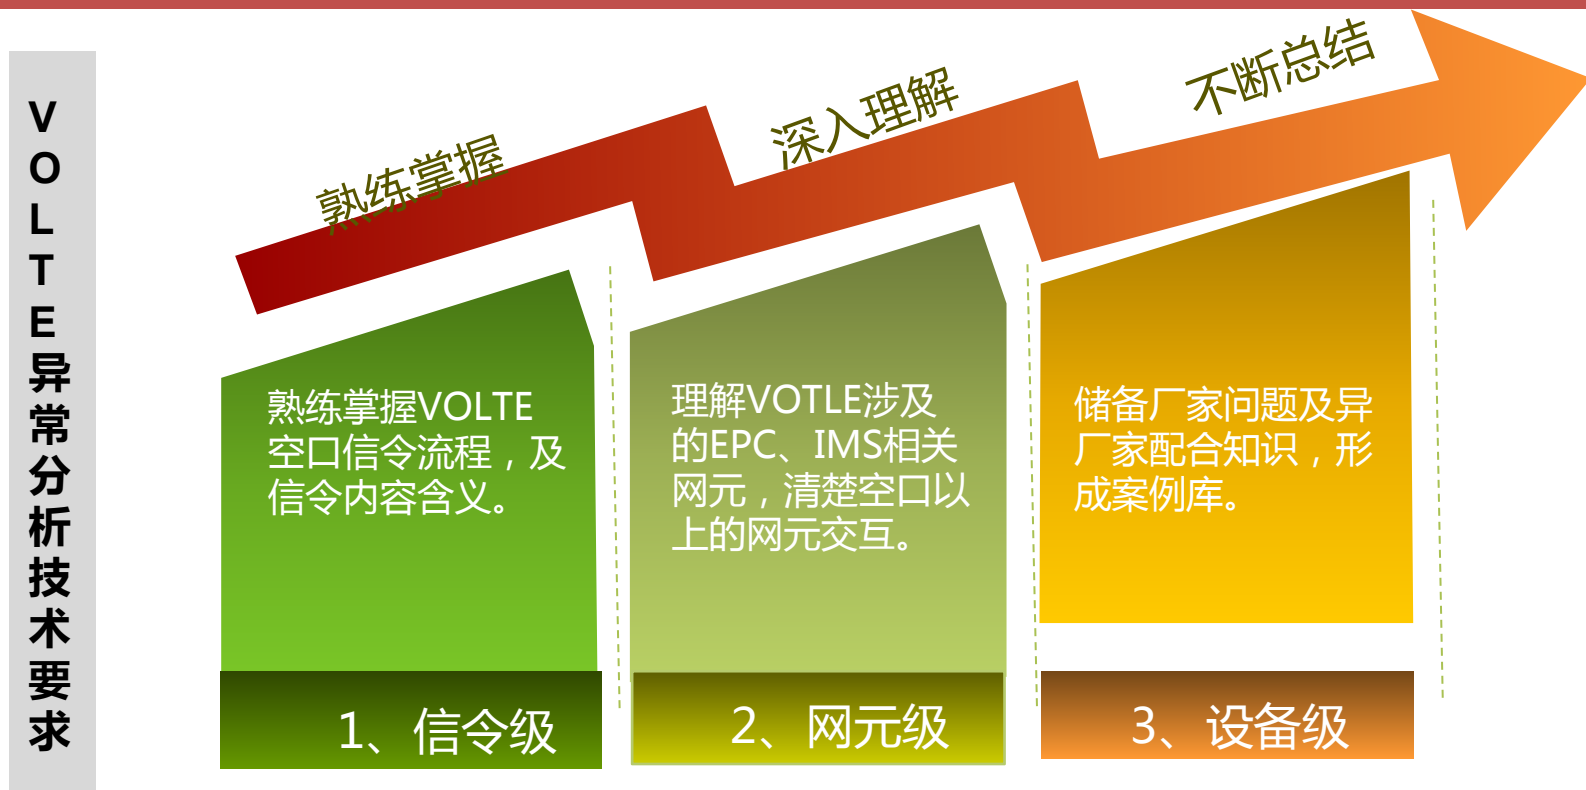
■ 信令级知识的掌握可以完成针对空口现象的对号入座，高效完成VOLTE异常事件分析但在定位网络问题（IMS、EPC、EUTRAN）存在较大的不确定性；网元级的了解，可以更准确的定位网络问题，但VOLTE属于新事物，功能尚不完善，网络设备厂家过多，异厂家的配合与协议理解存在差异，在设备级问题上，急需进行不断的总结归纳。
