# INVESTIGATION OF EAST CHICAGO RAMP COLLAPSE

By Nicholas J. Carino,<sup>1</sup> A. M. ASCE, H. S. Lew,<sup>2</sup>  
and William C. Stone,<sup>3</sup> Members, ASCE

**ABSTRACT:** A summary is presented of the investigation performed by the National Bureau of Standards (NBS), at the request of the Occupational Safety and Health Administration, to determine the most likely cause of the collapse of a portion of a highway ramp in East Chicago, Indiana. The investigative effort included an extensive field study to ascertain the conditions prior to and after the accident. In addition, the NBS performed physical tests on key components of the temporary support system used to build the ramp. A structural analysis was performed to compute the magnitude of the forces acting in various components of the support system prior to the failure. The calculated forces were compared with the expected strengths of the structural components. It was concluded that the most likely triggering mechanism of the collapse was the cracking of concrete pads supporting a shoring tower. It was further concluded that there were four deficiencies that contributed directly to the collapse. Had any of these defici

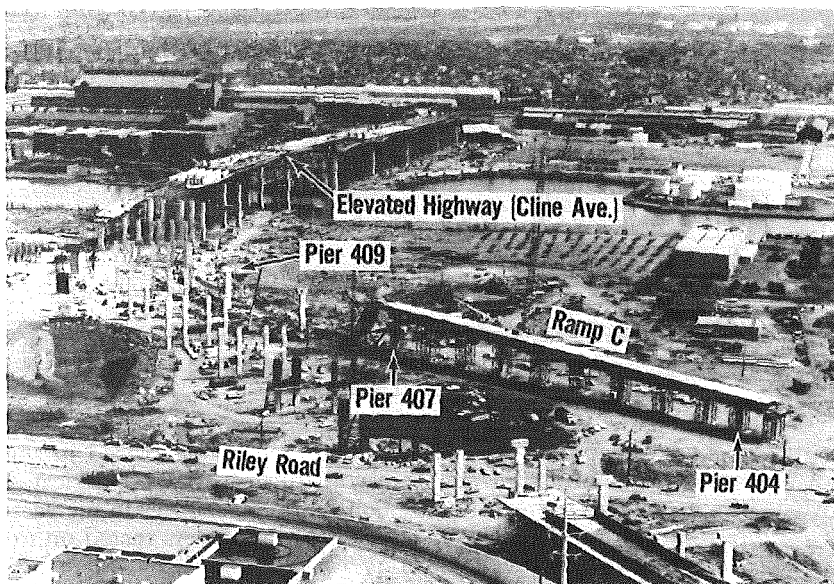
The structure is known as Ramp C of the Riley Road Interchange and is intended to move traffic from Riley Road to the eastbound lanes of Cline Avenue in East Chicago, Indiana. Fig. 2 is a view looking approximately east that was taken shortly after the collapse, and shows the portion of Ramp C that remained standing. The ramp was to be built in two portions. In the first phase, the portion from pier 404 to Cline Ave. would be built; and in the second phase, the western portion connecting to Riley Road would be built. At the time of the collapse, work was in progress east of pier 407.

**FIG. 2.—Overall View of Riley Road Interchange Site; View is Approximately Toward East (Courtesy of Post-Tribune, Gary, Indiana)**

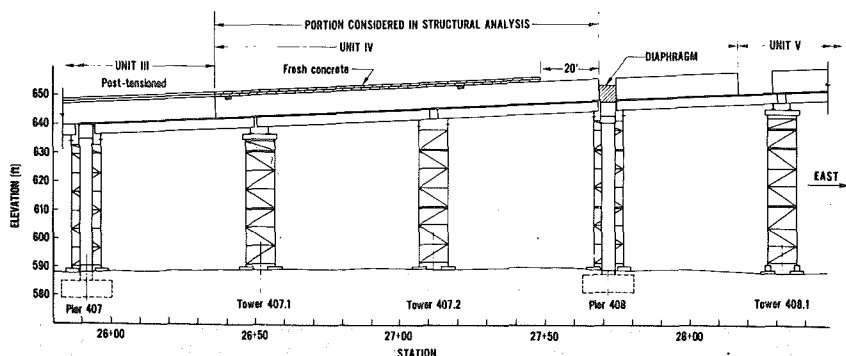
On the day of the collapse, concrete was being placed for the top slab of unit IV. Based on the statements of workers, concrete delivery tickets and other physical evidence, it was concluded that the top slab had been placed up to about 20-ft (6-m) from pier 408, and the diaphragm form over pier 408 was about half filled. Fig. 10 shows the state of construction prior to the accident. Unit III had previously been post-tensioned, and post-tensioning tendons were in place in unit IV. The unit-IV tendons were attached to unit III with coupler hardware, and they were wedged into place at the end of the portion of unit IV extending beyond pier 408. A gap existed between the bottom portions of units IV and V so that unit IV could be post-tensioned after the top-slab concrete had attained the required strength.

FIG. 10.—State of Construction at Time of Collapse

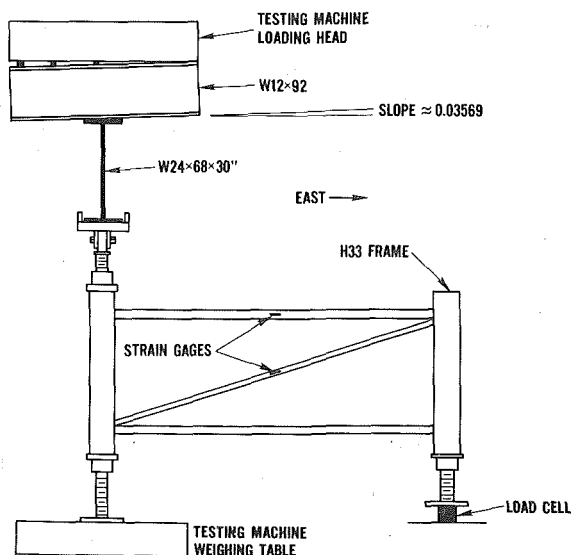
FIG. 13.—Arrangement of Falsework Assembly Tests

As previously mentioned, wedges were omitted from between crossbeams and stringers (Fig. 8). Tests were carried out to determine the consequences of this omission. The arrangement for these tests is shown in Fig. 13. A piece of a W12  $\times$  92 beam was bolted to the head of a testing machine so that it had the approximate slope of the ramp. This beam was used to load the falsework assembly consisting of a crossbeam, a U-head, a welded frame, and two lower screw jacks. The threaded bar of the U-head was instrumented with strain gages from which the axial load and bending moment could be determined. The braces of the frame were also instrumented with strain gages so that these member loads could be determined. The results of these tests indicated that the absence of the wedges caused a horizontal force and a bending moment on the U-heads. It was determined that the horizontal force, acting toward the east, was about 2.4% of the vertical load. It must be realized that while the horizontal force seems to be small, when it is applied to the U-heads at the top of the 45-ft (14-m) towers, it creates a significant increase in the leg forces on the east side of the towers.

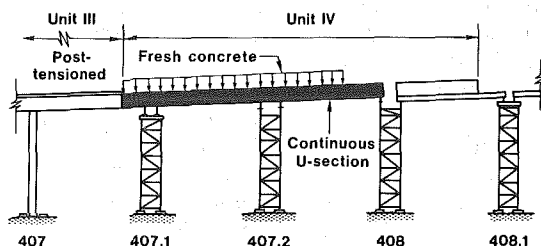
FIG. 14.—Structural Behavior of Partially Completed Ramp During Top-Slab Casting

When the top slab was placed, an entirely different structural system was involved. Because the U-section had hardened, the load of the fresh top-slab concrete was distributed to the towers by the continuous-beam action of the U-section. This behavior is shown in Fig. 14. The flexural stiffness of the U-section was more than nine times that of the stringers, and for this case it was assumed that the stringers only served to transfer bearing reactions to the crossbeams. The U-section was modeled by a series of overlapping plate-bending and membrane finite elements, and was supported by the crossbeams. A series of elastic constraints were applied at the end of unit IV in contact with unit III to model the restraint provided by unit III. The portion of unit IV east of pier 408 was not included in this analysis because concrete was not being placed in this part. The loading for this second analysis included the weight of the fresh concrete placed to within 20 ft (6 m) of pier 408 (Fig. 10).
