Tree Risk Assessment and Tree Protection

596 Ryan Road, Northampton, Massachusetts

II. Observations and Tree Risk – Site visit on 8/16/2022

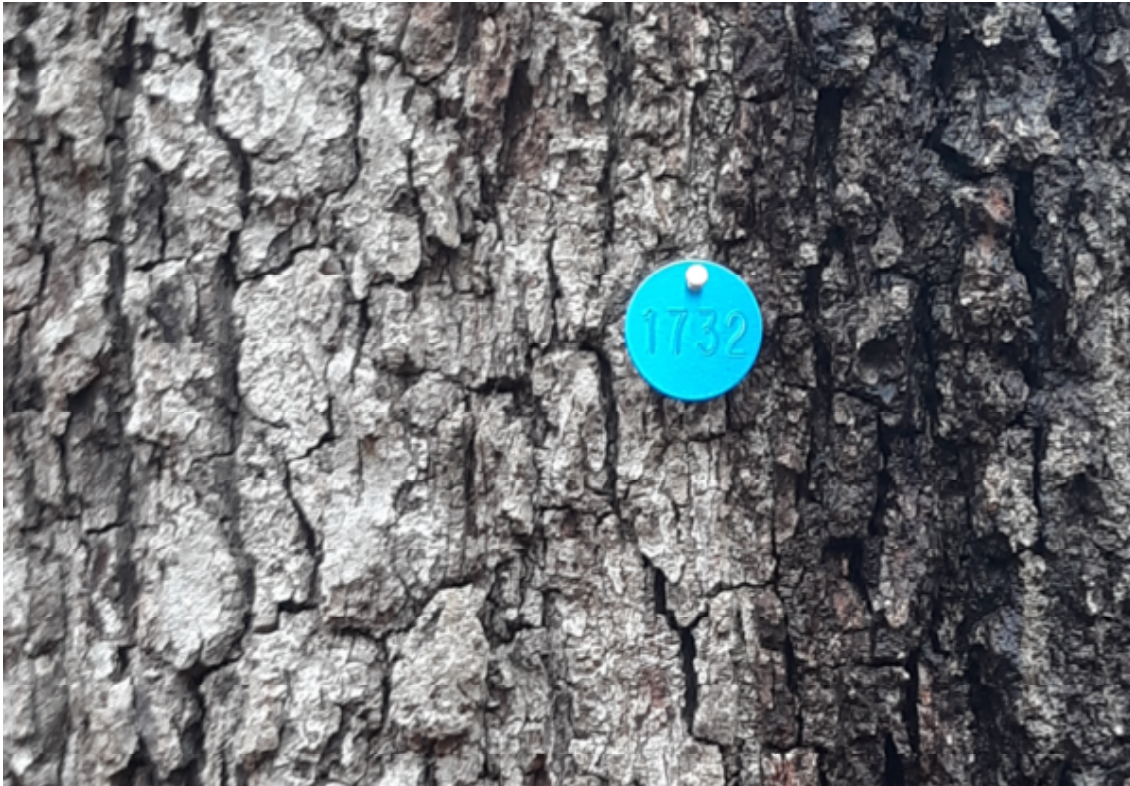
A tree identification number was affixed to every inventoried tree.

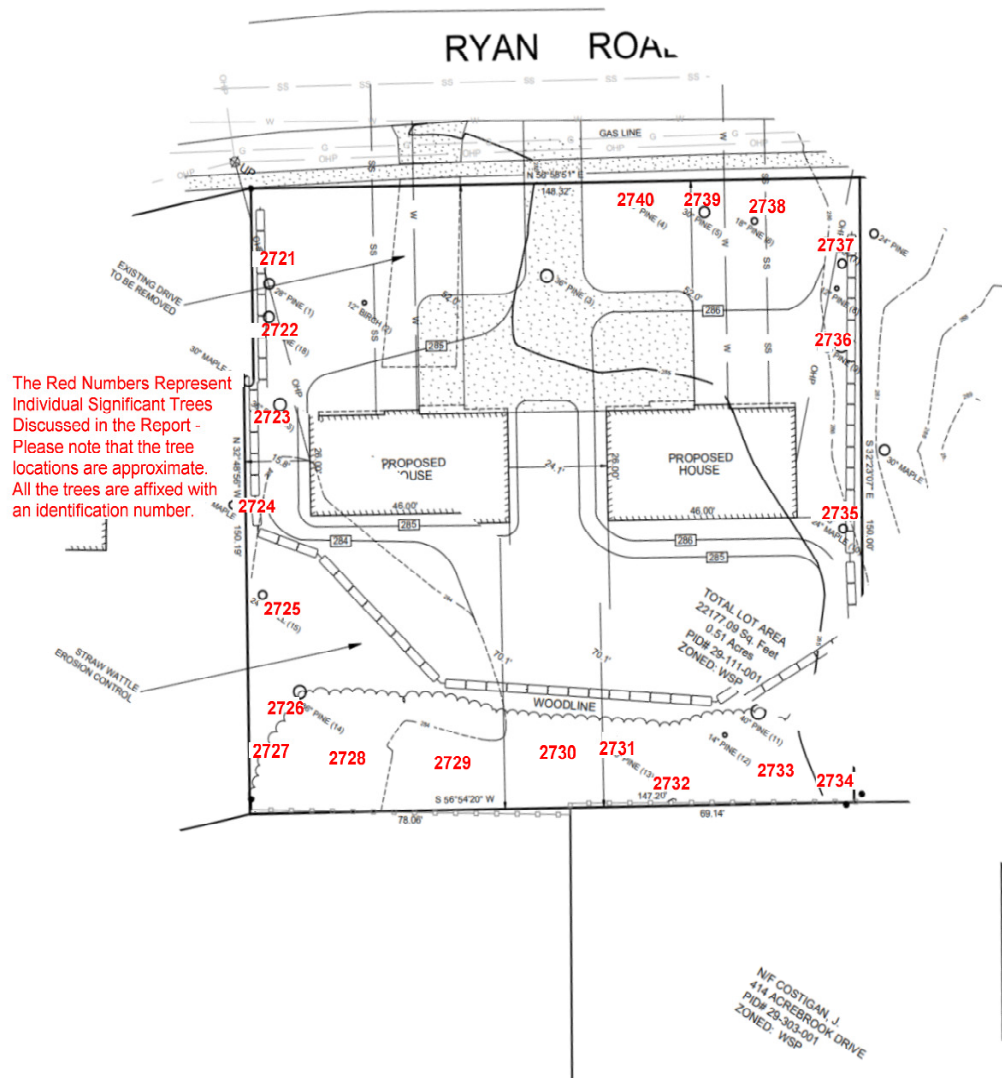
Tree Location Drawing #1

The numbers in the drawing supplied by Nu-Way Homes represent the approximate locations of individual significant trees that were inventoried.
