5<sup>th</sup> Year Monitoring of Mitigation Provided  
on the Birch River  
for the O'Brien #2 Surface Mine.

June 20, 2012

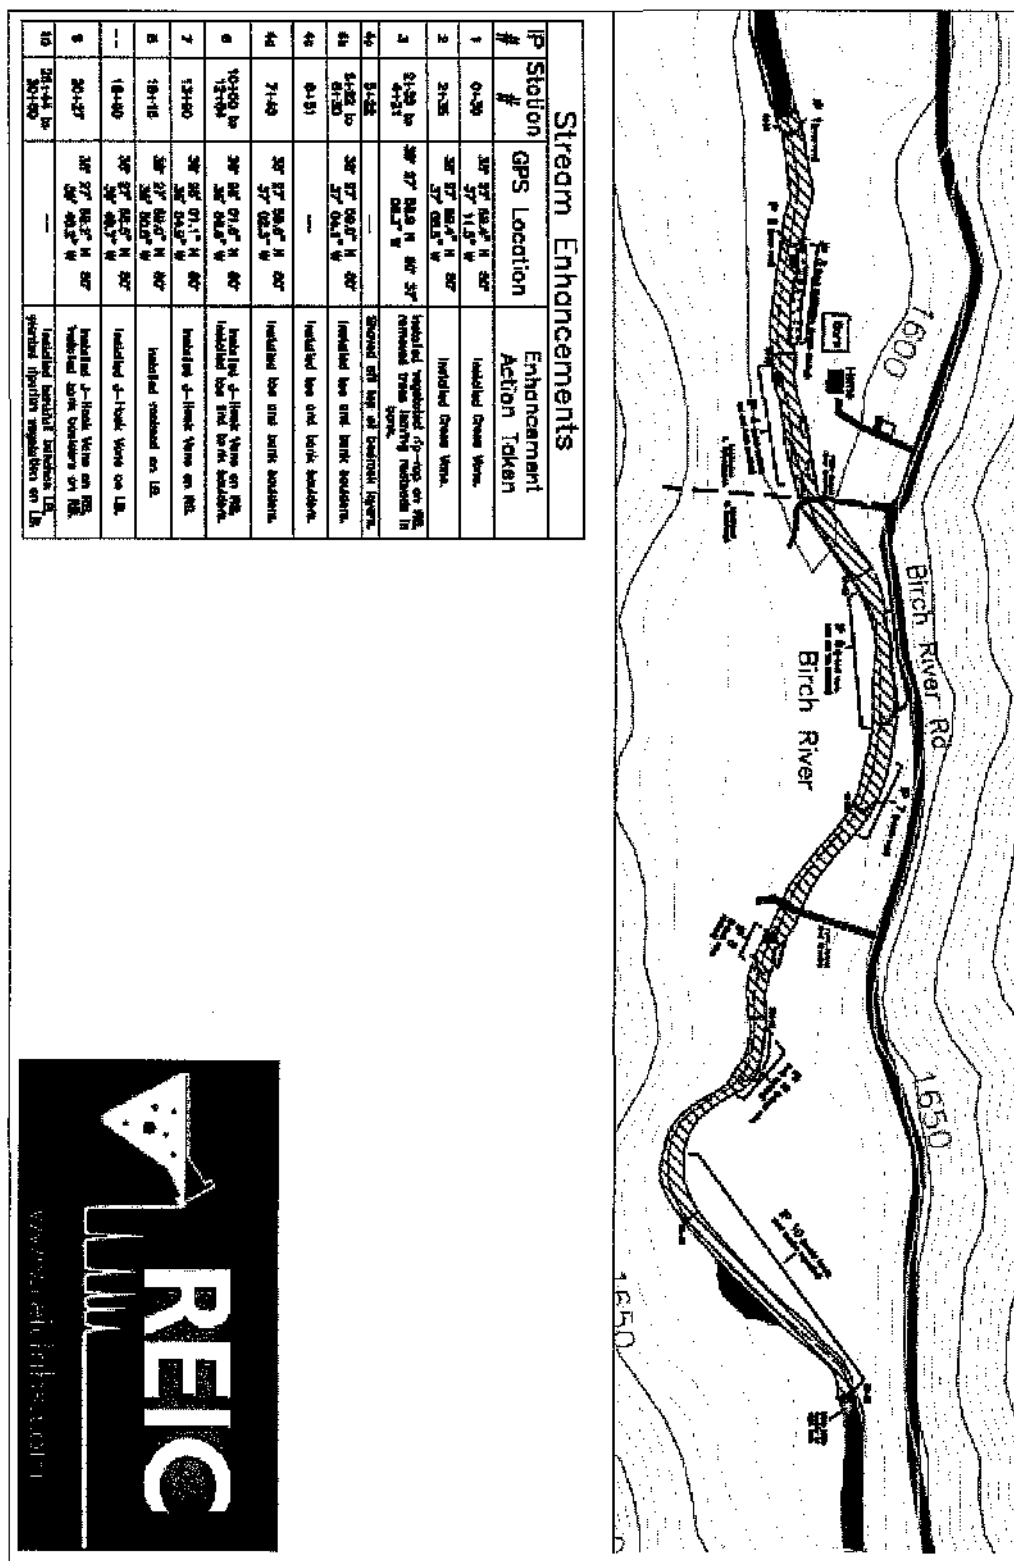
FIGURE 6. Birch River IP summary. May 2012. (See report hard copy for full-size version.)

As part of the approved CMP, ICG Eastern proposed to provide mitigation for those sections of streams permanently impacted by the O'Brien Surface Mine by providing stream improvements and enhancements on the Birch River. The construction on Birch River associated with this permit was completed in the Summer of 2007 (see FIGURE 6).
