Embankment breaching and its management in Gosaba and Basanti blocks of Sundarbans, West Bengal

Kanail Das¹

Karabi Das²

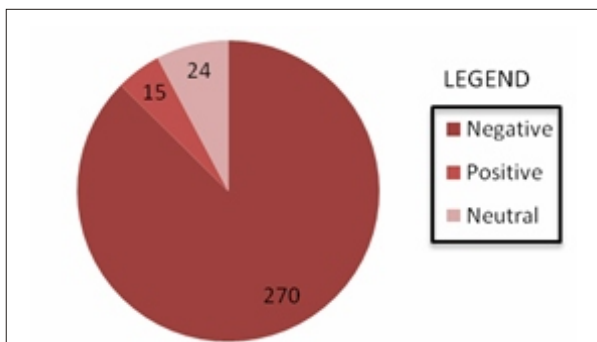
Fig. 7: People's Perception about Change in the last 5 Years (Birajanagar)

Mostly the surveyed people have opined that land type, water quality, status of local resources, livestock quantity, capital and stock, sanitation conditions have undergone negative change in the last five years. Nutrition and health condition, livelihood, security, banking and credit have also recorded a negative change in last five years. Positive change has been recorded for connectivity through cellular phones and unity despite political disparity. The post Aila response in Gosaba for Bairagipara, Luxbagan, Kachukhali and Birajnagar have been shown and it is evident that in all the cases majority of the people have opined that in the last five years negative change has been recorded in all respects.

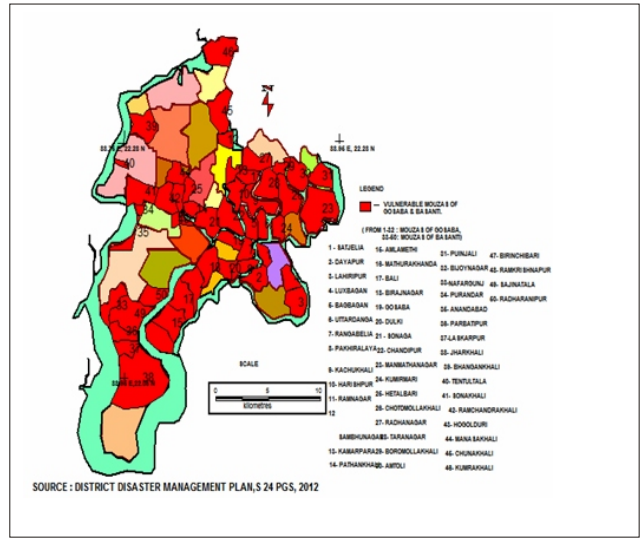
Fig. 11: Vulnerable Mouzas of Gosaba, and Basanti

due to breaching of embankments. For this lengths of damage more than 600m have been taken into account. Gosaba testifies 18 sites of damage while Basanti has 6 sites of damage with damaged length of more than 600 m. The rivers and the banks damaged have also been tabulated. Subsequently a map has also been prepared according to this data. In the map all the sites have been shown with lengths of damages ranging from 200 m to 7000 m.
