MIN-D

NASA's Space Grant Midwest High-Power Rocket Competition

University of Illinois at Urbana-Champaign

September 6th, 2019

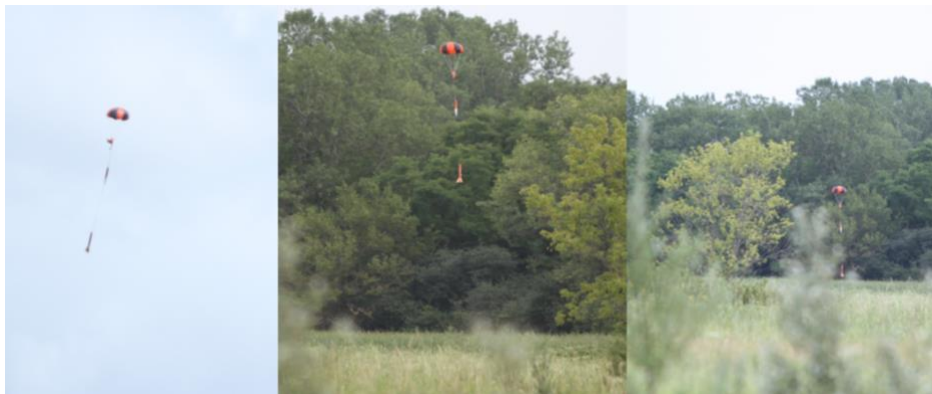
Figure 6: In-flight recovery sequence during the second flight

The rocket descended at a speed of 66.24 ft per second under the drogue parachute, and after the Jolly Logic Chute Release deployed as expected at 700 ft, the rocket descended at 19.32 ft/sec under the main parachute. During this time, the shock cord system successfully kept all components of the rocket attached as seen in Figure 6.

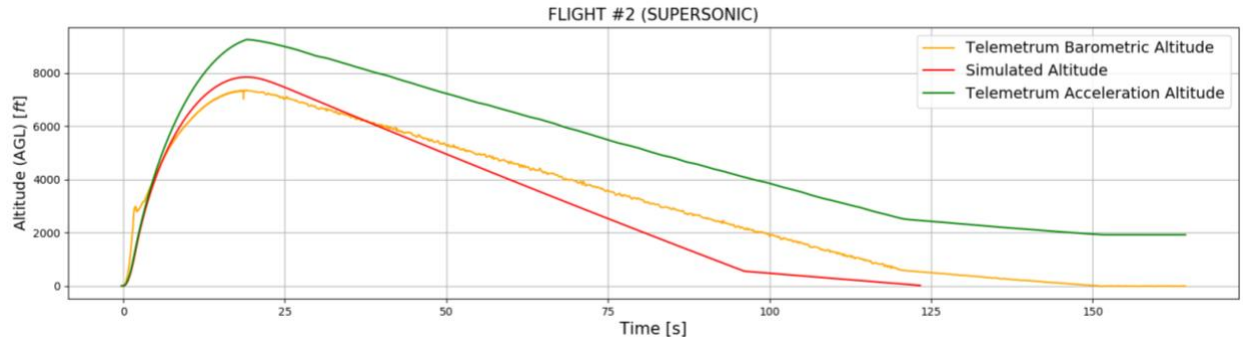
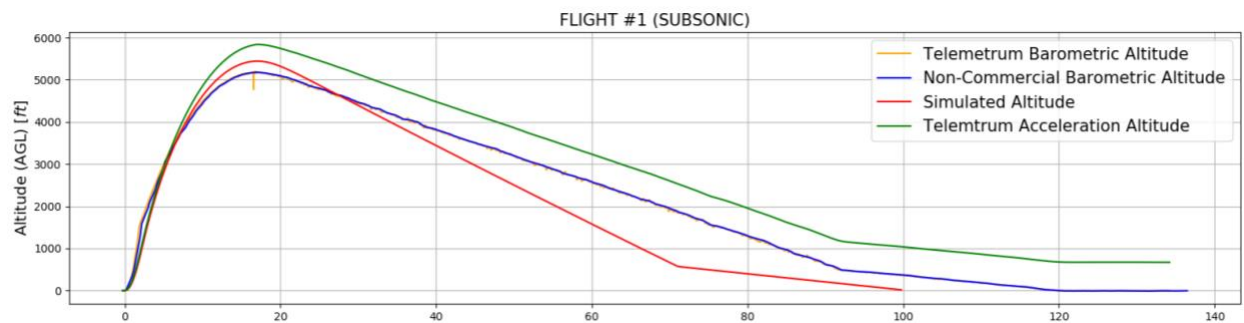
Figure 9: Altitude (AGL) vs. time plot for both simulated data and recorded data.

The graph shown below in Figure 9 compares the real altitude measurements of the rocket to the simulations made in OpenRocket for both flights. It is important to note that the accelerometer based altitude appears to be inflated as the altitude measurements are based on a double integrating acceleration data, and the team believes that the error factor in the data is compounded.

The maximum altitude for both flights was lower than predicted. As detailed in Table 1, the first flight was 202 ft below the predicted maximum altitude, and the second flight was 443 feet below the predicted maximum altitude. The percent errors in altitude for the first flight were only 3.8% and 5.7% respectively. Additionally, the rocket took longer than simulated to land for both flights and took longer to reach apogee for the second flight. Analysis of the descent part of the flight is further discussed in 3.4 Recovery System Performance and Descent Velocity.

During its second flight with the J-430 motor, the rocket was expected to achieve a peak velocity of 1237 ft/s. The rocket flew at supersonic speed during this flight. This is evidenced by an anomaly in the barometric-based TeleMetrum data near the time the rocket approached Mach 1. As explained in 4.1, the maximum velocity occurs around 1.71 seconds, about when the barometric-based TeleMetrum data experiences an unexpected jump in velocity in Figure 9. On the other hand, it is observable that the accelerometer-based data does not have any anomalies.

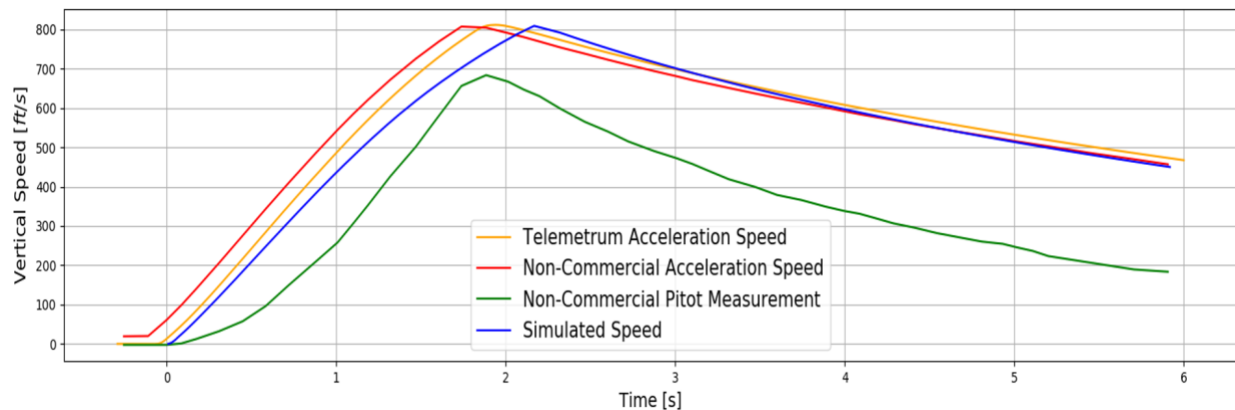
Figure 10: Flight 1 Acceleration and Velocity Measurements

Figure 10 shows the velocity versus time plot with the TeleMetrum, Raspberry Pi, and the OpenRocket simulations and includes measurements from the pitot tube for the second flight.

Unfortunately, due to the loss of the Raspberry Pi, the team was not able to receive any data from the pitot tube during the second flight. The maximum speed achieved in the first flight was 811 ft/sec, which is .3% greater than the predicted speed of 809 ft/sec. The Mach number varies according to altitude since the temperature of the atmosphere generally decreases with altitude, making it harder for air to conduct sound. Equation 1 was used to calculate the Mach value given the altitude and temperature, where a is the speed of sound, γ is the ratio of specific heats, R is the gas constant and T is the absolute temperature at the altitude in consideration.

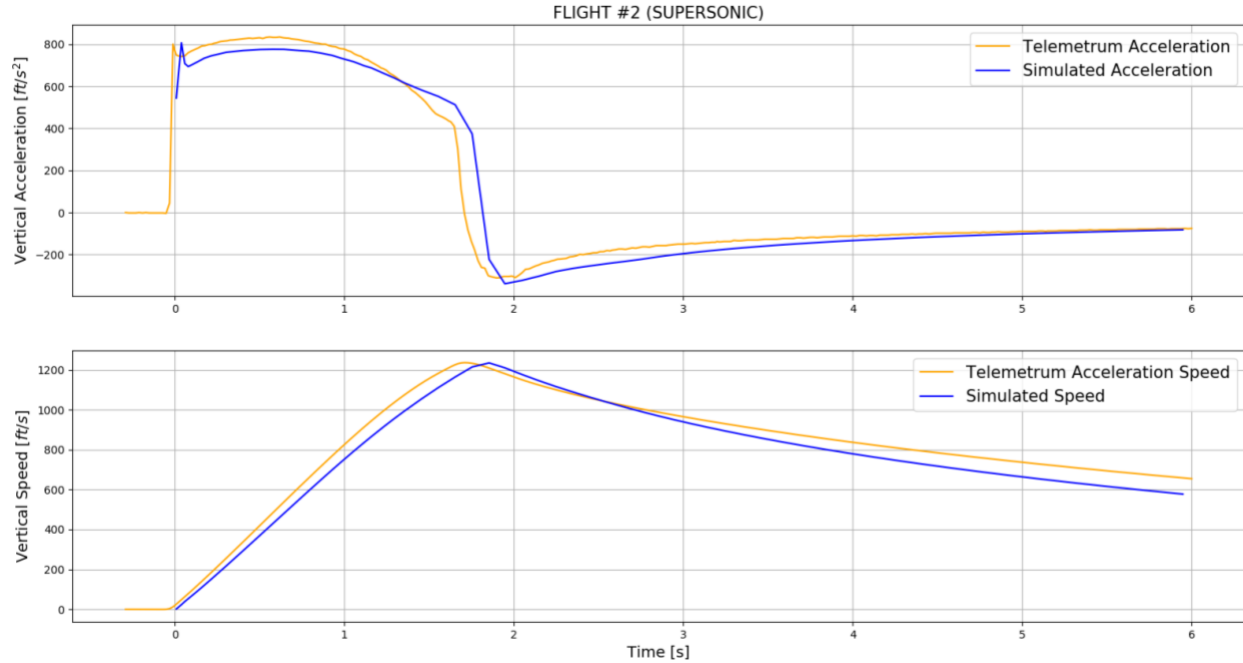
Figure 11: Flight 2 acceleration (top) and velocity (bottom) comparing actual velocity and acceleration to the simulated measurements

Figure 11 shows the acceleration versus time plot with the TeleMetrum recordings and OpenRocket simulations.
