U.S. CHEMICAL SAFETY AND HAZARD INVESTIGATION BOARD

INVESTIGATION REPORT

SUGAR DUST EXPLOSION AND FIRE

IMPERIAL SUGAR COMPANY

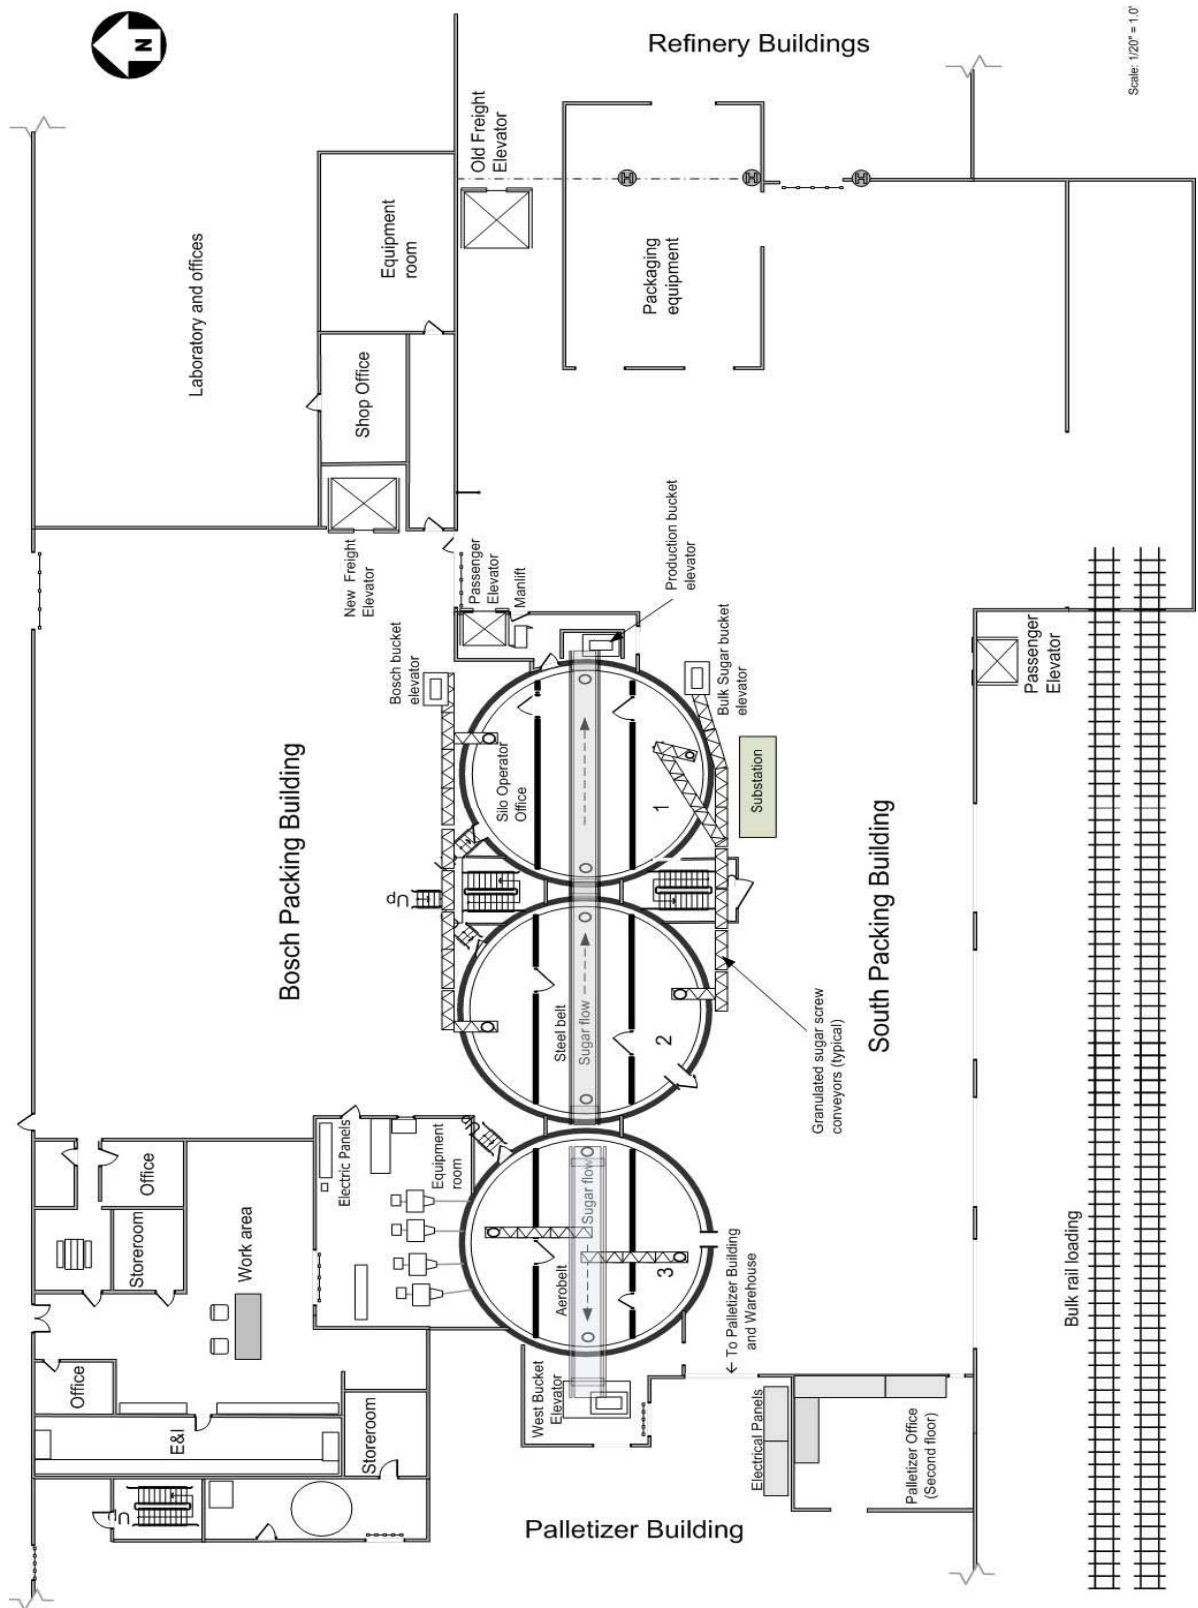
Figure 5. Packing buildings first floor plan

Dozens of screw conveyors,⁶ bucket elevators,⁷ and horizontal conveyor belts transported granulated sugar throughout the packing buildings (Figure 5). Although bucket elevators were enclosed and screw conveyors were covered, they were not adequately sealed to prevent releasing sugar dust and sugar into the work areas. Because the large open work areas were not equipped with airborne dust removal equipment, sugar dust accumulated on overhead conduit, piping, ceiling beams, lights, and equipment. The closed granulated sugar screw conveyors located throughout the facility were not

²³ Although the enclosure on the belt conveyors in the penthouse could have been designed to safely vent an explosive overpressure outside the building, designing a deflagration vent system for the belt conveyor in the silo tunnel was impractical. That conveyor was located on the ground floor in the center of the building (Figure 5) far from any building exterior wall or roof.

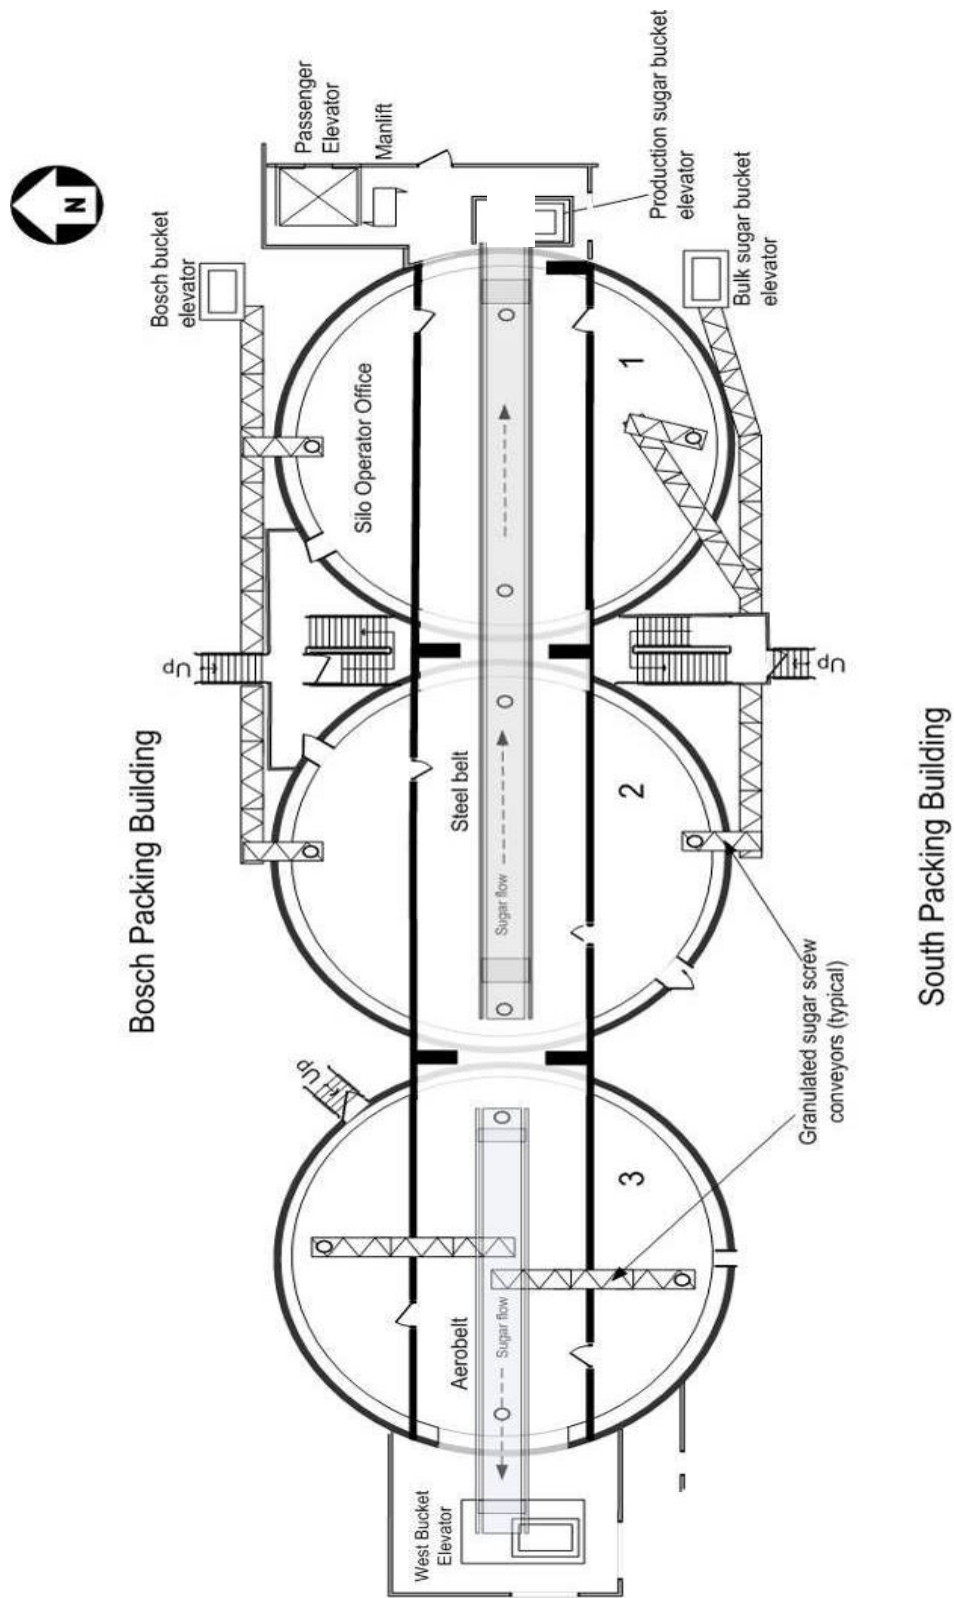
Figure 6. Silo tunnel and conveyor plan

Three 40-foot diameter, 105-foot tall concrete silos conditioned and stored the granulated sugar produced in the refinery. Each 5-million pound capacity silo sat on a raised circular concrete foundation above the packing building floor. Two belt conveyors were located under the silo floors in a 130-foot long tunnel, which was 7 ½ feet tall and 12 feet wide (Figure 6) .

above the silo tunnel (pantleg rooms, see Figure 7) and concluded that the primary dust explosion most likely occurred in the silo tunnel, approximately midway along the length of the steel belt.

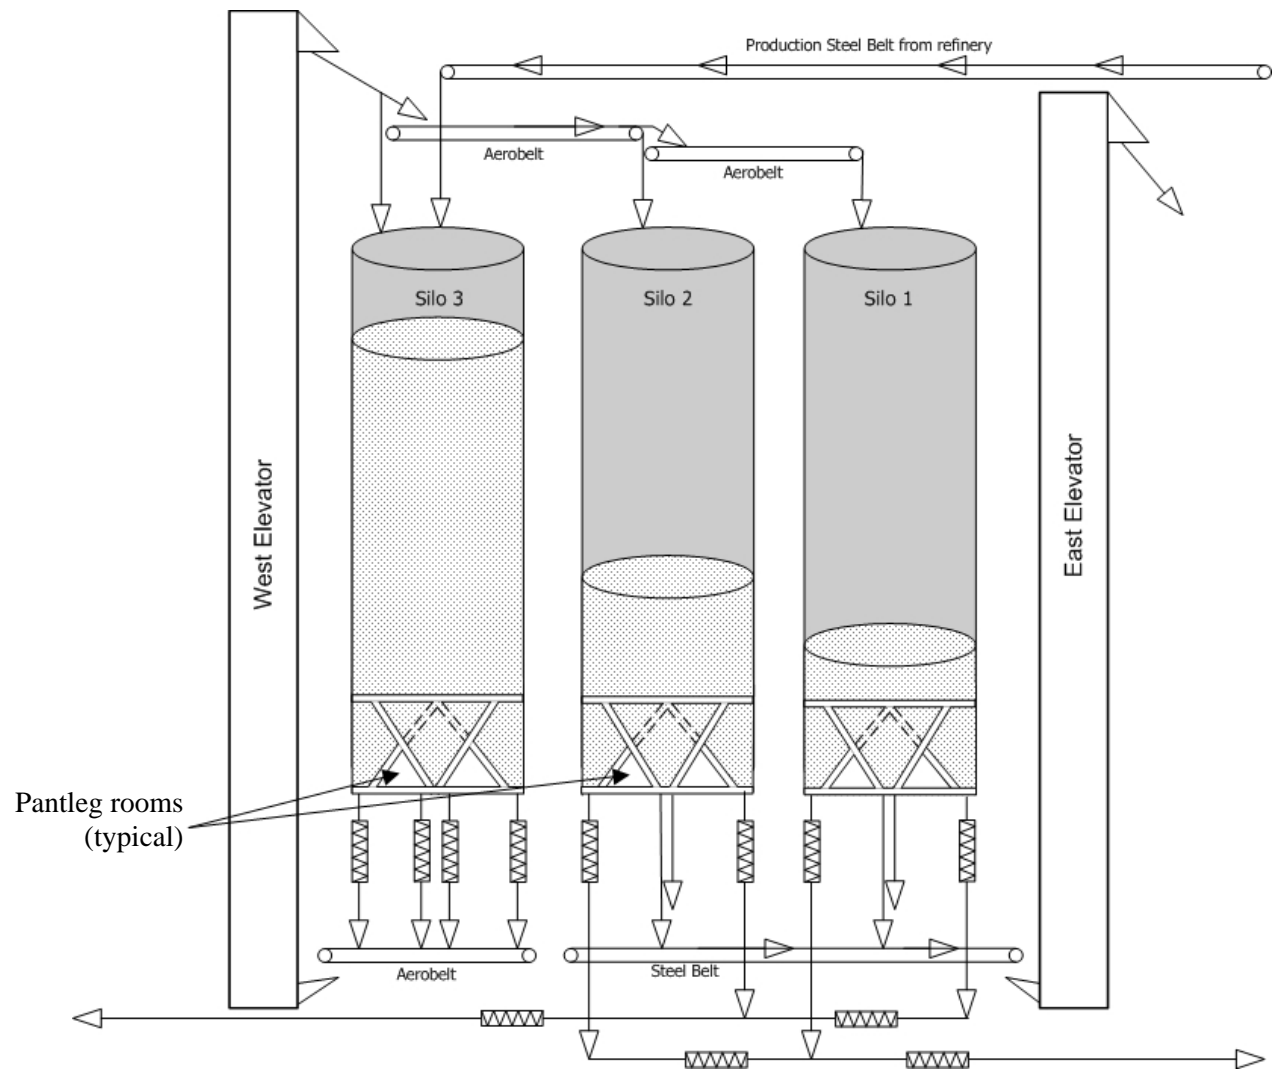
Figure 7. Granulated sugar supply and discharge through the silos

Sugar exited silo 3 into an Aerobelt^{® 8} conveyor in the silo tunnel, which discharged the sugar into the west bucket elevator pit. The bucket elevator lifted the sugar to the penthouse and onto another series of conveyor belts, into silos 1 and 2 (Figure 7 and Figure 8). Granulated sugar exited two 18-inch diameter penetrations in the floors of silo 1 and 2 onto a steel conveyor belt in the silo tunnel.

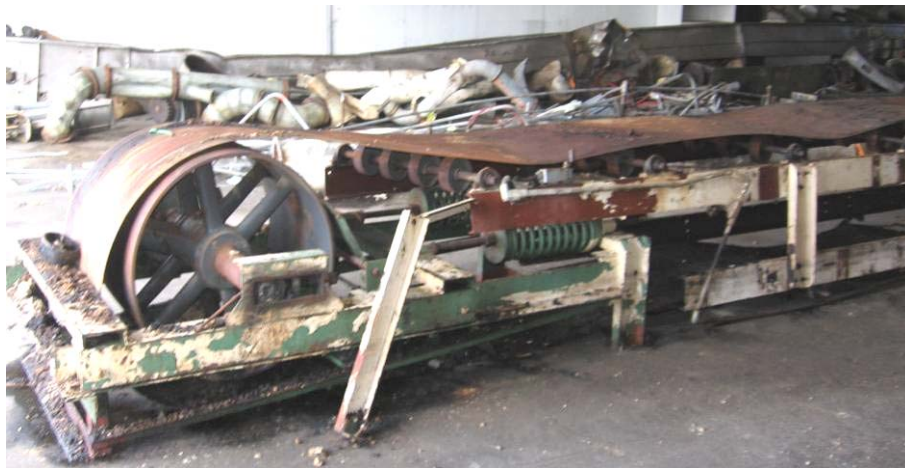
Figure 9. Silo tunnel steel conveyor belt (removed after incident)

A 32-inch wide, 80-foot long steel conveyor belt (Figure 9) in the silo tunnel transported granulated sugar from silos 1 and 2 into the packaging production bucket elevator pit at the east side of silo 1. Similar steel belt conveyors were located in the penthouse above the silos.
