# **EPA CHEMICAL ACCIDENT INVESTIGATION REPORT**

## **Tosco Avon Refinery Martinez, California**

EPA550-R-98-009  
November 1998

At approximately 7:41 p.m. on January 21, 1997 at the Tosco Avon Refinery in Martinez, CA, a section of effluent piping ruptured on the Hydrocracker Stage 2 Reactor 3. A mixture of light gases starting with methane through butane; light gasoline; heavy gasoline; gas oil and hydrogen was released from the pipe and instantly ignited upon contact with air, causing an explosion and fire. A Tosco Hydrocracker operator checking a field temperature panel at the base of the reactor was killed; 46 Tosco and contractor personnel were injured. Thirteen injured personnel were taken to local hospitals, treated and released. There were no reported injuries to the public.

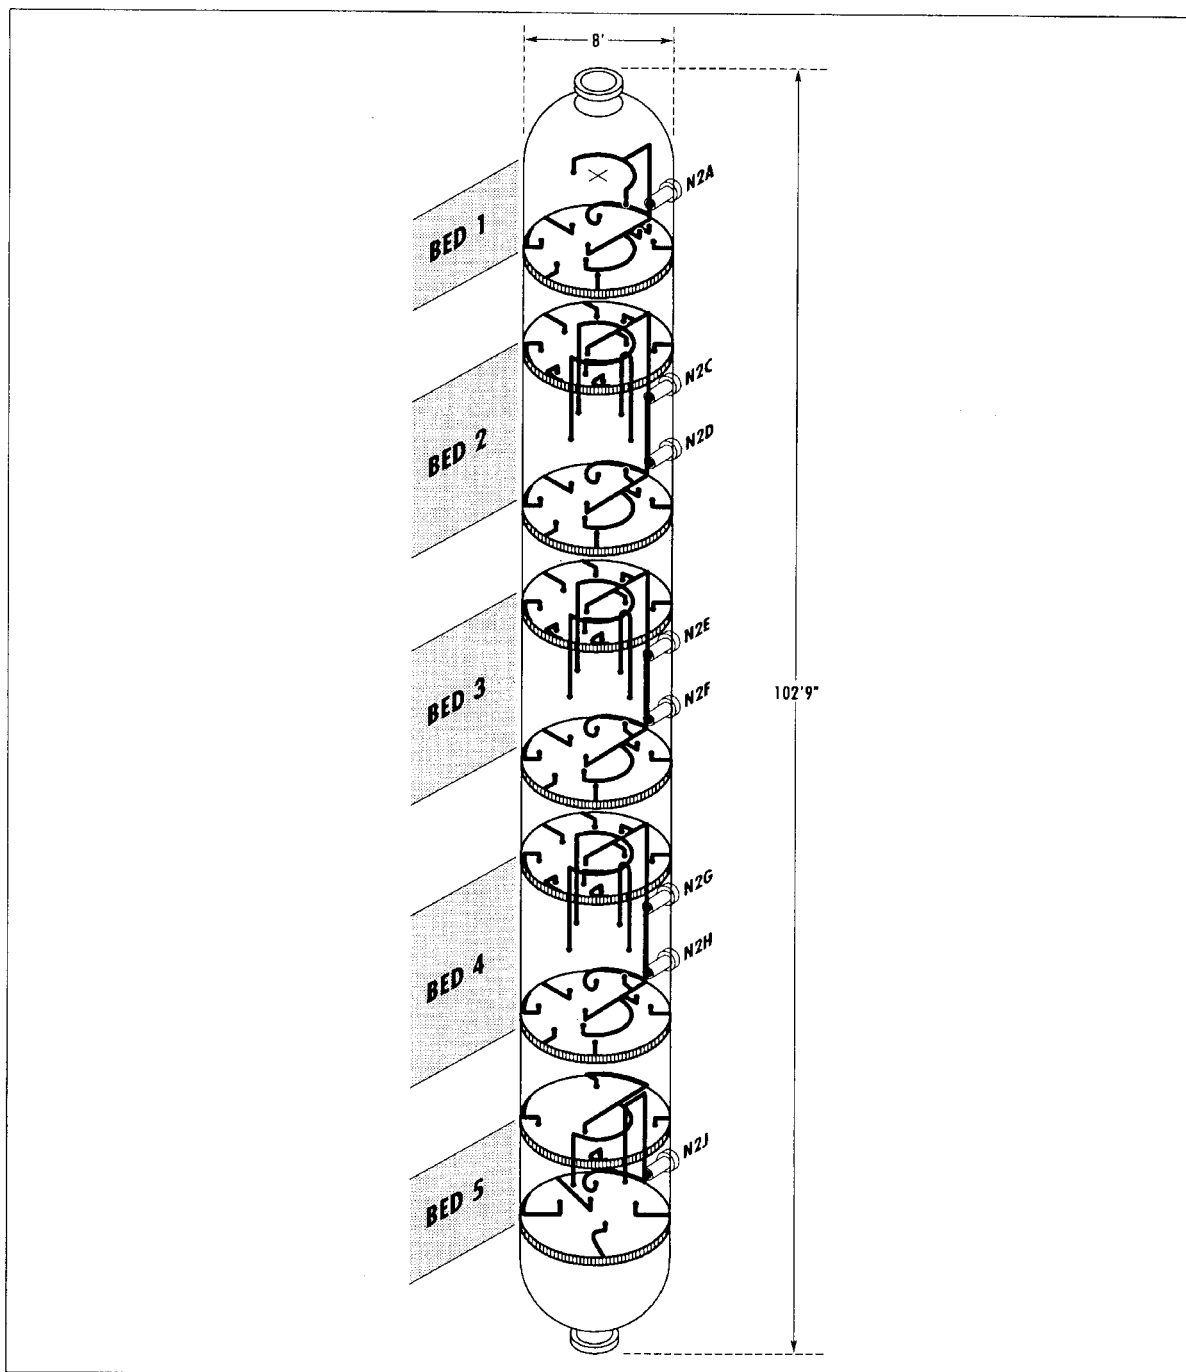
**Figure 5**      **Stage 2 Reactors Thermocouple Arrangement - Isometric Drawing**

were located in each Bed 2 through 4, and twelve were located in Bed 5. Figure 5 shows the location of the internal Stage 2 reactor thermocouples. Additional thermocouples (not shown) monitor the feed, reactor inlet, reactor outlet and reactor skin temperatures (three skin temperatures per reactor).

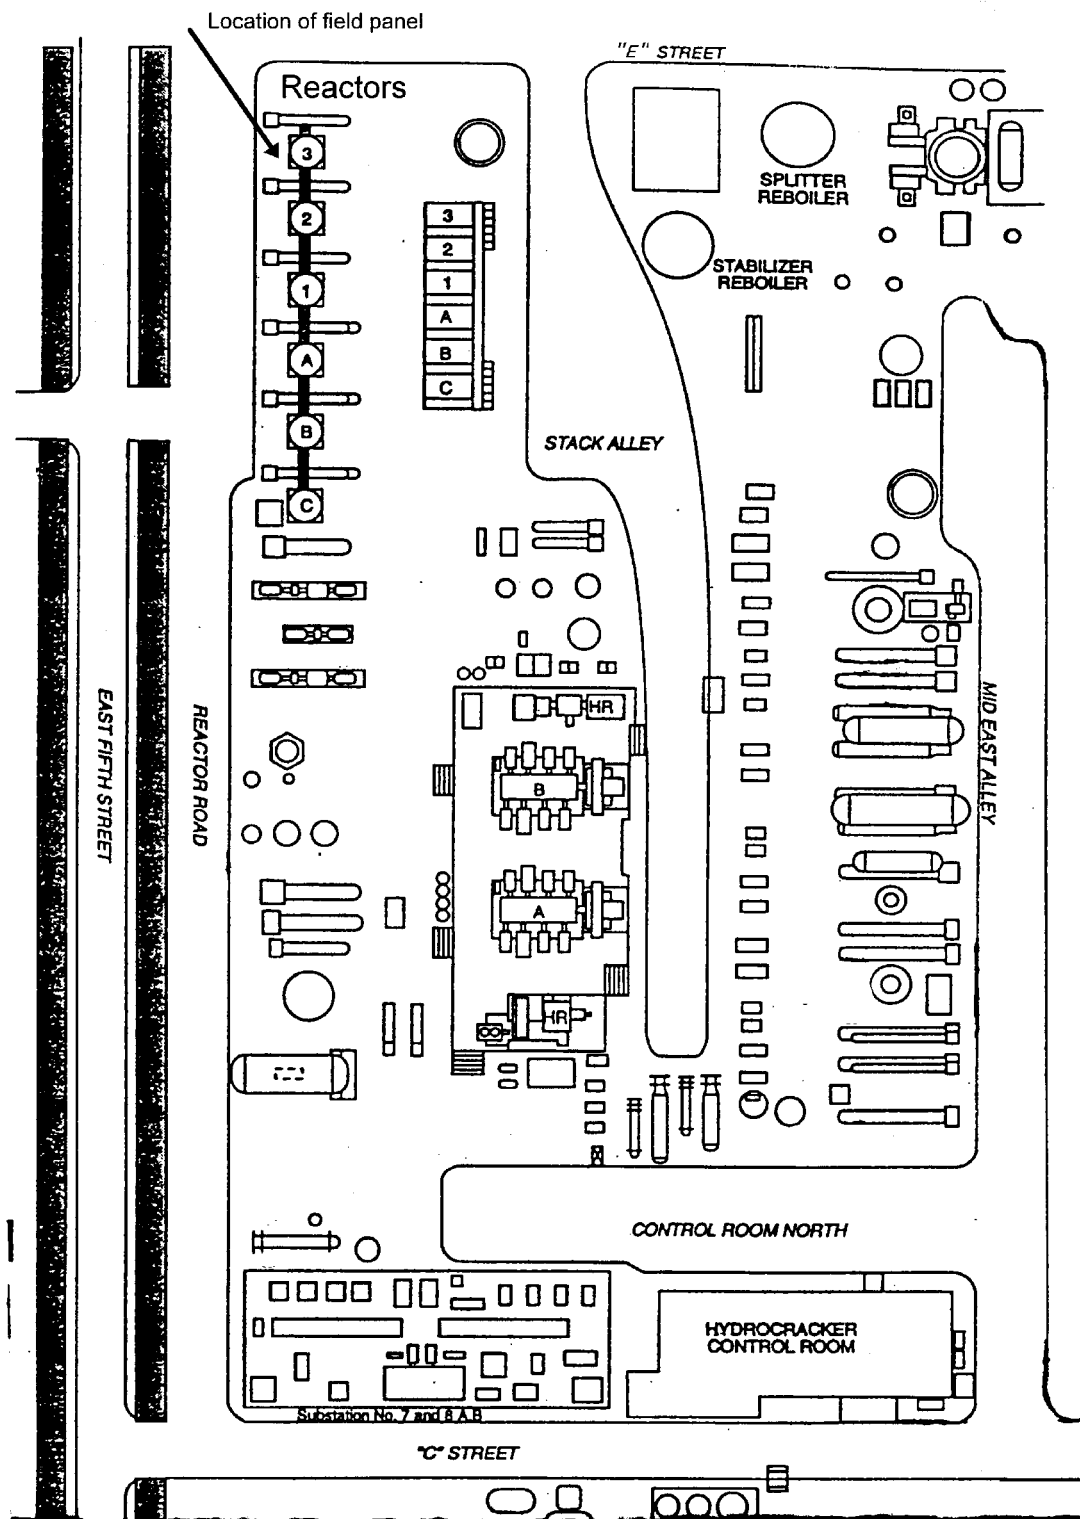
Figure 6 Hydrocracker Plot Plan Tosco Avon Refinery

Field panels were installed under the reactors during the 1996 January-February turnaround in order to provide additional temperature readings in the catalyst beds. Figure 6 is a plot plan of the Hydrocracker operation that shows the location of the panel under Reactor 3 relative to the control room. Seven points from each thermocouple array were displayed on the panels. Individual temperatures could be displayed by the operators at the panel using multipoint rotary switches; one switch to select the bed desired and five other switches for selecting the point within each bed. The field panel could display temperatures between -10°F and 1200°F. If the temperature was outside this range, the display would show all dashes (---).

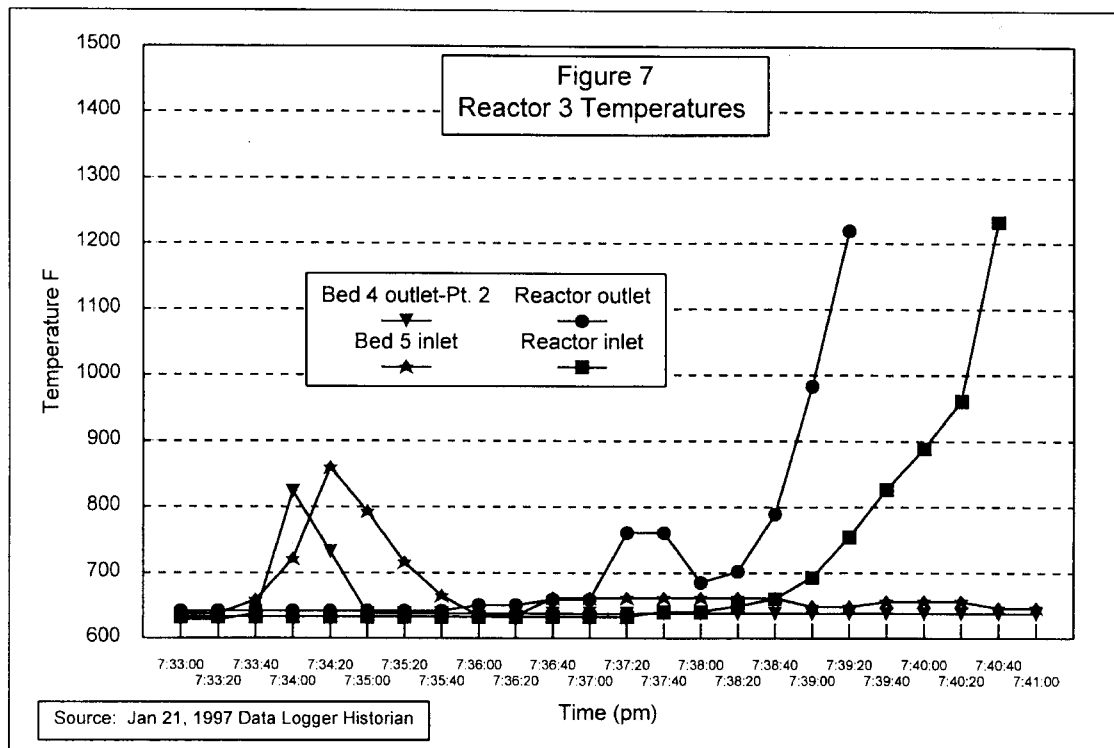
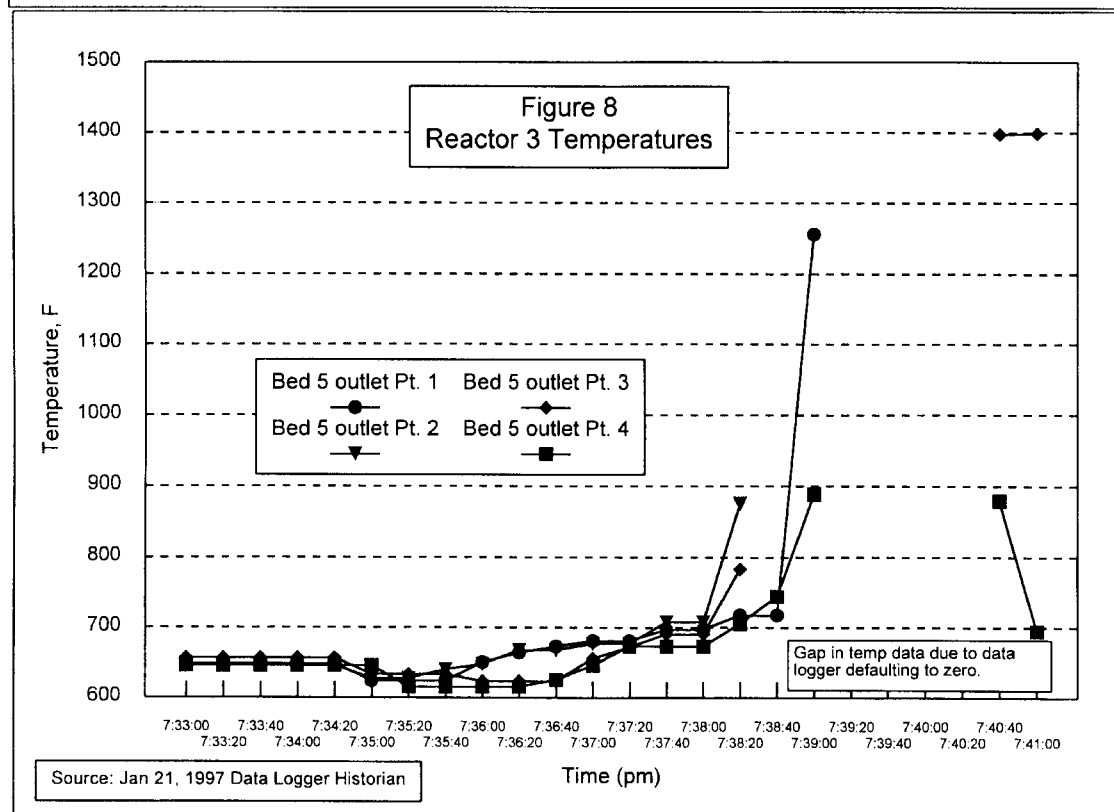
The time listed in the table above is the actual time; the time in the data logger historian report was 52 minutes ahead of actual time. Highest temperatures recorded per point are **bolded**. A reading of 0.0 means temperature was above 1400°F. A reading of 0.0 ??? means loss of power to data logger computer. Bed 4 inlet temperatures did not vary during the incident. Only the Bed 4 outlet temperature that experienced an abnormal rise in temperature is included in the table. Unchanged temperature readings mean that temperature did not change more than 7°F from last reading, therefore data logger historian retains last previous recorded value.

After 7:40 pm, the strip chart readings for the reactor inlet and outlet temperatures continued to read off scale high. The reactor inlet temperature reached a maximum of 1234°F on the data logger at 7:40:40 pm before defaulting to 0. About the same time, the extra No. 1 Operator called the shift supervisor by phone, who immediately returned the call. The operator requested the assistance of an instrument technician to work on the temperature logger on Stage 2. Also at this time, the Stage 2 Board Operator noticed that the reactor inlet temperature had increased to over 800°F. In response, he reduced firing on the trim furnace and lowered the temperature set points to the top two beds, as a means of increasing quench flow.

At 7:41 pm, the highest recorded temperature on the data logger was the Bed 5 Point 2 outlet temperature, which registered 1398°F. At this time, the two outside operators had reached the northwest corner of the control room and the Stage 2 Board Operator was lowering the temperature set point on Bed 3. At approximately 7:41:20, an explosion occurred, followed by a fire. Seconds before the explosion, one observer driving by the Hydrocracker Unit reported seeing a glowing red-hot pipe elbow in front of the Stage 2 reactors.
