United States-
Environmental Protection
Agency

Region 7
Emergency Response and Removal Branch
Kansas City, KS

CHEMICAL ACCIDENT INVESTIGATION REPORT

TERRA INDUSTRIES, INC. NITROGEN FERTILIZER FACILITY PORT NEAL, IOWA

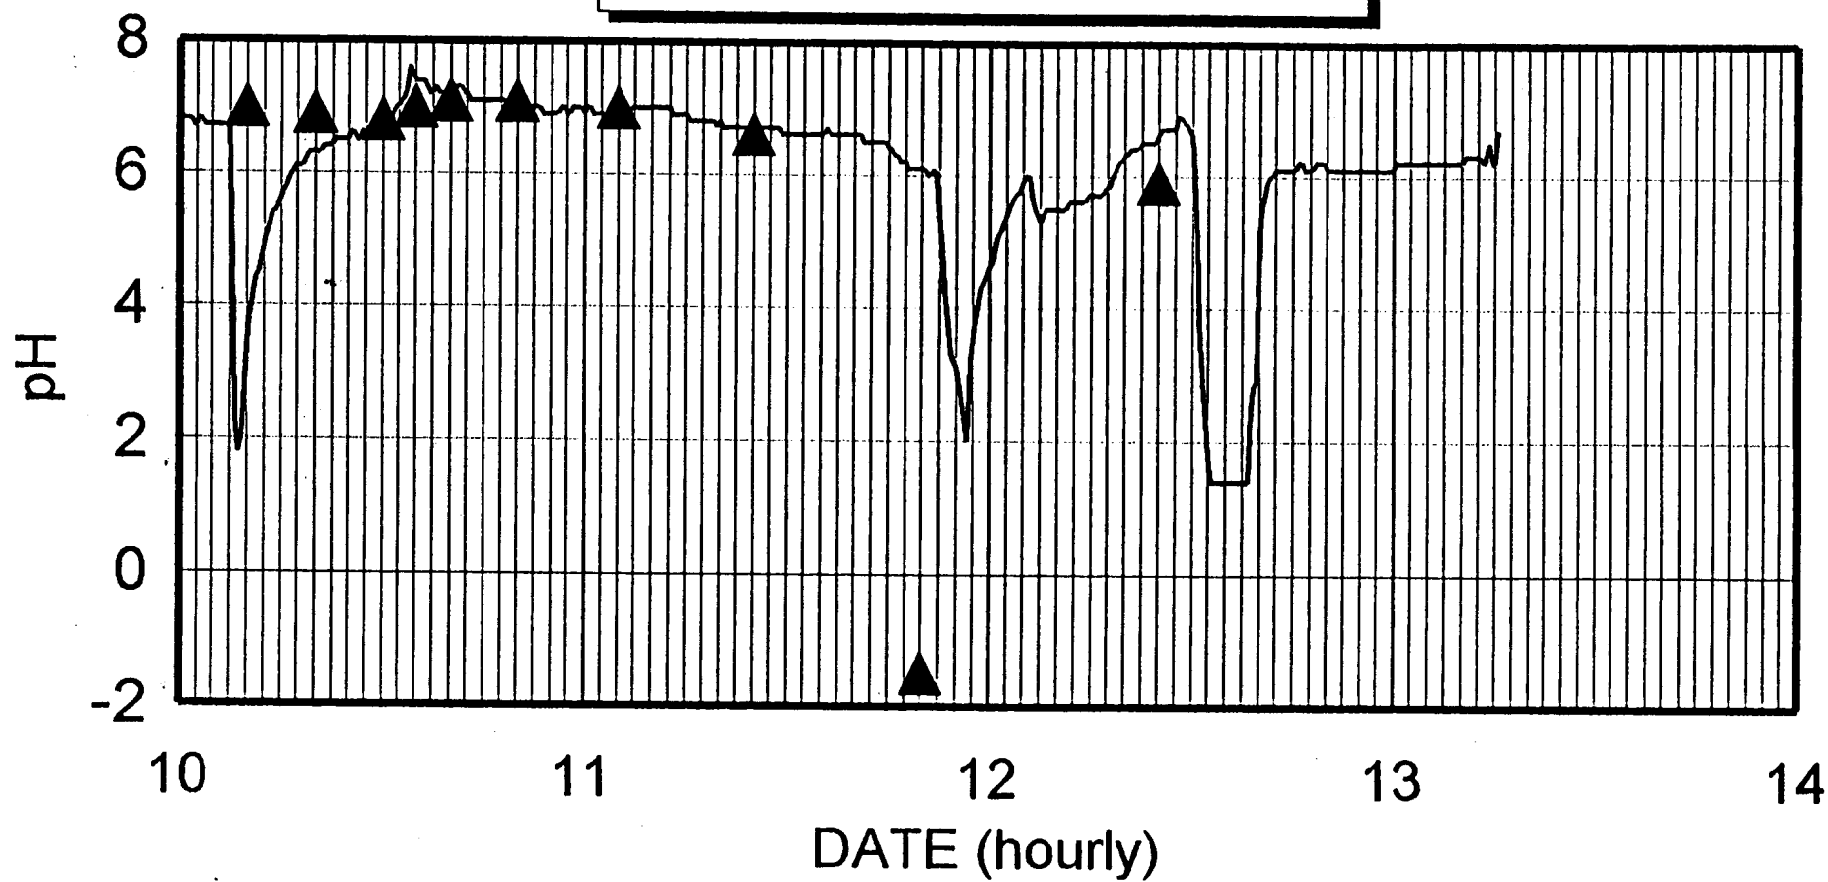
FIGURE 7.2

The investigation team contacted persons familiar with pH probe operations, who advised that the pH probe did appear to be working and indicated that response delays might be caused by an intermittent obstruction in the rundown sample line. The physical configuration of the sample line could contribute to this problem, as well as ambient temperatures. Ambient temperatures for the Sioux City, Iowa, area are contained in *Figure 7-3*.

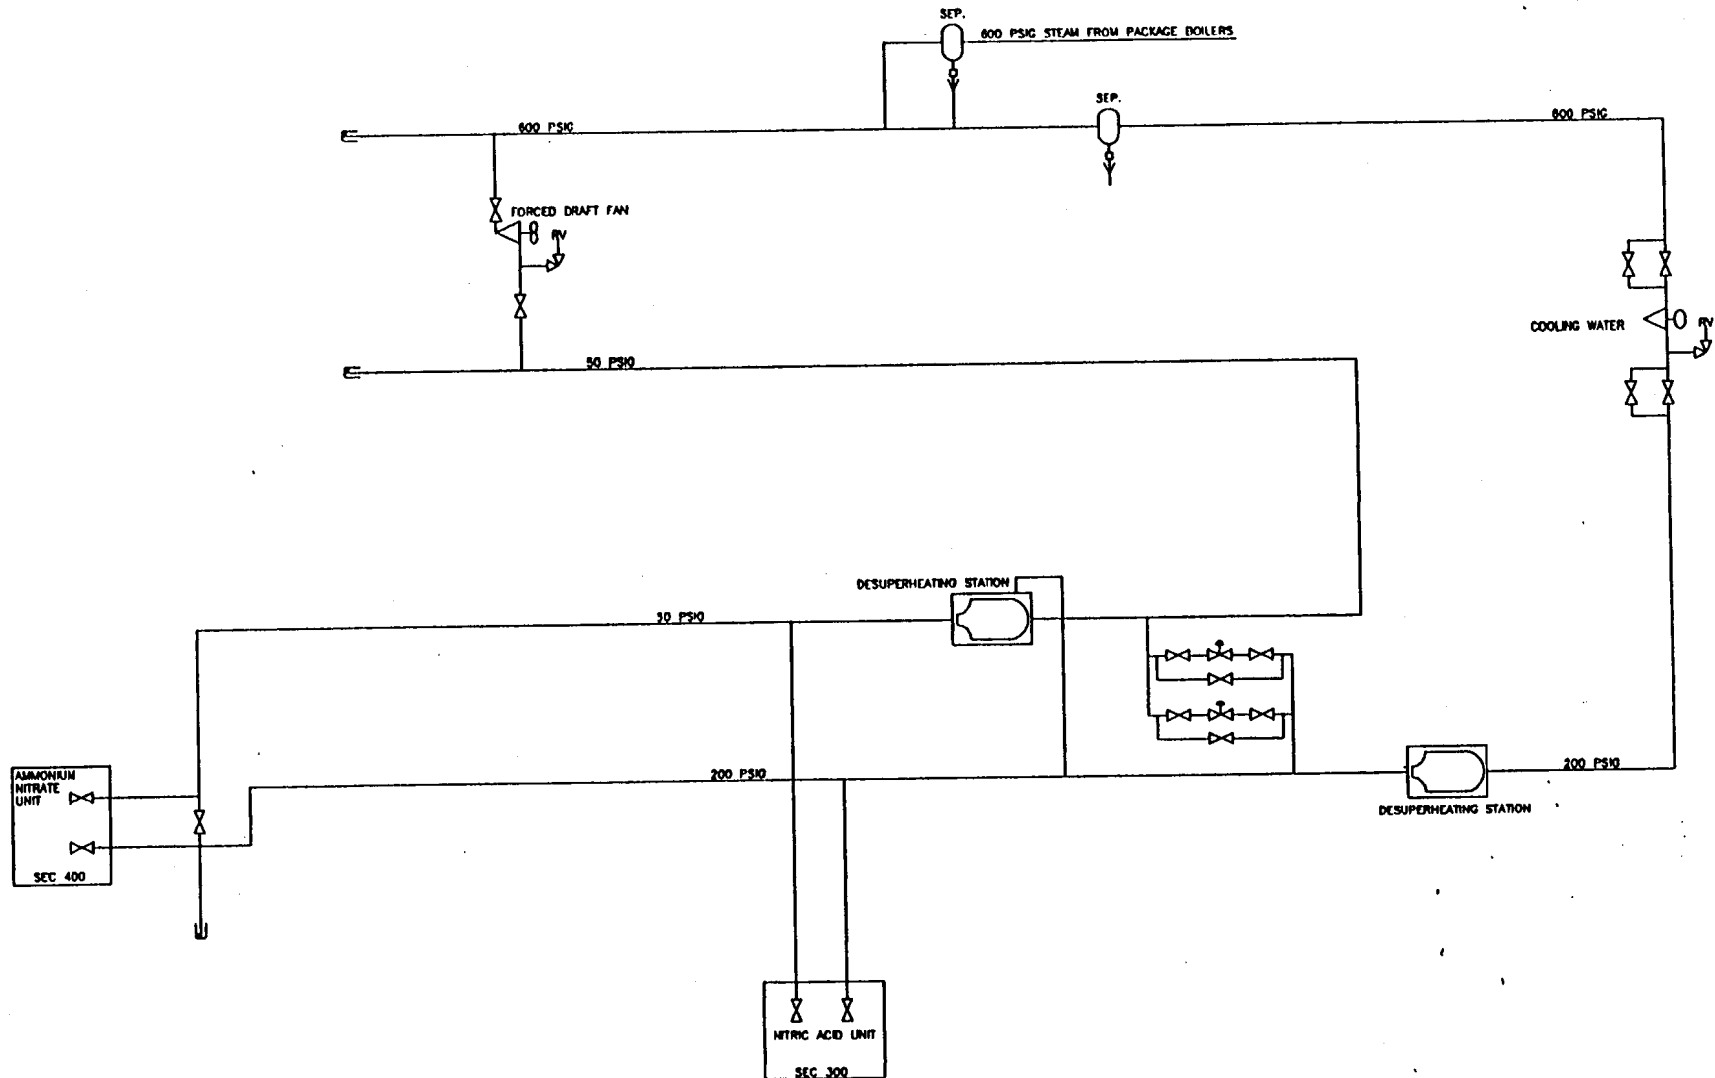
FIGURE 7 - 4
STEAM DISTRIBUTION SYSTEM (PARTIAL)

The investigation team concluded that the steam distribution system had the potential to supply superheat during high demand events such as the slow roll of the nitric acid compressor.

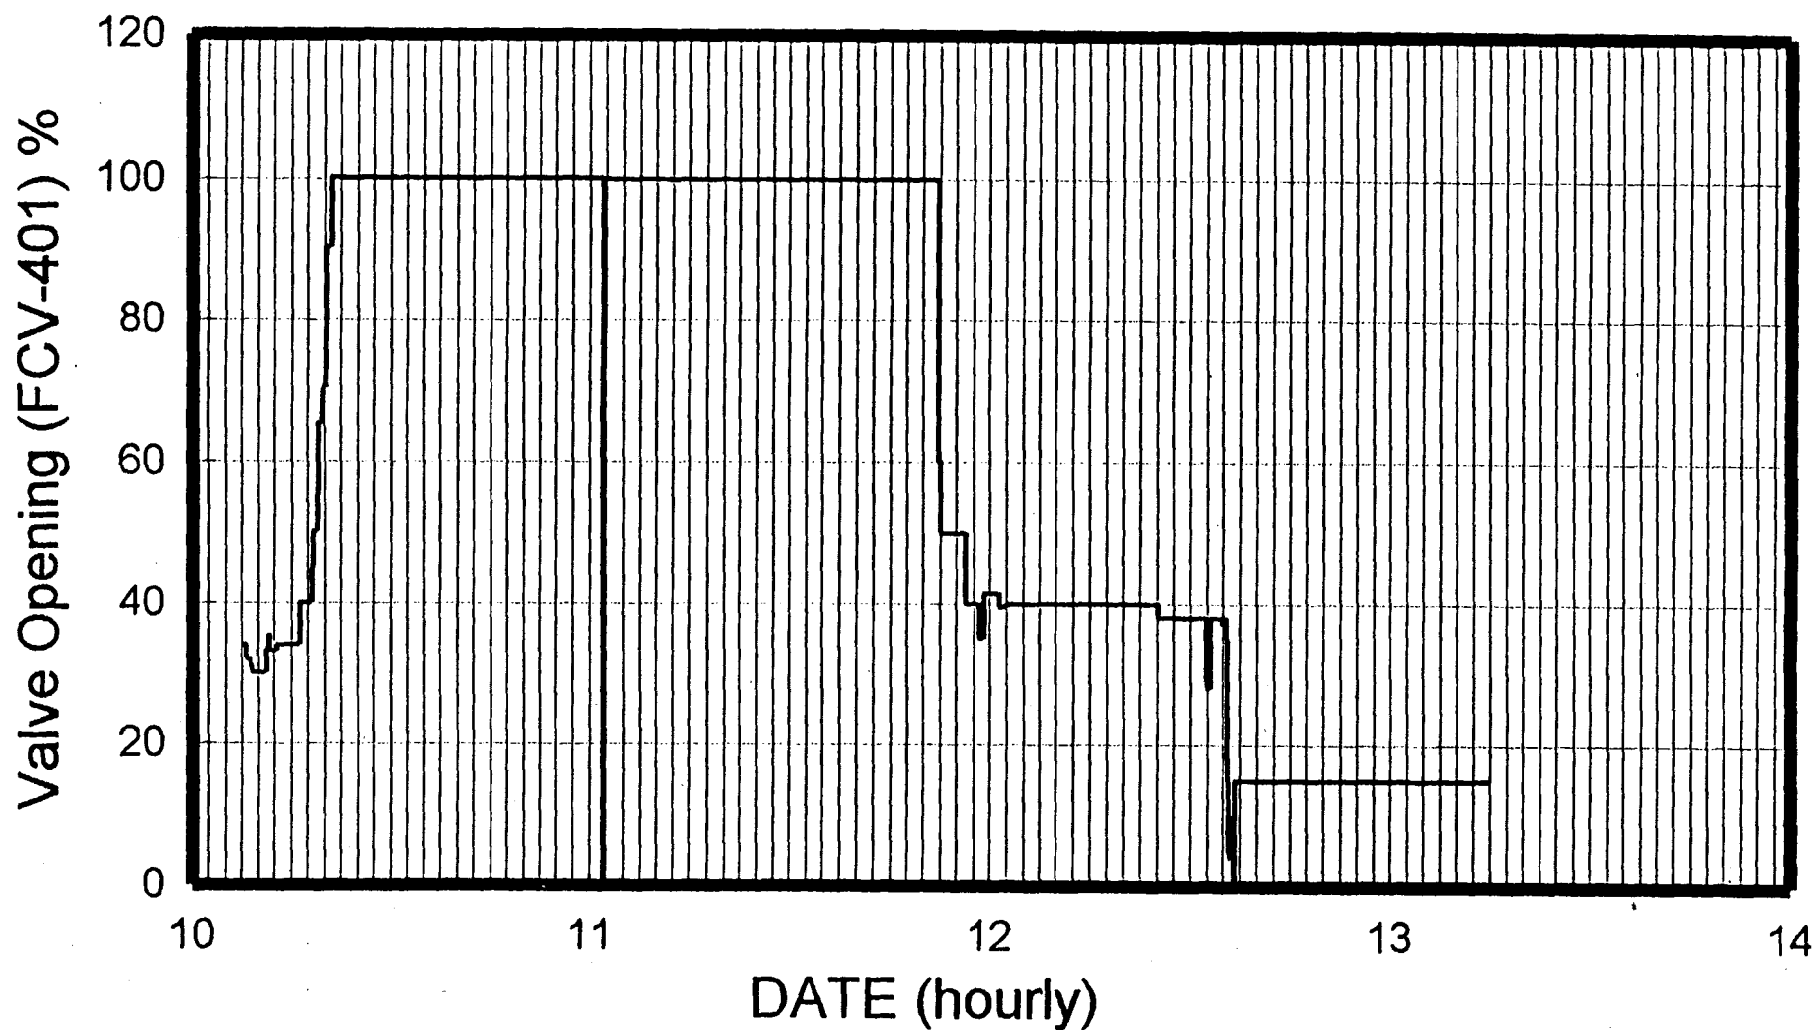
Figure 7-5

The investigation team graphed AN plant DCS data provided by Terra to document conditions in the AN plant for three days preceding the explosion. DCS data indicated that from 0903 hours on December 10 through 2050 hours on December 11, the neutralizer nitric acid control valve (FCV-401) was 100% open (*Figure 7-5*). Outside operator grab sample analyses for these periods indicate a rundown pH in the 7.0 range, heavily on the free ammonia side of the AN pH curve (*Figure 7-6*). Urea offgas flow during this period ranged from 70-85%. It appeared to the investigation team that when the urea plants were operating efficiently, the supply of nitric acid to the AN plant was limited and would not maintain the specified pH range of 5.5-6.5.

Interviews with Terra employees indicated that acid supply to the AN plant had been a periodic problem for a few years prior to the installation of the scrubber [ID-14, ID-23]. Terra increased the nitric acid pump capacity to overcome the problem, but periodic shortages still occurred in the AN plant, apparently due to losses in the piping resulting from a combination of pipe diameter and length. The investigation team determined that when the AN scrubber was installed, the nitric acid supply for the scrubber was taken from the same nitric acid line that supplied the neutralizer without increasing the capability to supply nitric acid to the AN plant.

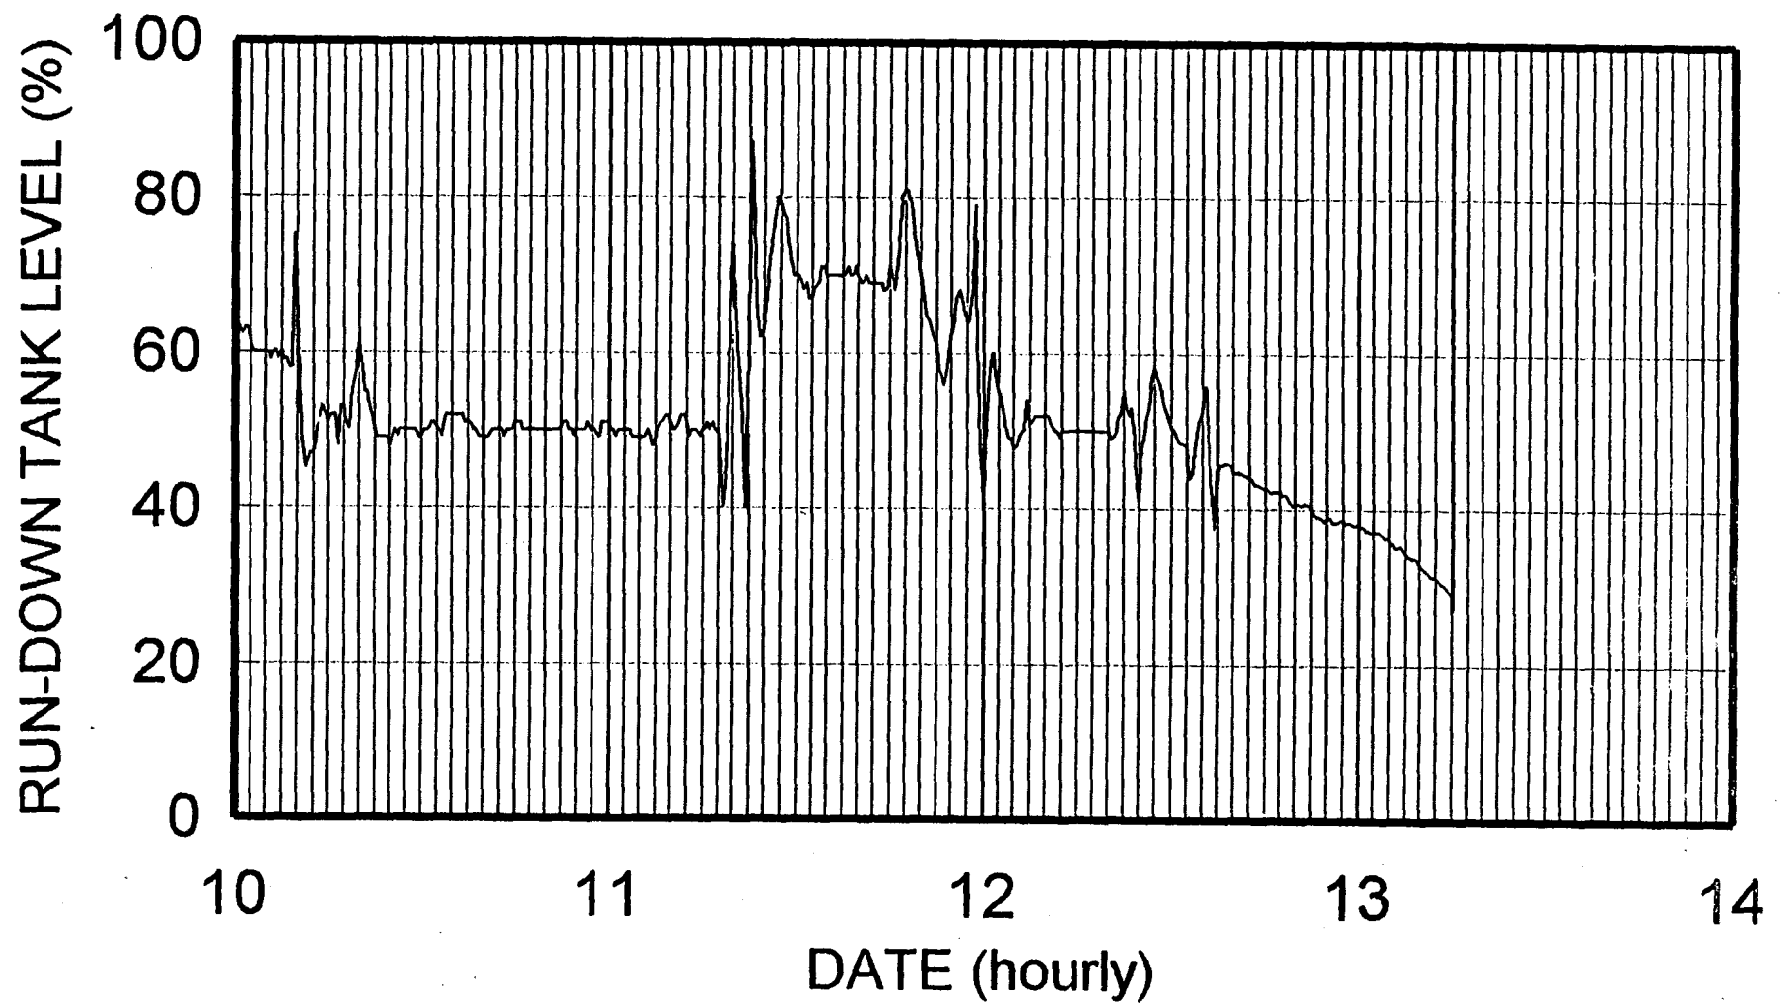
FIGURE 8-1

2. The indicated level in the rundown tank (DCS data) steadily declined at a rate of approximately 50 gallons per hour from the time that the AN plant was shut down until the explosion. The rate of decline of the DCS indicated rundown tank level remained constant over this time period. (*Figure 8-1*)

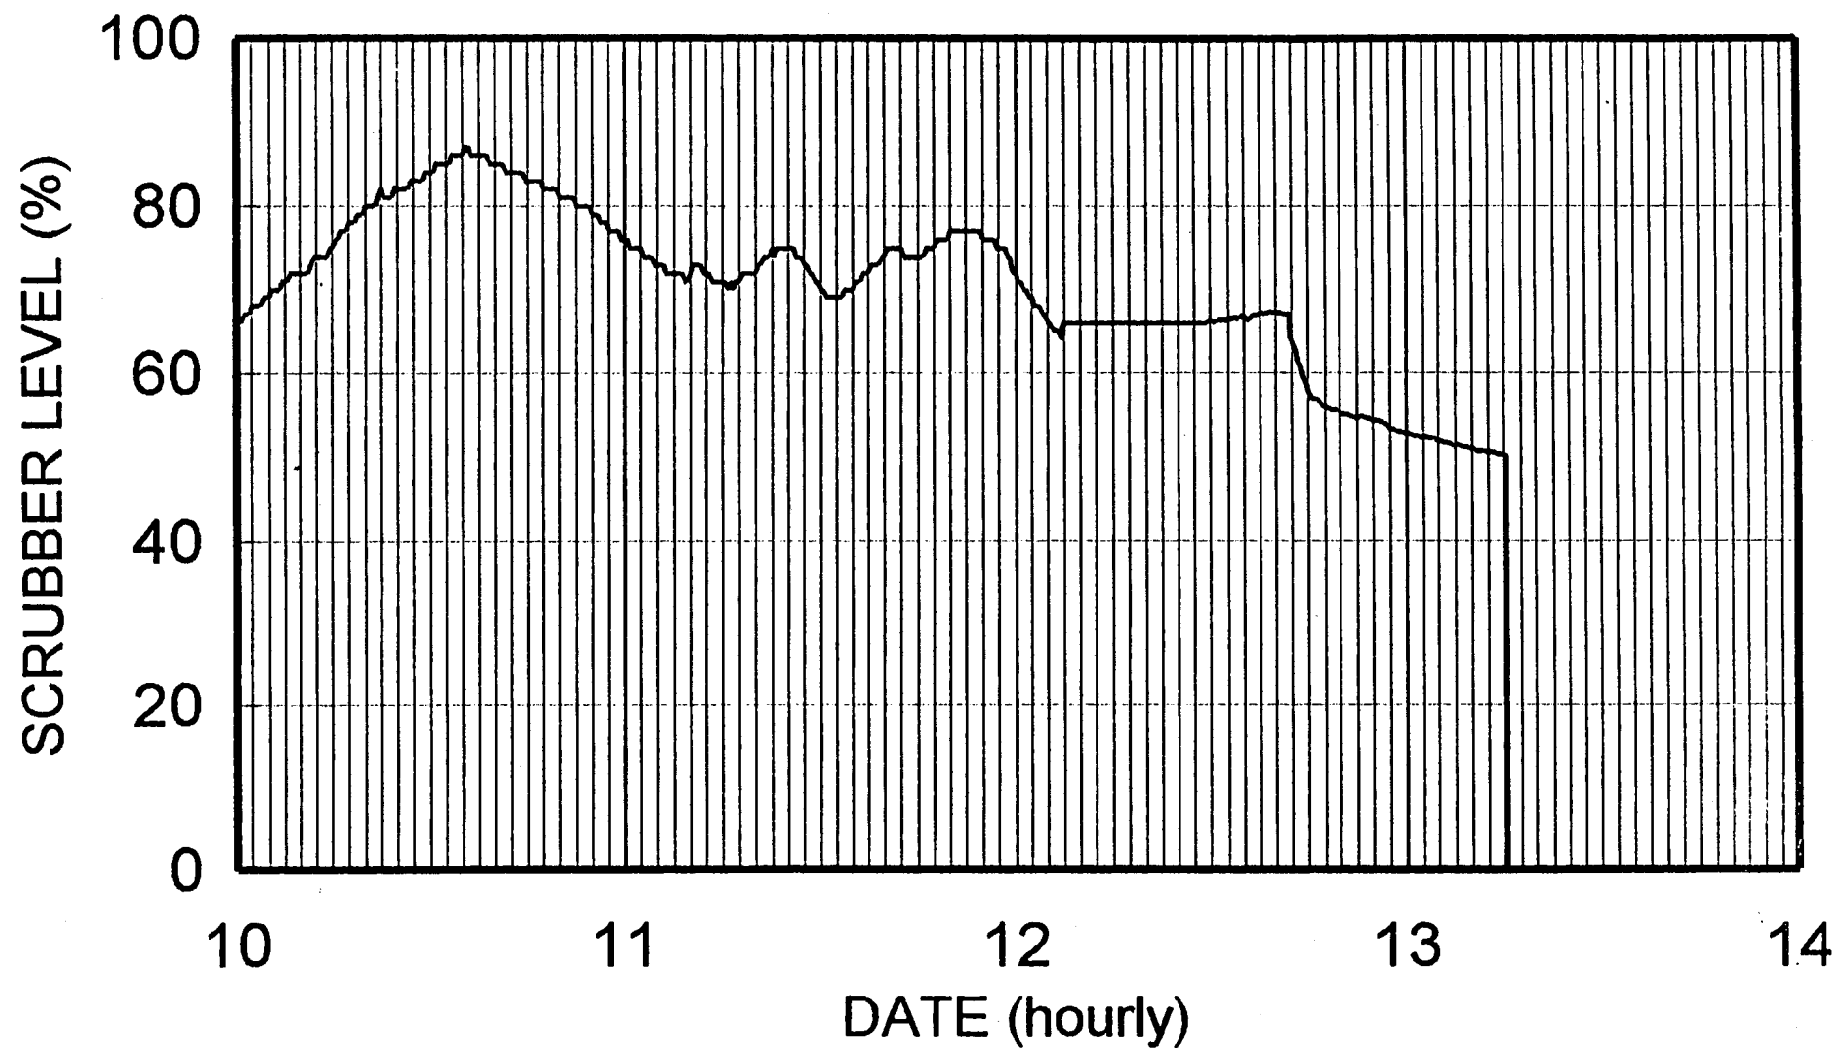
FIGURE 8-2

The investigation team reviewed DCS data pertaining to the AN scrubber. The data indicated that the scrubber level declined at a steady rate following the blowdown event occurring on December 12 through the time of the explosion (*Figure 8-2*). The investigation team determined that two plausible scenarios for this decline were:

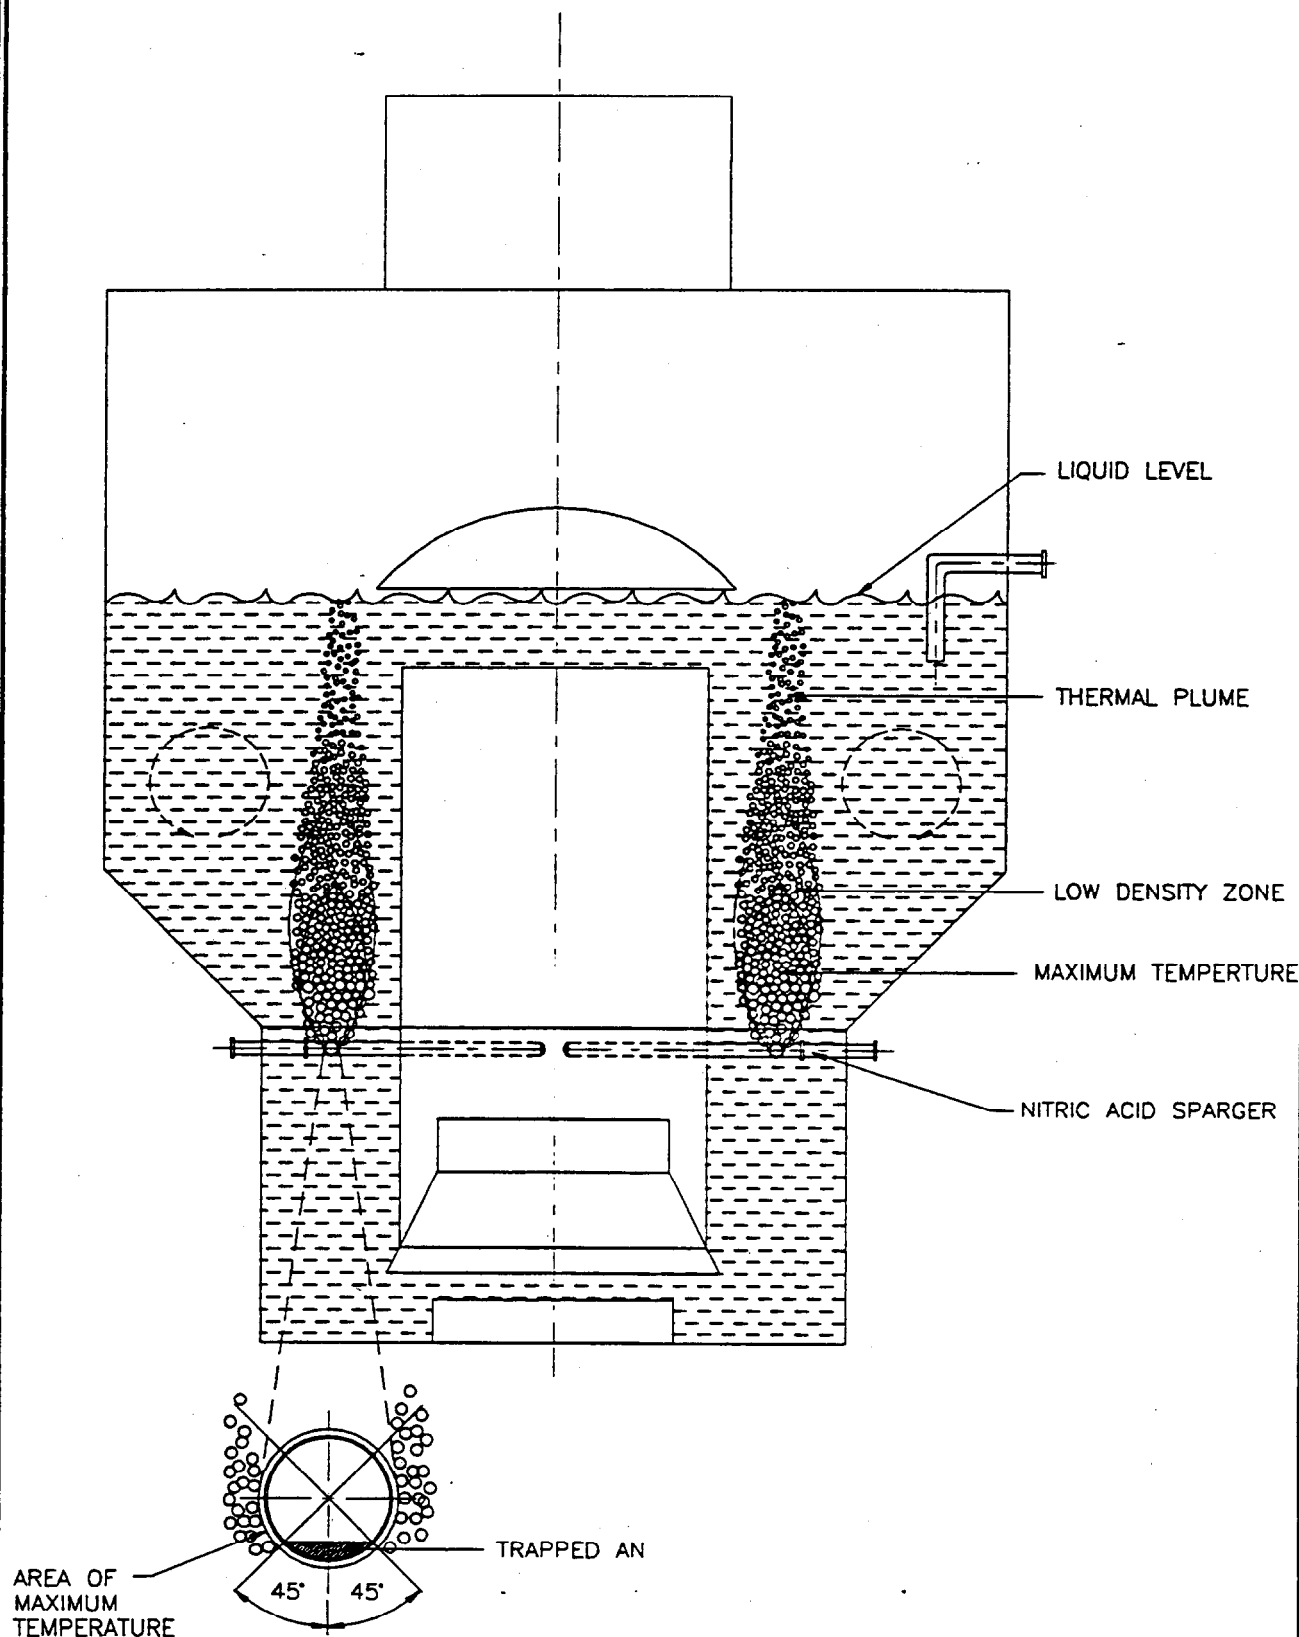
CUT CROSS SECTION OF NEUTRALIZER

Calculations indicated that continued steam heating would have resulted in a high temperature (near the temperature of the steam) and a low-density zone to develop directly around or above the sparger. Sensitizing factors lowered the thermal decomposition activation energy of the AN. The combination of energy in the input steam and the addition of superheat (possibly due to high steam demands in the nitric acid plant) exceeded the activation energy of the AN, resulting in the onset of thermal decomposition. The initial dissociation reaction was endothermic, and would have been quickly overcome due to its close proximity to the heating source. As heat continued to be transferred into this zone, the reaction became exothermic and self-sustaining [13]. At this point, large volumes of gases would have been formed. The effect of the rapidly expanding gas would have been twofold:

1. Adiabatic compression of the bubbles in the AN solution resulted in a more rapidly expanding wave front (deflagration propagation) [1]; and
2. Overcoming the vent capacity of the neutralizer, rundown tank, and scrubber system that, in turn, resulted in additional confinement until the vessels failed [21].

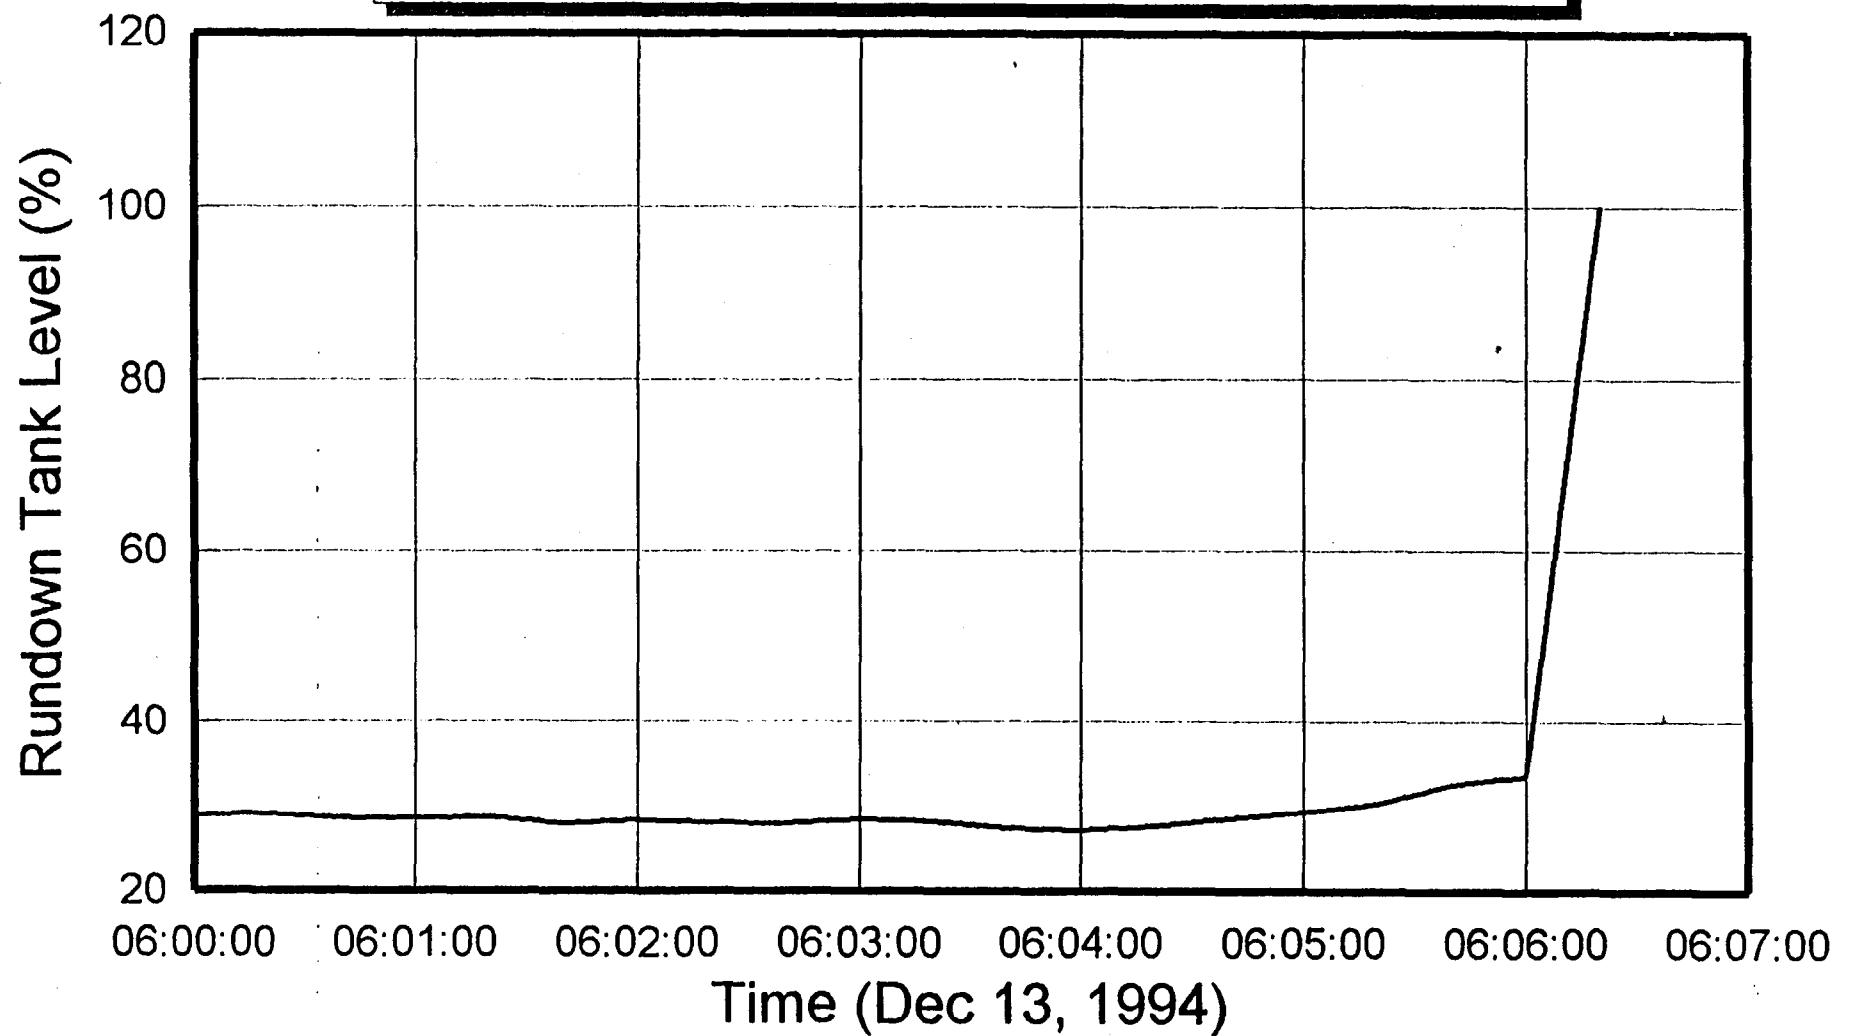
FIGURE 8-5

3. The rundown tank was equipped with steam coils that were attached to a steam header, but steam was not applied because of problems with the coils.
4. The pH of the rundown tank solution was determined to be approximately 1.0 and analytical data indicated the presence of chlorides.
5. Approximately 2 minutes before the explosion (DCS time), the level indication showed an exponential increase to an indicated level of 100% at the approximate time of the explosion (*Figure 8-5*).

The investigation team determined that the explosion in the rundown tank most likely occurred as a result of impacts of high-energy metal fragments originating from the exploding neutralizer.

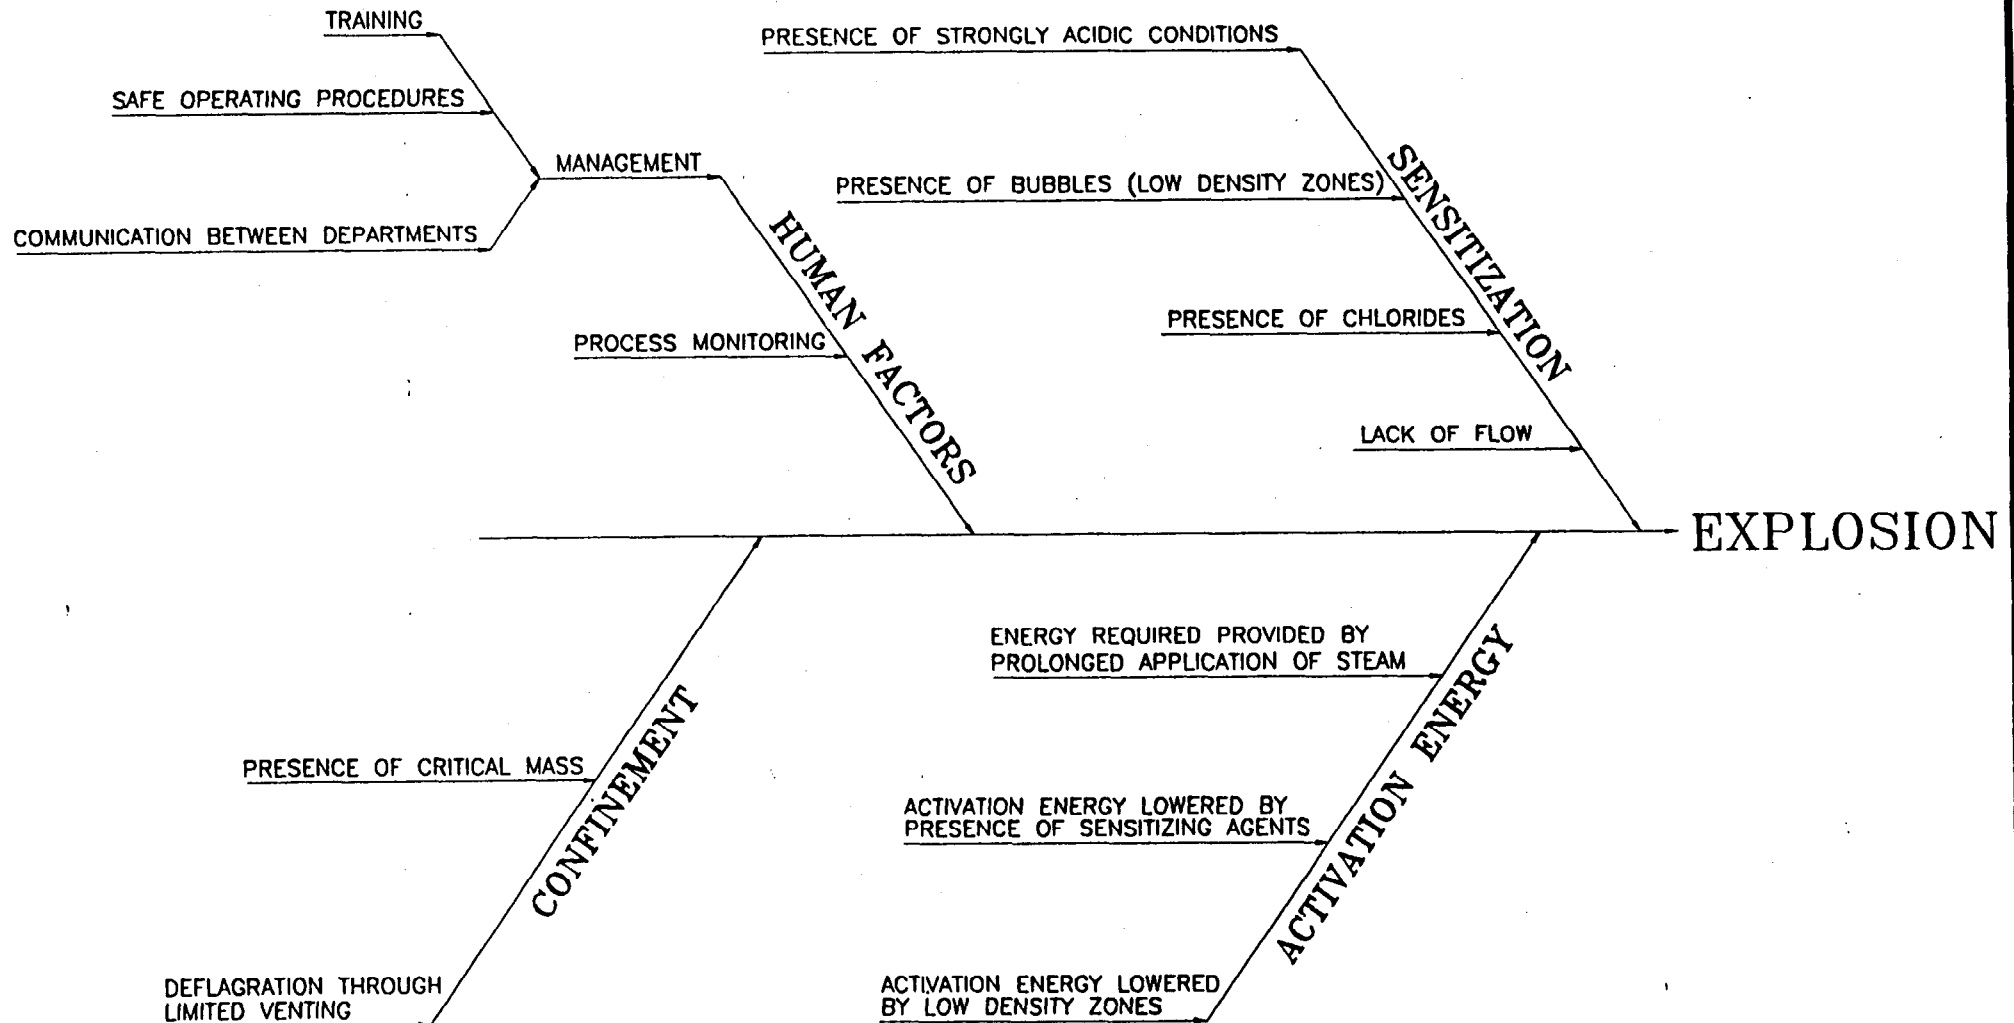
FIGURE 10 - 1
EXPLOSION FACTOR FLOW CHART

CONTRIBUTING FACTORS TO THE EXPLOSION AT THE TERRA PORT NEAL, IOWA FACILITY ON DECEMBER 13 - 1994
