Aviation Safety

Maintainer

Issue 2/2004

Cross-Wired Side-Stick Almost Brings Down Airbus A320

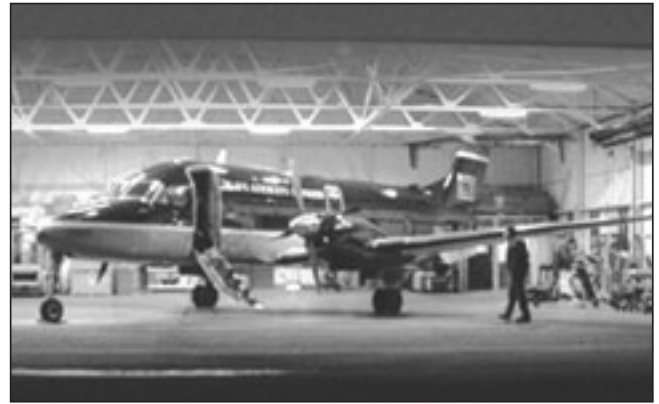
What maintenance action could have caused such a pitch change? Investigators were able to recover the elevator control system cables, elevator control rods, bell cranks, and elevator counter balance weights, all intact, from the wreckage. Examination of the elevator control cables revealed that the turnbuckle on the “down” elevator cable was offset to nearly full extension and the turnbuckle on the “up” elevator cable was near the fully retracted position, a difference of 1.8 in. The turnbuckles are used to set cable tension and are typically adjusted to about the same length. Through ground tests, which included a series of control column sweeps to collect data on the movement of the elevator and various cable tensions and turnbuckle lengths used during testing, investigators were able to reproduce similar conditions and obtain results that confirmed that the BE1900D had sustained a failure of its flight controls in pitch because of the incorrect rigging of the elevator control system. The extent of the loss of pitch control was further compounded by the airplane’s centre of gravity that was substantially aft of the certified limit. The accident occurred at the most crucial stage of flight and presented the most dangerous situation that a crew may be faced with; loss of elevator control authority following takeoff with an aft centre of gravity moment past maximum. “This accident shows how important it is for everyone involved in the safety chain to do their jobs properly,” said U.S. National Transportation Safety Board (NTSB) Chairman, Ellen Engleman-Conners. “It is imperative that the recommendations we’ve issued today be

Same aircraft type as in accident.
