Electrical Infrared & Thermal Imaging Inspection **Nova Centre IR Scan 2023**

Report Title	Nova Centre IR Scan 2023
Company Name	Page Property Management
Phone	902-579-2686
Email	cthomas@pagepm.ca
Site Name	Nova Centre, Halifax
Site Location	1650 Grafton St, Halifax, NS B3J 0E8
Thermographer	Patrick Miller
ITC Certification No.	Level II Thermographer (221112-1)

On May 17, 18, 19, 2023, Dynamic Thermal Imaging conducted a thermal inspection of the electrical assets at The Nova Centre in Halifax, Nova Scotia.

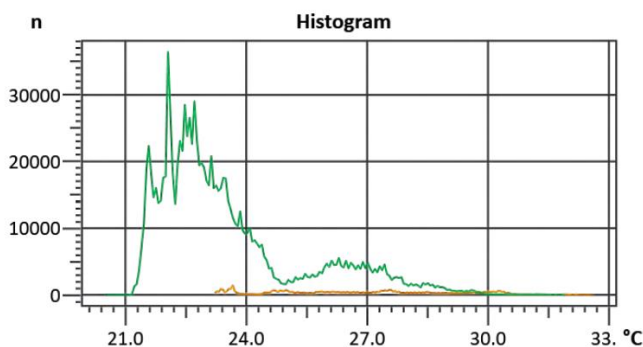
Equipment Summary		Measurements		Parameters	
DTI Infrared No.	222125	Sp1	29.3 °C	Emissivity	0.95
Location	Mechanical Room 676	Bx1		Distance	0.24m
Label	E6P2A cct 15,17,19	Max	35.8 °C	Atmospheric temp.	20.0 °C
Equipment Type/Description	Breaker	Avg	28.1 °C	Relative humidity	50.0%
Rating	208V 30A	Min	23.2 °C	Ext. optics temp.	20.0 °C
Problem	Current exceeds 80% of the breaker rating.	Dt1(公式)		Reference temp.	0.0 °C
Recommendation	Replace breaker.	Bx1.Max-Sp1	6.5 °C		
Action	Repair Required	Delta			
		Value			
Amperage Reading:	31.2200 A

High temperature connection found on 3p30A breaker CCT 13,15,17, feeding Emergency Panel E6LP2D. Current readings are: PhA 22A, PHB

31A, PhC 7A. This emergency panel shows an unbalanced load which should be investigated further. Unbalanced loads may be caused by too many loaded circuits on one phase, or time of day use. Balancing a panel can be particularly difficult due to different loads being energized at different times.

Current readings exceed the rating of the breaker. Wire appears to be #6awg copper, which can safely be put under a 3p60A breaker. Recommend upsizing this breaker to avoid unwanted

Severity: Potential Problem

downtime of emergency panel.
