Stewardship for Buckwater

Lead Steward: Neil

2023-12-18

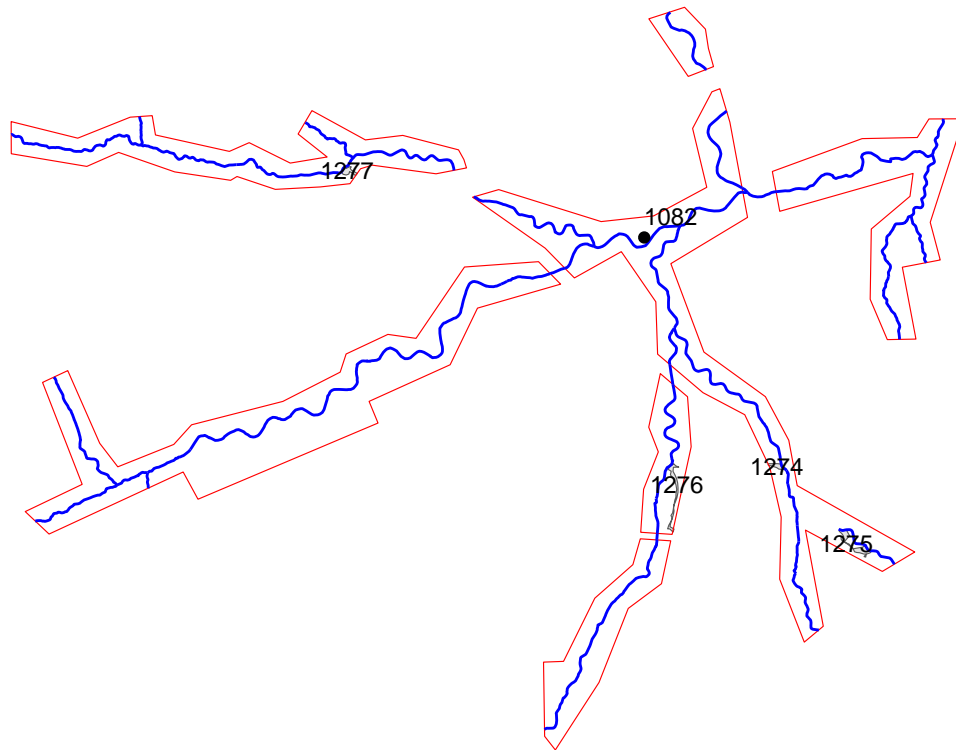
Miscellaneous Issues

OBJECTID	Year	Subtype	Description	Resolved
1274	2023	Misc	Repair area 1 LOD	No
1275	2023	Misc	Repair LOD 2	No
1276	2023	Misc	Repair area 3 LOD	No
1277	2023	Misc	Repair area 4 LOD	No
1082	2023	Misc	need live staking	No
1666	2023	Beaver Dam		No
849	2022	Soil Sample	BUC3B	
850	2022	Soil Sample	BUC3A	
31	2019	Soil Sample	BW-B	
32	2019	Soil Sample	BW-B	
33	2019	Soil Sample	BW-A	
34	2019	Soil Sample	BW-C	
35	2019	Soil Sample	BW-C
